## **Unusual Corrosion of Well Tubulars and Casings in Sour Gas Lift Well Annuli – Causes and Mitigations**

### **ABSTRACT**

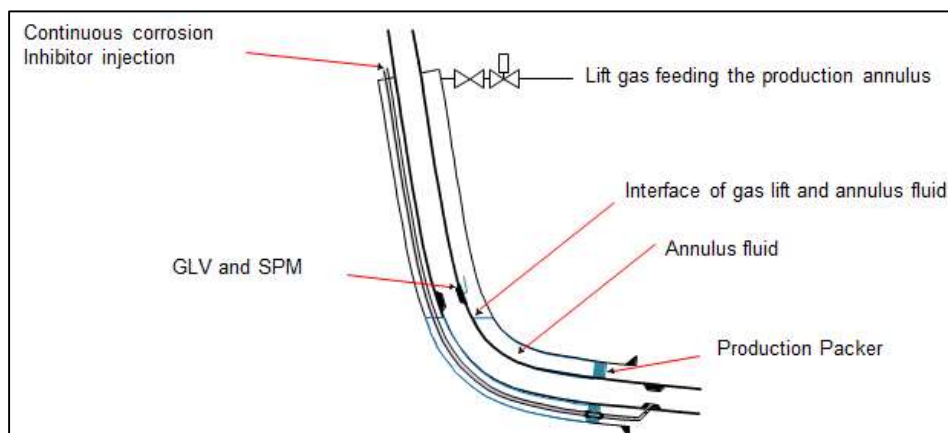
Figure 1: Basic well design

The basic well design, equipment and location of the injected gas and annulus fluids are shown in Figure 1.
