## **Failure Analysis of a Pulsation Dampener Using Statistical Fractography**

### **ABSTRACT**

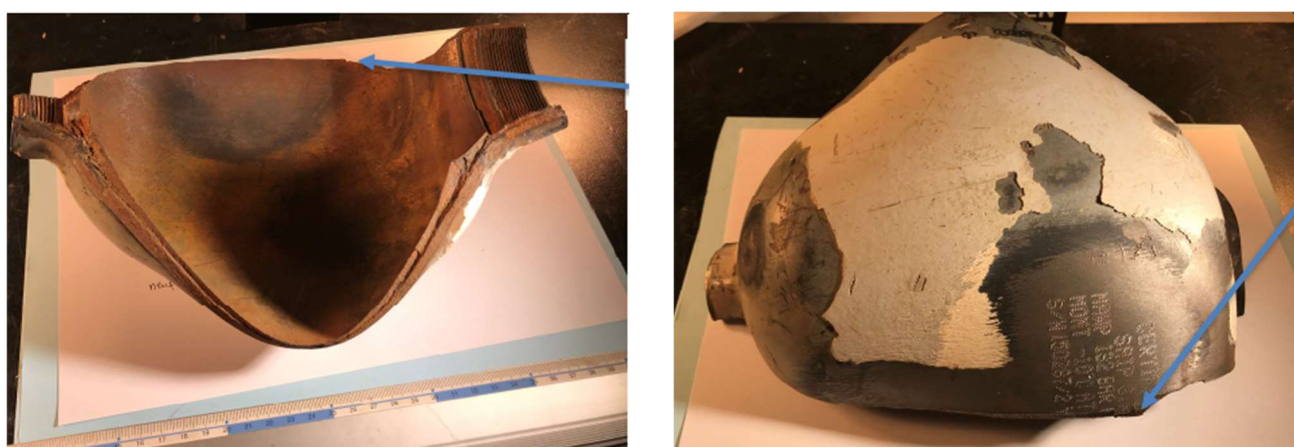
**Figure 3: Retrieved part of dampener showing high degree of deformation**

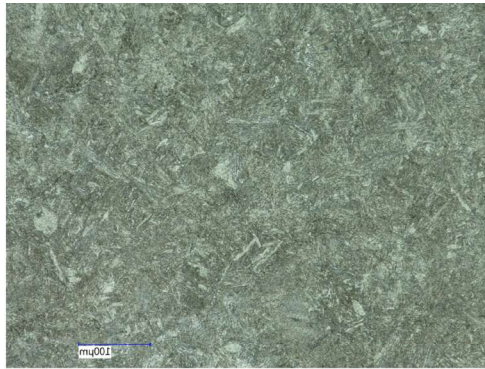
- No mechanical property anomalies against material certification were present.
- Chemical analysis was seen to meet specification.
- The microstructure was typical of a quenched and tempered low alloy steel and as expected for the given material grade. Refer Figure 4.
- There was no evidence of fatigue with an absence of striations and other typical features. See Figure 5.
- The hardness was seen to be higher on the highly deformed side (321 to 360 HV<sub>0.5</sub>) as opposed to other lesser deformed side (321 to 339 HV<sub>0.5</sub>). It is noted that the singular 360 HV<sub>0.5</sub> value on the deformed side was located within 0.4mm of the outer edge (not exposed to internal fluids), whilst lower values (< 321 to 339 HV<sub>0.5</sub>) were found closer to the inner edge. See Figure 6.

**Figure 4: Microstructure of failed dampener.**

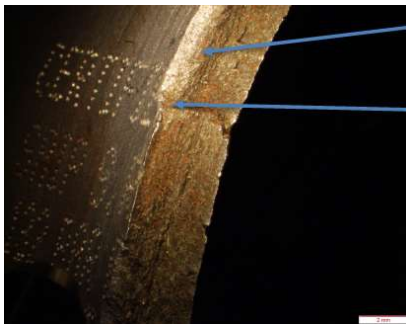
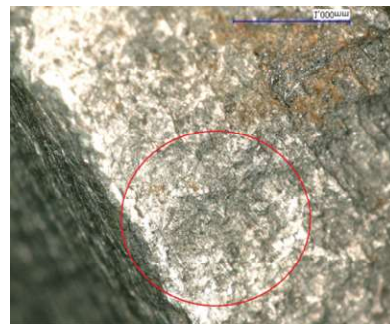
**Figure 5: Suspected area of fatigue initiation at component marking area confirmed to be free of typical striations by SEM.**

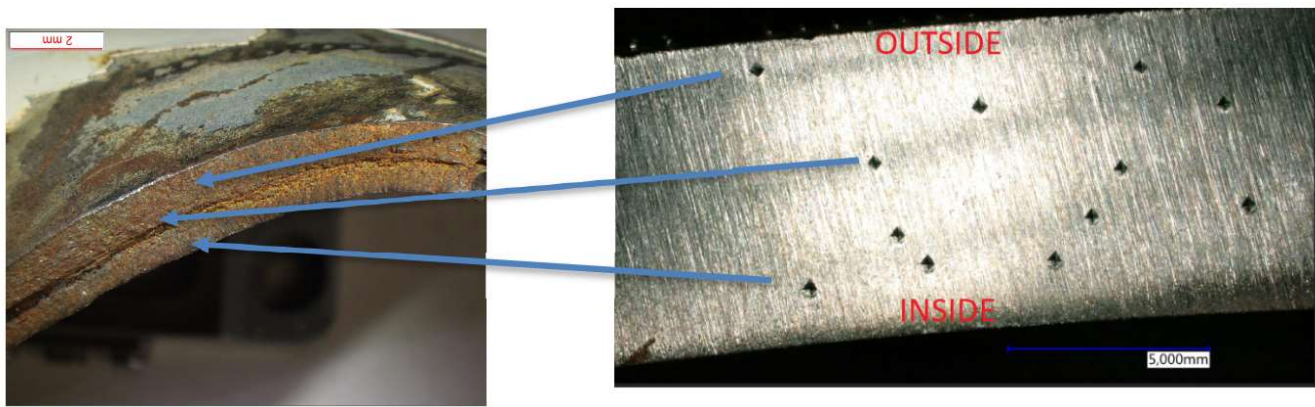
**Figure 6: Representation of fracture surface and hardness indentations.**

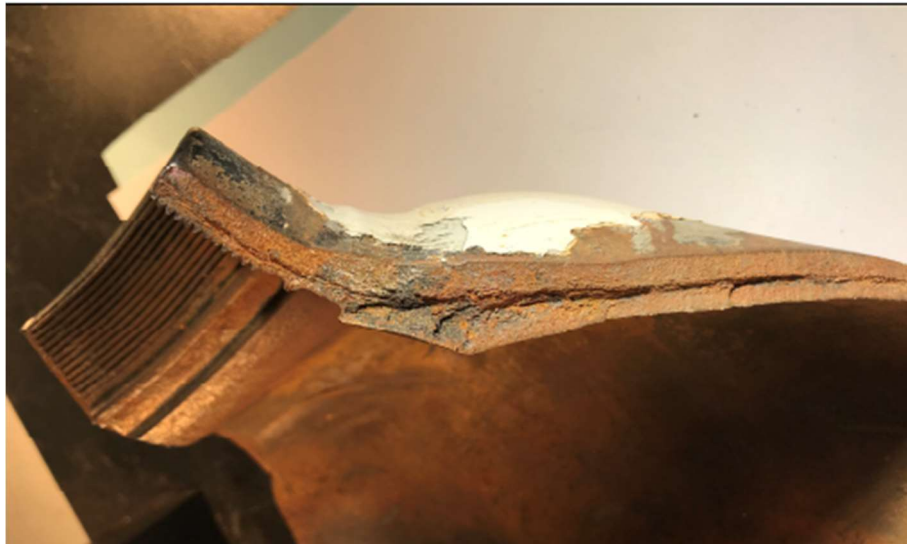
The fracture surface of the bulged region displayed two distinct regions running linearly along its length. In addition, there was some evidence of the failure proceeding in multiple stages by the presence of curved 'steps' on the inner facet. Refer Figure 6.

**Figure 6: Fracture surface with stepped appearance and curved steps on inner facet**

As seen in Figure 6, there was no evidence of thread stripping, suggesting that the dampener did in fact fracture then proceed to be propelled from its location.
