## **A CASE STUDY-CAUSTIC GOUGING OF BOILER TUBES**

**Suresh Divi and Sri Krishna Chimbli**

Stress Engineering Services, Inc.

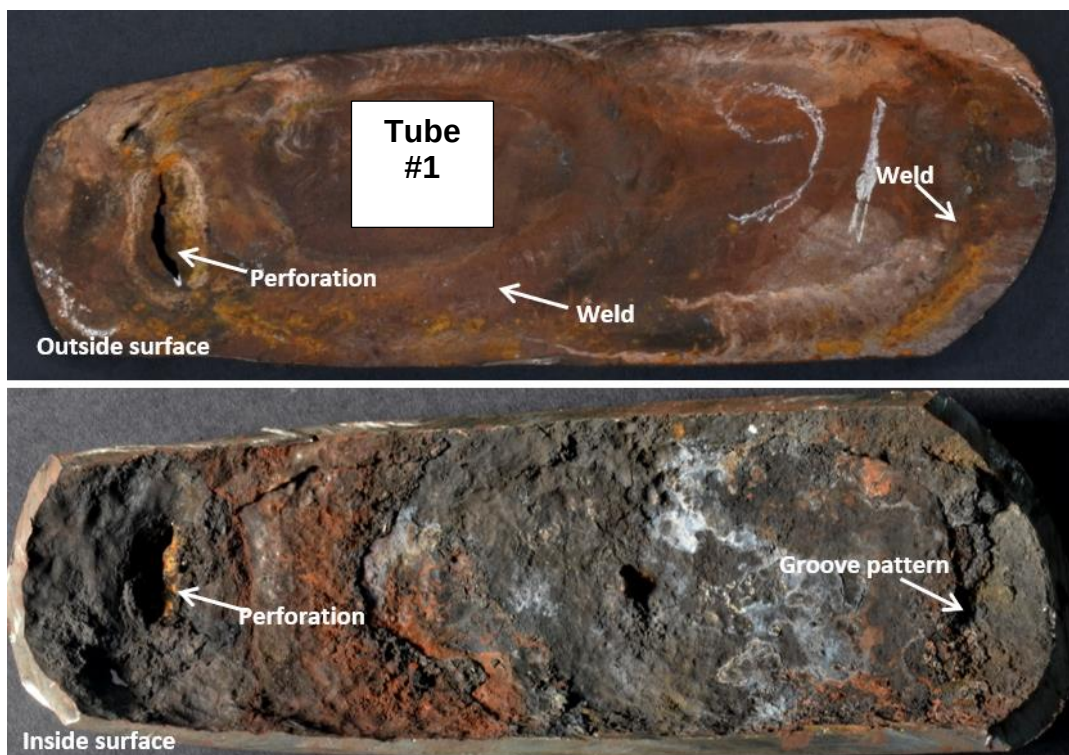
Perforation and a groove pattern adjacent to a repair patch weld was observed in one tube (Tube #1). Figure 1 shows the OD and ID surface of Tube #1. Reddish brown, dark and white colored deposits were observed on the ID surface.

**Figure 1: Outside and inside surfaces of tube #1 showing perforation at patch weld.**

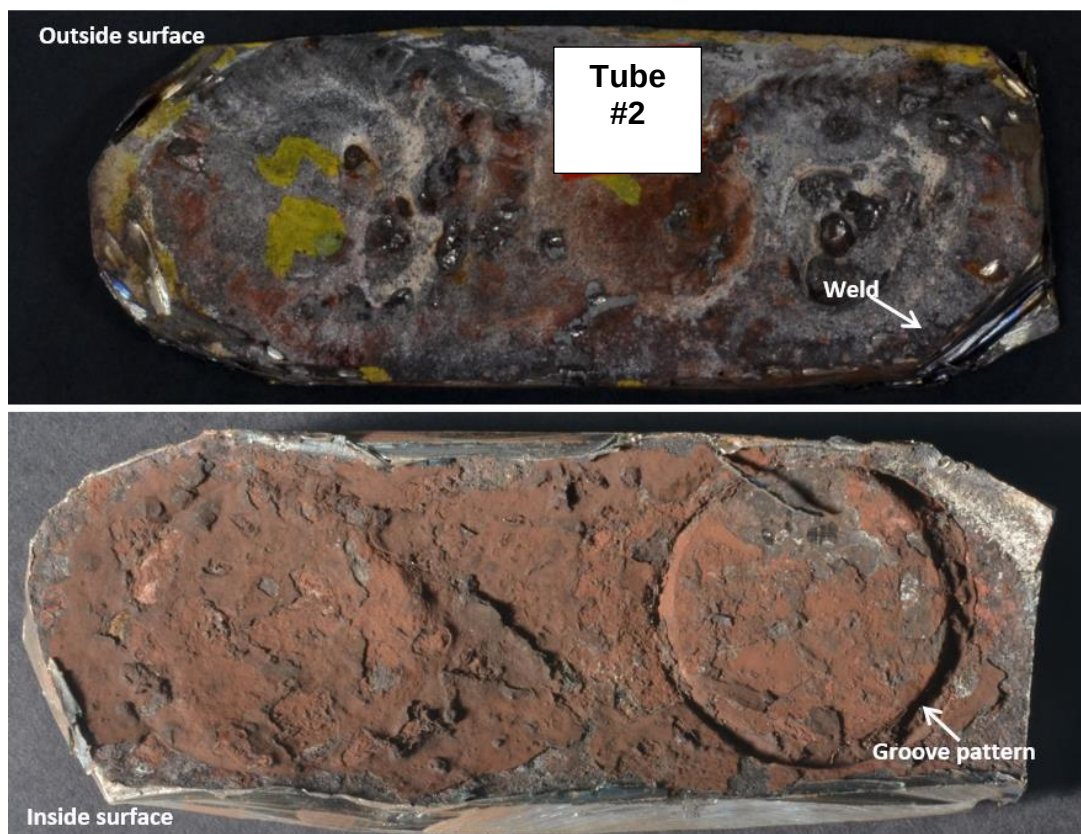
Several groove patterns at or adjacent to the repair patch weld root were observed on ID surface of Tube #2. Figure 2 shows the OD and ID surface of Tube #2. Reddish brown corrosion deposits were observed on the ID surface of Tube #2.

**Figure 2: Outside and inside surfaces of boiler tube #2. The tube inside surface exhibited groove patterns at repair patch weld root.**
