## **Premature Failure of Ni-coated Carbon Steel Fittings in Water Injection Service due to Microbiologically Induced Corrosion**

### **ABSTRACT**

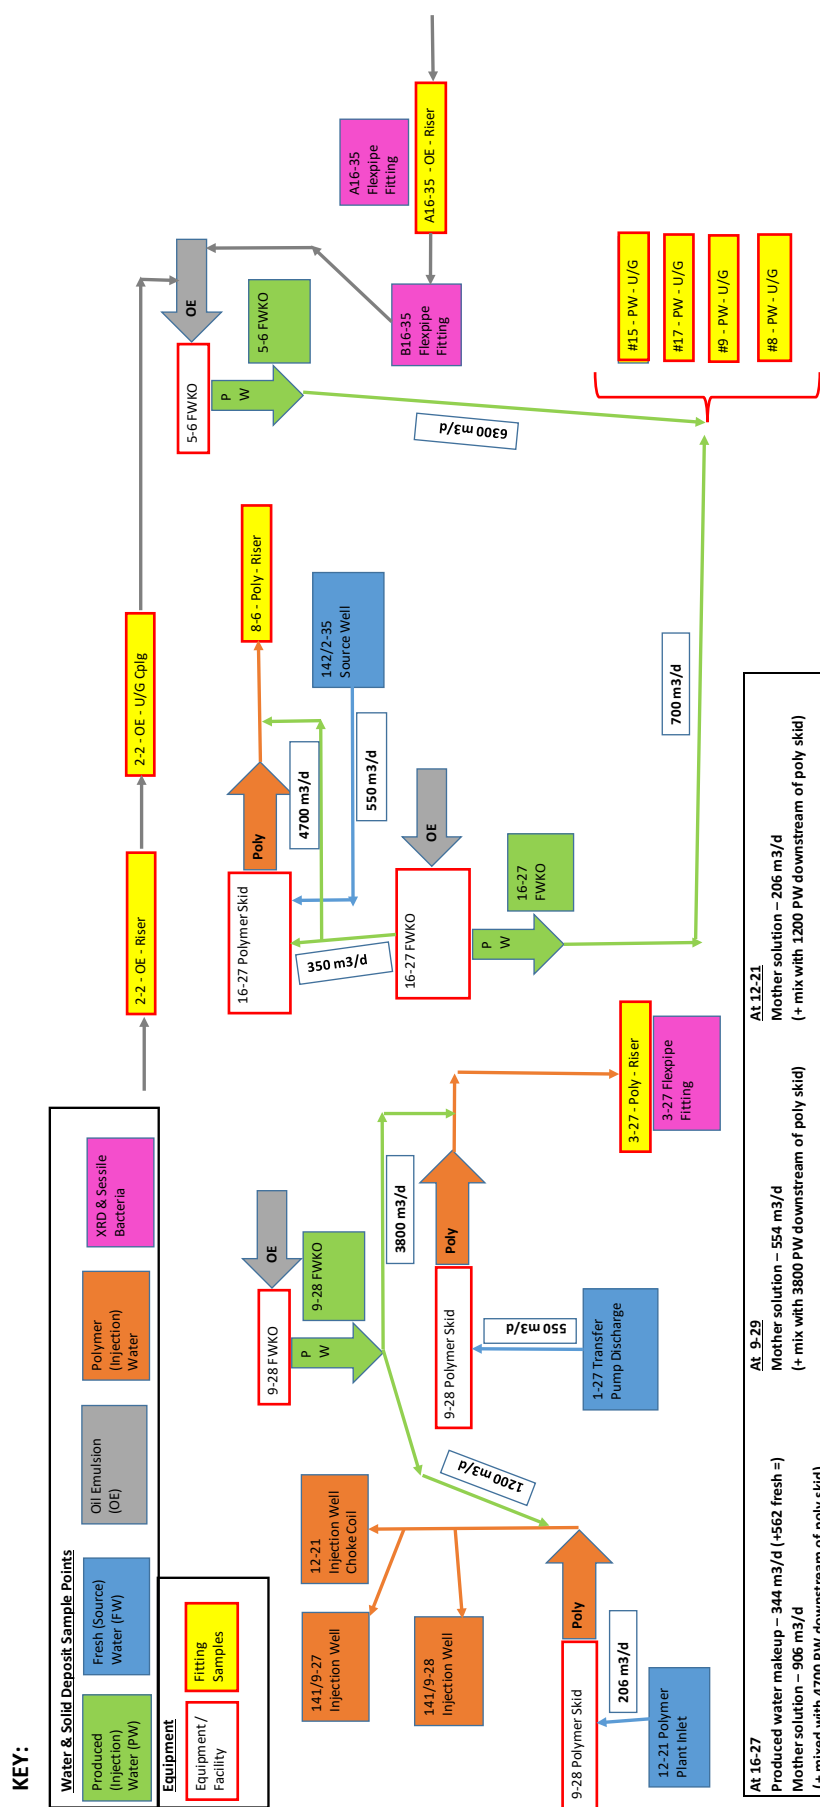
**Figure 1. Process Flow Diagram of the Oil and Gas Production Facility Showing the Various Process Streams with Key Facilities, Equipment and Locations of the Collected Samples of Water, Solids, and Bacteria**

A schematic flow diagram for the oil production and processing system is depicted in Figure 1, which shows the layout of the various process streams with the key facilities and equipment. The specific locations of the failed fittings that were used for the failure investigation, including the locations of the collected samples of water, solids, and bacteria, are also indicated on the diagram.
