## **Formicary Corrosion and EAC of Copper Tubes in Contact with Building Sealant**

Kimberly Steiner  
Wiss, Janney, Elstner Associates, Inc.  
330 Pfingsten Road  
Northbrook, IL 60062  
USA

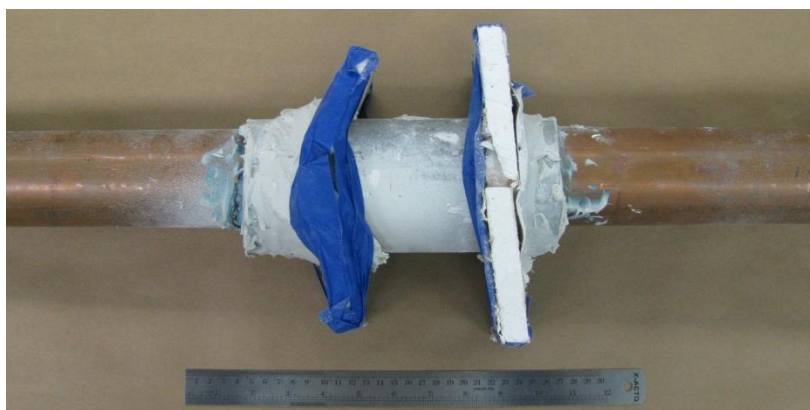
**Figure 1: Sample A as received.**

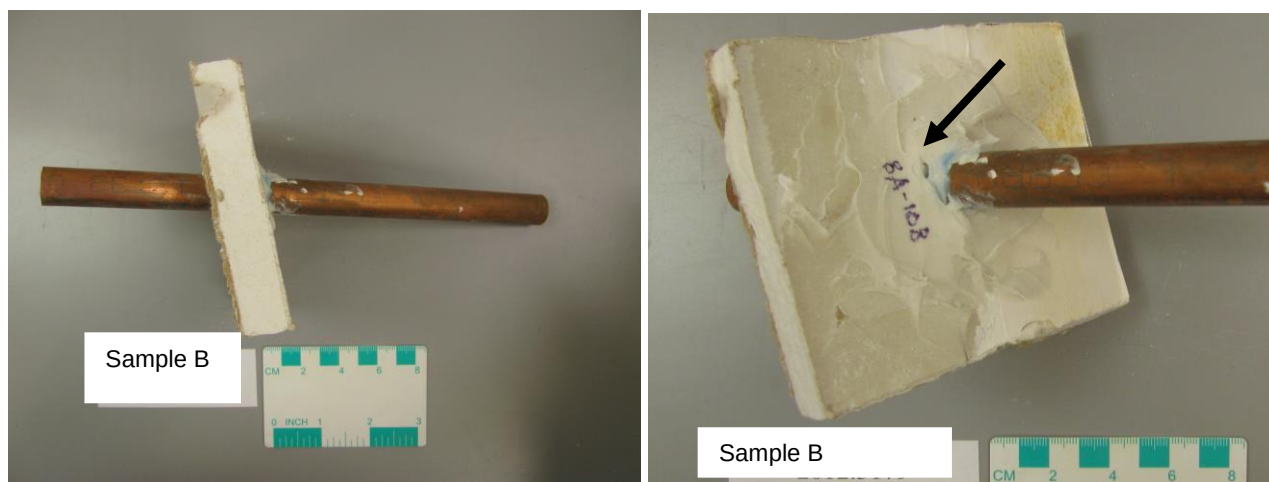
**Figure 2: Sample B as received, showing the tube penetration through the drywall on the left, and the sealant at the tube location on the right. Note the blue discoloration of the tube, indicated with an arrow in the photograph on the right.**

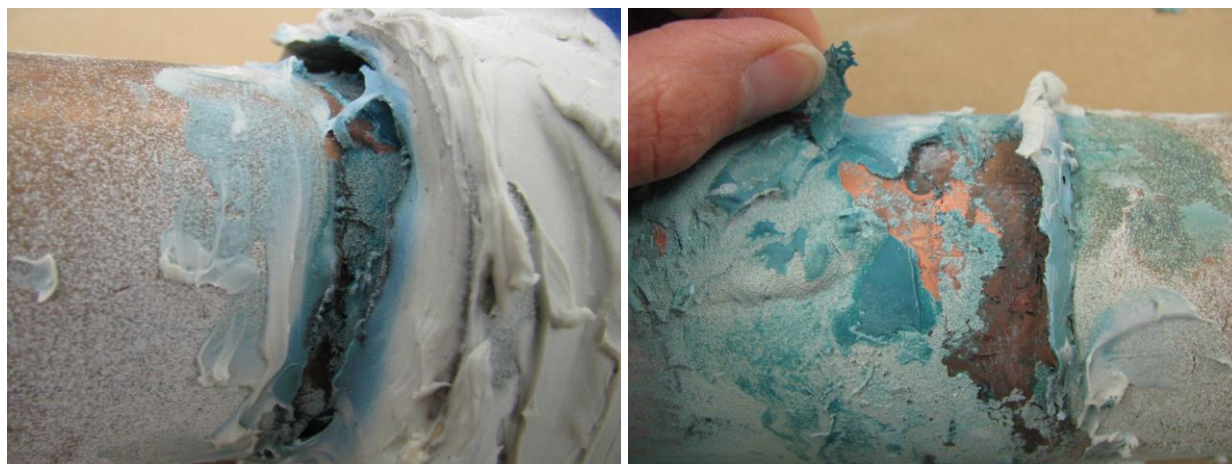
The through-wall penetration assembly of Sample A was examined visually as received. The galvanized steel pipe and copper tube did not appear to be in direct electrical contact at any point. The portions of the copper tube on the exterior of the drywall had a slightly dull copper color that is typical of copper that has been exposed to an air environment. In the immediate vicinity of the sealant, the copper tube was blue in color (Figure 3). The sealant was also blue at contact surfaces with the copper pipe. The sealant in contact with the galvanized steel pipe was generally not discolored.

**Figure 3: Sample A, showing discoloration of sealant and copper at contact location (left) and shiny copper when sealant was removed (right).**
