## **Failure Analysis of 4-Inch Welded Fittings in Treated LPG Service**

Sudhakar Mahajanam

Stress Engineering Services (SES), Inc.  
13800 Westfair East Drive  
Houston, TX 77041

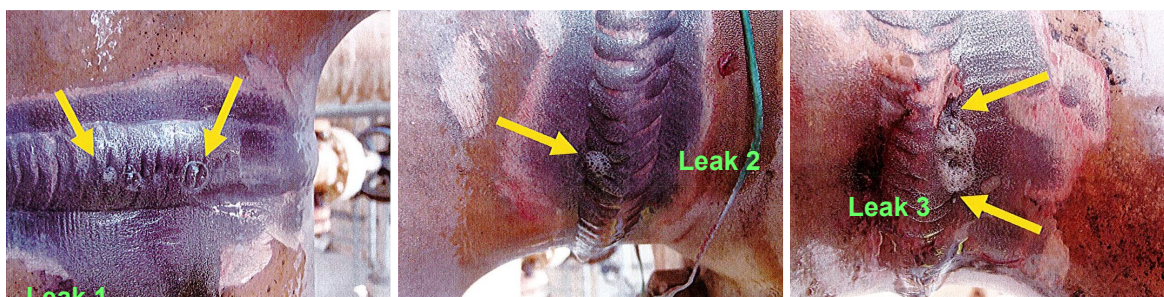
feed heat exchanger (shell side) to the depropanizer tower (LPG Merox unit) which uses caustic for extraction and about 1 ppm of carryover was expected. It was believed that caustic was concentrated within the exchanger bypass piping resulting in the cracking of these welds. Temperature monitoring at the exchanger outlet over the past 1 year indicated temperature spikes (up to 300°F from the average of 140°F), which likely increased cracking susceptibility. Leaks were found at three locations downstream of the heat exchanger during a Snoop® leak detection test of the welds, as shown in Figure 1.

Figure 1. Photographs showing the locations on the welds where leaks were found.

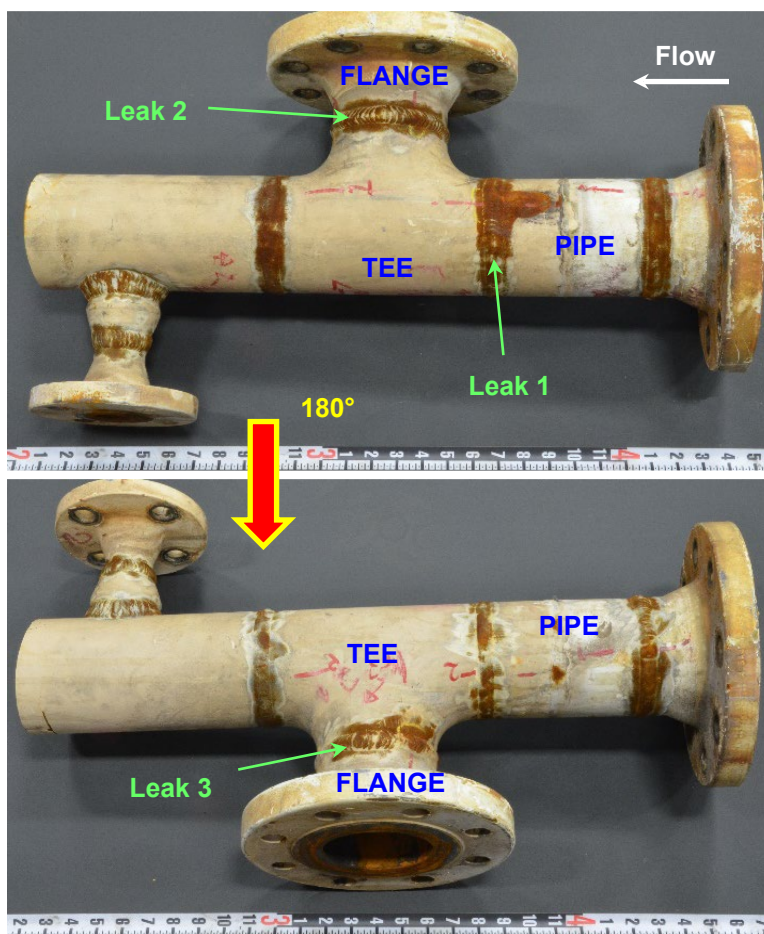
Figure 2 shows as-received photographs of the three leak locations (arbitrarily labeled 1, 2, 3). Leak 1 occurred at the pipe-to-tee weld, while leaks 2 and 3 occurred tee-to-flange weld. The flow direction was upwards, with the leaks 1 and 2 facing north, while the leak 3 was facing south.

Figure 2. As-received photographs showing the leak locations. Numbered scale divisions are feet.

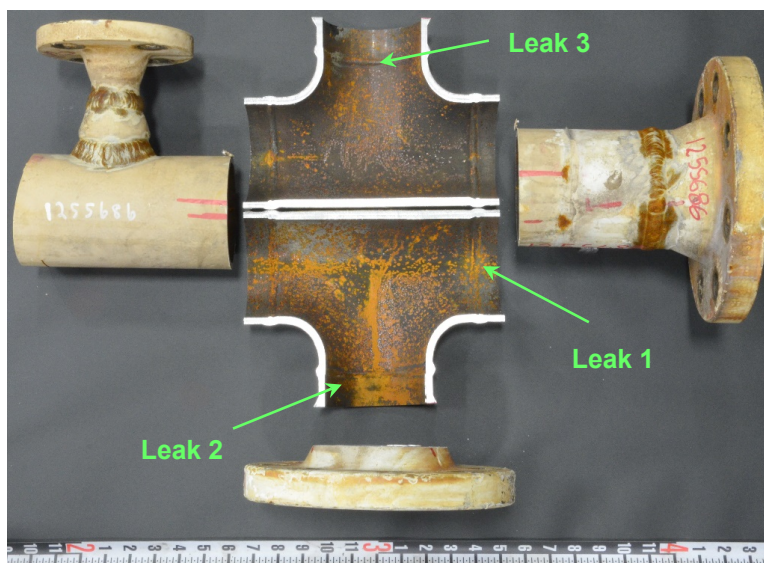
The tee was sectioned longitudinally in order to isolate the leak locations as shown in Figure 3. Light corrosion was observed on the inside surface of the tee.

Figure 3. Leak locations following sectioning in the lab. Numbered scale divisions are inches.

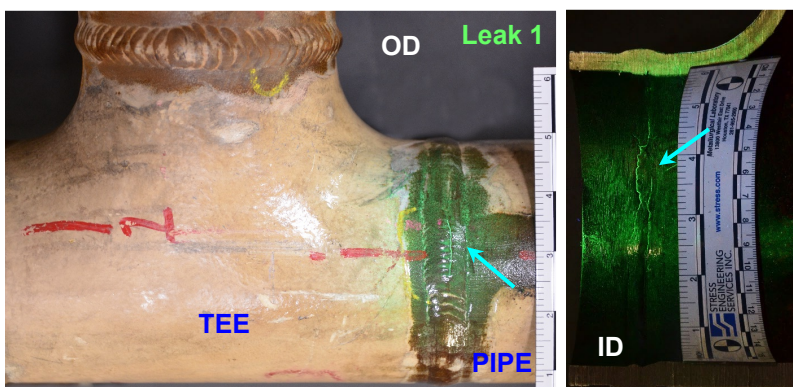
Non-destructive examination (NDE) using wet fluorescent magnetic particle (WFMP) inspection was performed at the three leak locations. Crack-like indications were observed on the outside (OD) and inside (ID) surfaces of leak 1 as shown in Figure 4. More crack branching was observed on the ID than the OD. Similar observations were made for leaks 2 and 3 are shown in Figures 5 and 6 respectively.

Figure 4. WFMP inspection of leak 1. Blue arrows indicate cracks. Numbered scale divisions are inches.

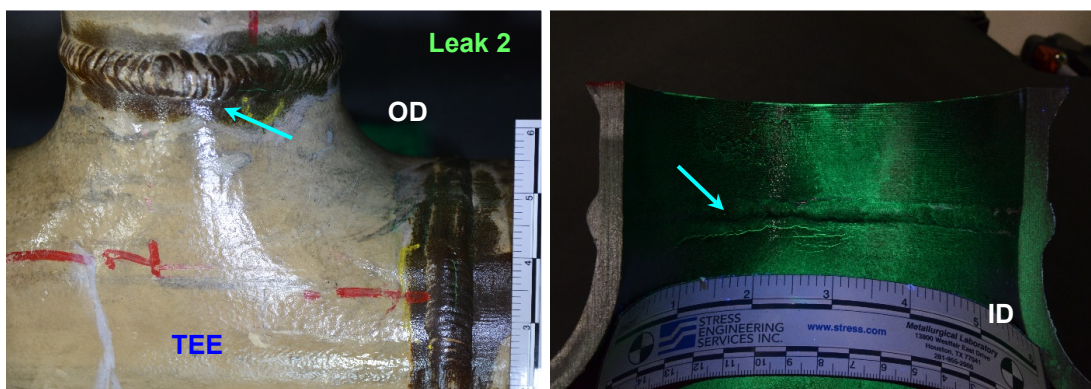
Figure 5. WFMP inspection of leak 2. Blue arrows indicate cracks. Numbered scale divisions are inches.

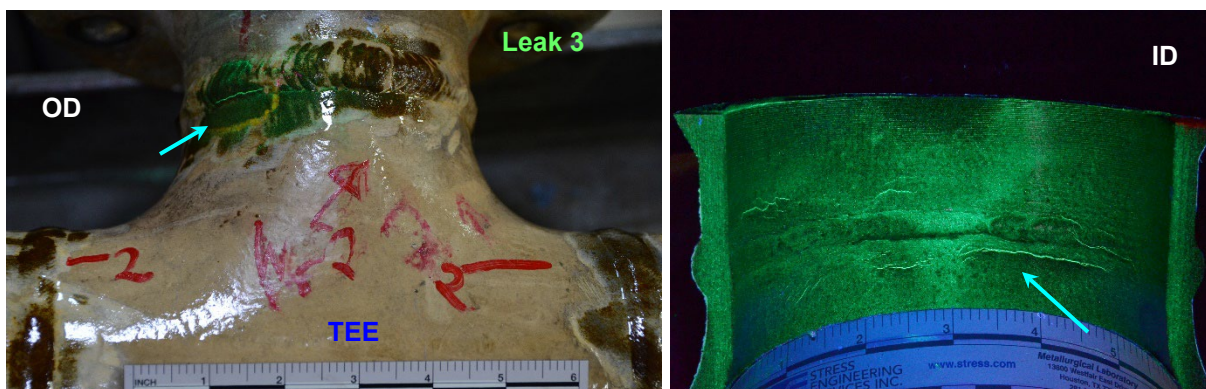
**Figure 6. WFMP inspection of leak 3. Blue arrows indicate cracks. Numbered scale divisions are inches.**

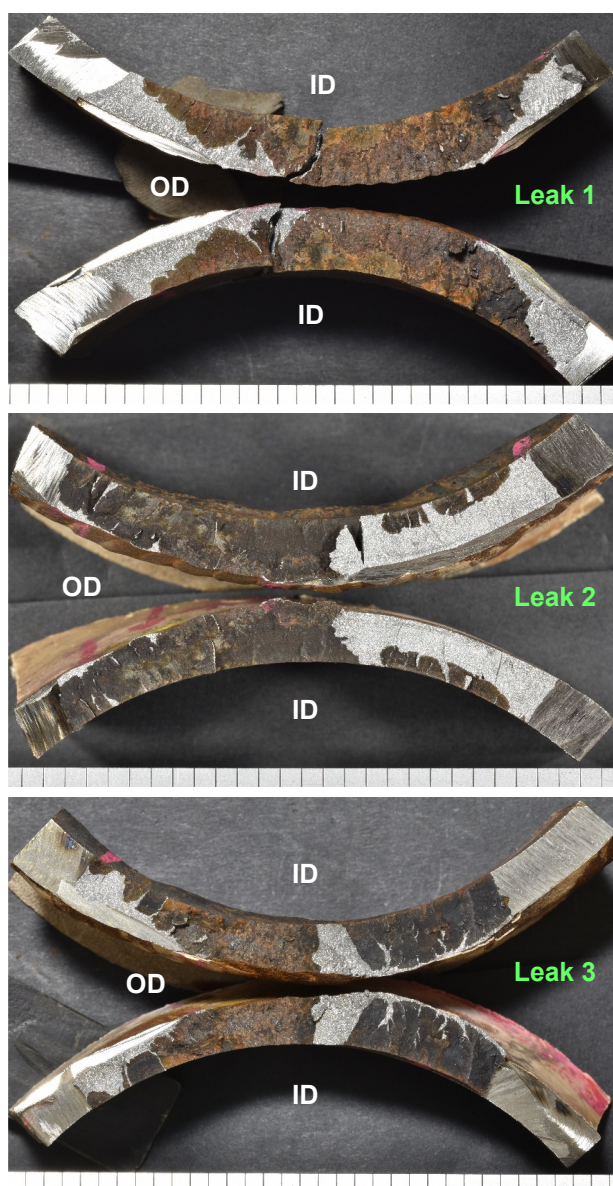
These crack-like features were broken open in the lab using liquid nitrogen. Figure 7 show photographs of these fracture surfaces following the lab fracture. The cracks initiated on the ID and all the fracture surfaces were covered with a brown corrosion product.

**Figure 7. Photographs of fracture surfaces following lab break open. Scale divisions are 0.1 inches.**

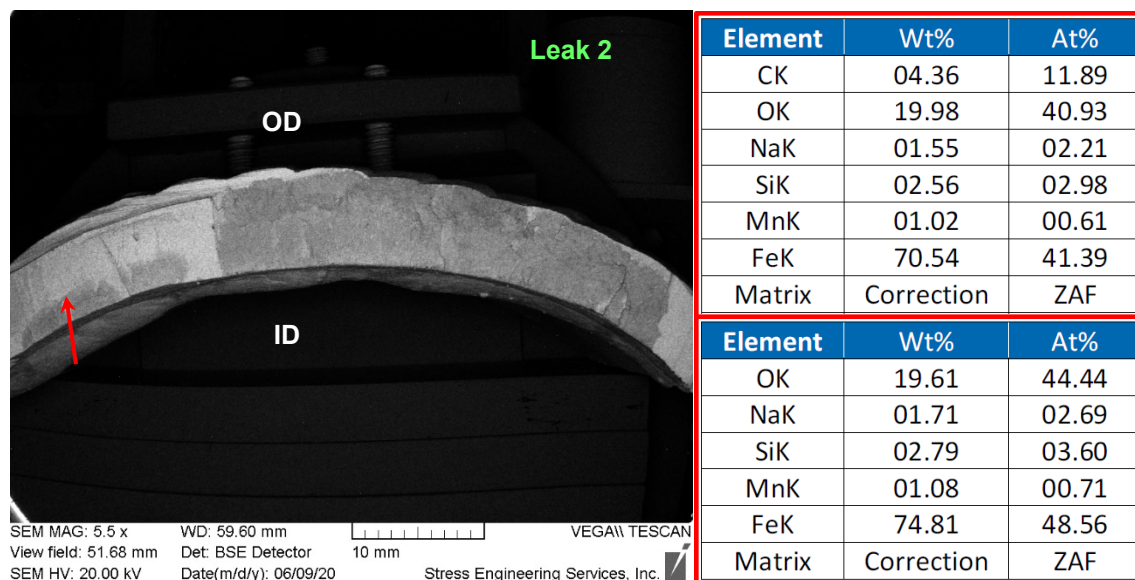
The fracture surfaces from the three leak locations were analyzed using energy dispersive x-ray spectroscopy (EDS) prior to performing SEM fractography. Since standardless EDS analyses do not accurately measure carbon contents, the results for the leak 2 fracture surface are shown twice in Figure 8, once with carbon included in the analysis and once with it deliberately excluded. The primary elements present were iron and oxygen, with traces of silicon, sodium and manganese. Similar results were obtained for EDS analyses performed on leak 1 and leak 3 fracture surfaces.

Figure 8. EDS analysis of leak 2 fracture surface.

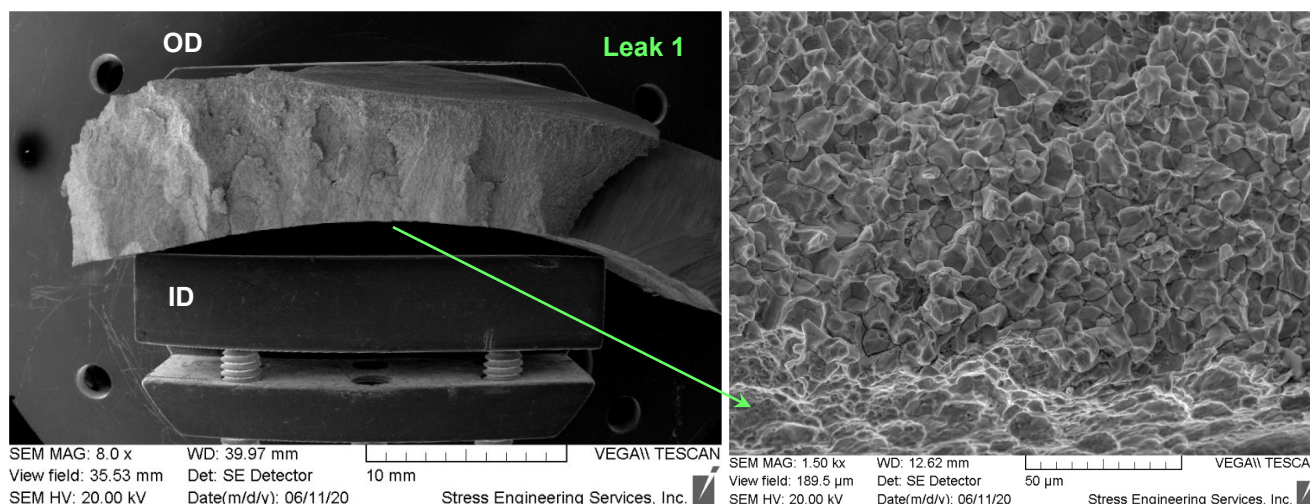
As shown in the SEM fractographs (Figures 9-11), the morphology of the fracture surfaces for the three leaks was predominantly intergranular.

Figure 9. SEM images showing part of the leak 1 fracture surface.
