## **Failure Analysis of Hydrotested 12-Inch Type 304 Stainless Steel Pipe Sections**

Sudhakar Mahajanam, Chris Miller, Cody Robinson, Scott Harding and Amilcar Oberto

Stress Engineering Services, Inc.  
13800 Westfair East Drive  
Houston, TX 77041

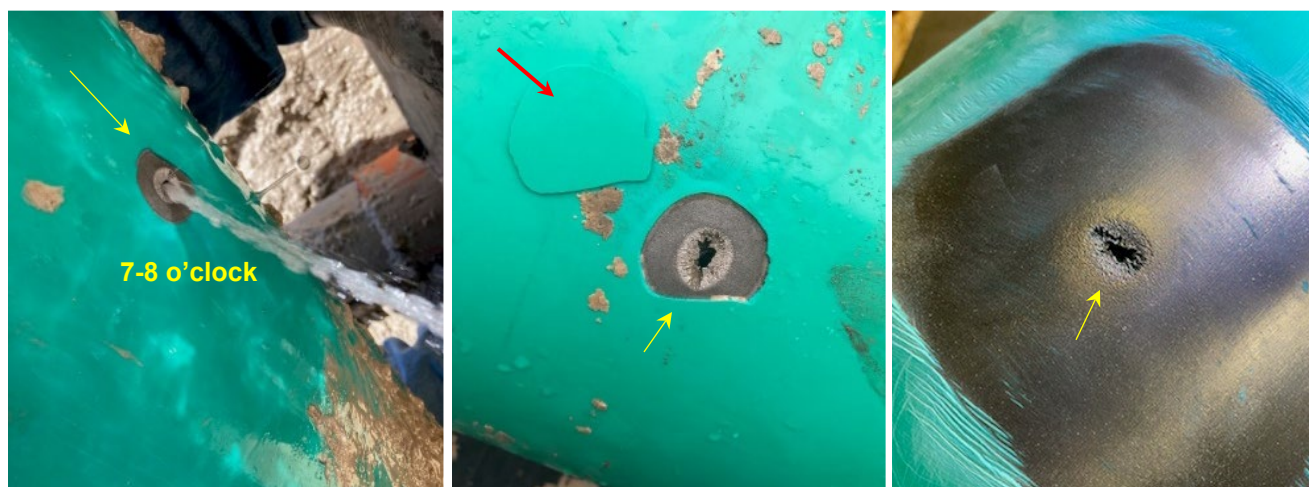
Three pipe sections 12-inch outside diameter (OD), 0.375-inch wall thickness, that leaked during hydrostatic testing were evaluated – one from the pipe body that leaked, a second pipe body section from a different joint of pipe that has not leaked (about 30 feet from the leaked section), and a third pipe section containing a girth weld. These sections were part of the same line that was installed in May 2020, failed the same hydrotest at less than 100 psi test pressure (immediately after pressure was applied), located 1.5 miles apart. City water was reportedly used for the hydrotest. Information on water quality, such as chemical treatment, storage and water chemistry was not provided. The pipe body sections were located above ground and were coated with Scotchkote™ 212 spray coating. The girth weld sections were located underground, buried underneath a creek, and were coated with an abrasion resistant outerwrap (ARO) coating. It was reported that the line was open to the environment for several months prior to the hydrotest. Figure 1 shows a picture indicating the location of the leak on the pipe body section onsite.

**Figure 1. Photographs showing the leak during hydrostatic testing.**

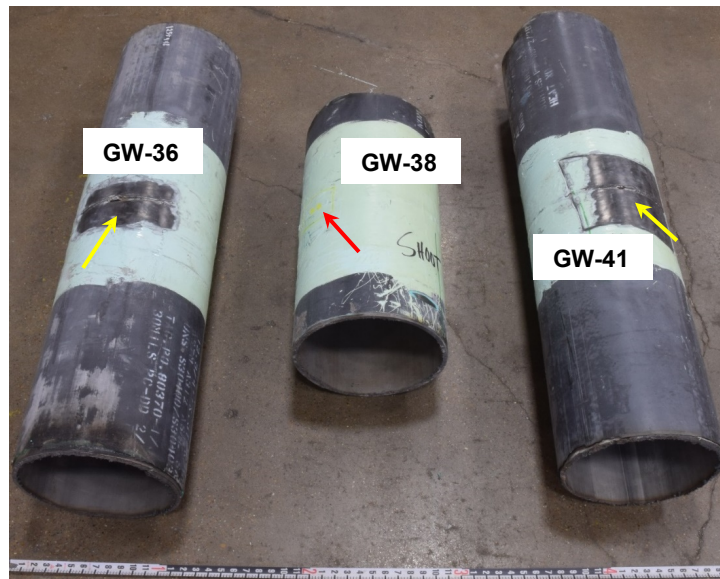
The girth weld leaks were retrieved from pipe that had been newly installed by horizontal directional drilling (HDD). These pipe segments – identified as GW-36, GW-38 and GW-41 – leaked at the girth welds as shown in Figures 2 and 3 (yellow arrows). The girth welds in two of these segments contained internal voids (red arrow in Figure 2) identified earlier by radiography as shown in Figure 4.

Figure 2. As-received photographs showing the GW-36, GW-38 and GW-41 pipe segments.

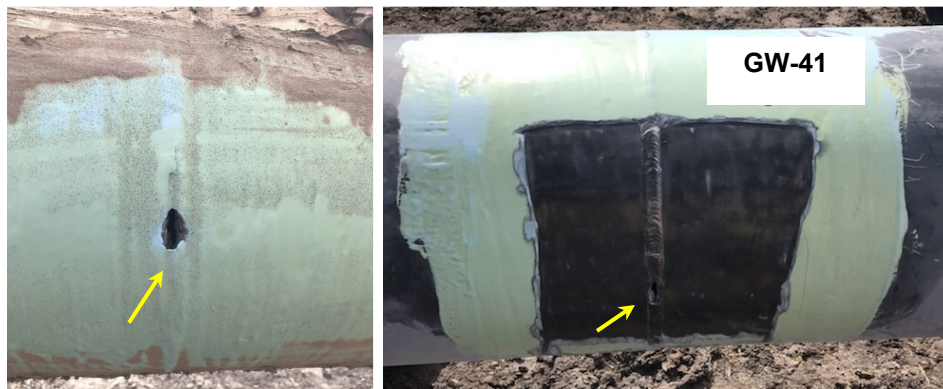
Figure 3. Photographs of leak at the girth weld for pipe segment GW-41 (before/after removal of ARO).

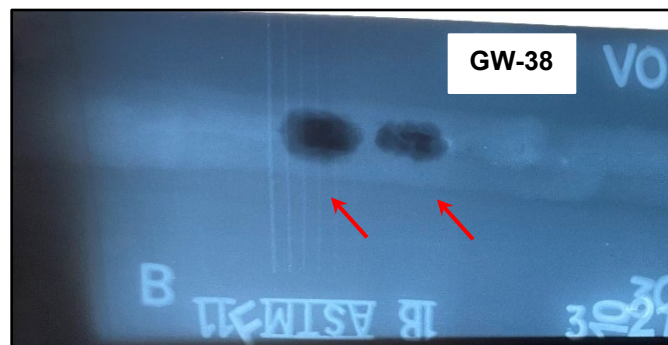
Figure 4. Section of the radiograph showing internal voids for pipe segment GW-38.

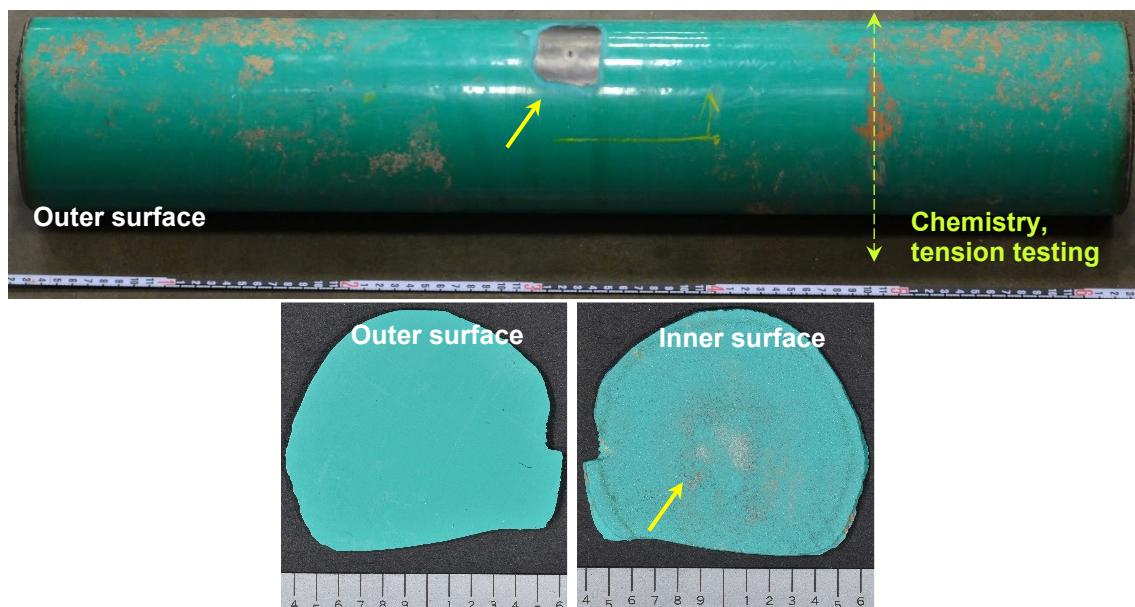
Both the pipe body and the girth weld sections were examined. Photographs of the pipe body section that leaked and the loose piece of spray coating are shown in the as-received condition in Figure 5. Very little corrosion product was observed on the coating piece. One section of the pipe was sent out to an

**Figure 5. Pipe section that leaked (top) and the loose coating piece (bottom) shown in the as-received condition. Numbered scale divisions are inches (top), 0.1 inch (bottom).**

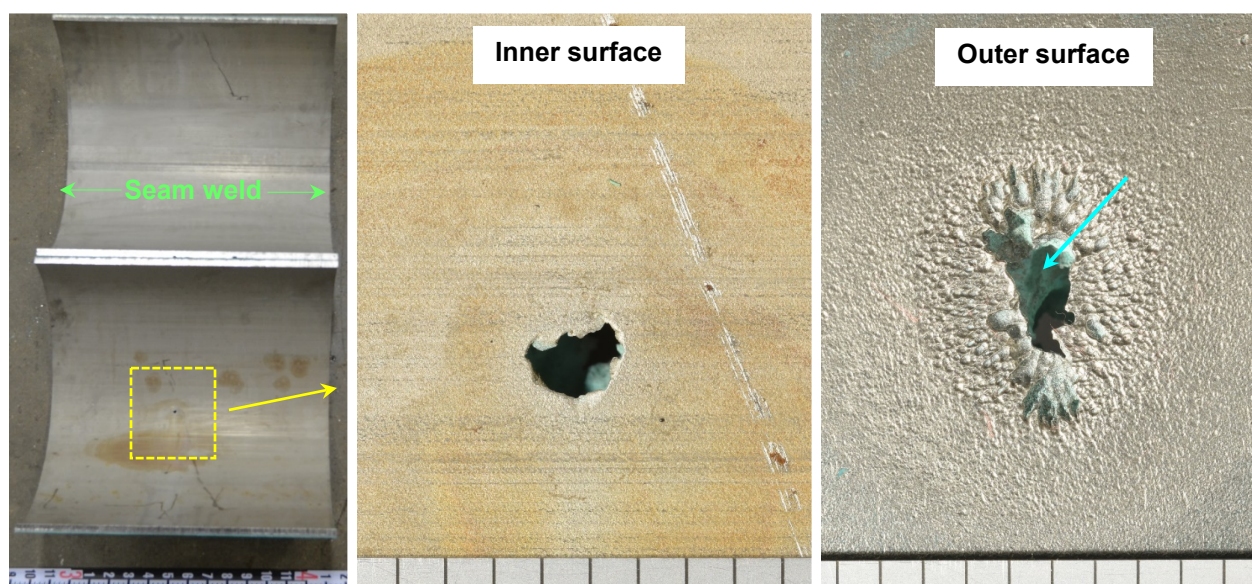
Figure 6 shows close-up photographs of the pit at the inner and outer pipe surface that led to the leak. The outer surface of the pipe exhibited a rough, pitted appearance surrounding the leak region. A green layer was also observed on the inside of the pit (blue arrow in the figure). However, this green layer was easily removed when an air blower was used. This implies that the layer/powder was a remnant of some non-destructive examination performed onsite by the client.

**Figure 6. Close-up photographs of the pit at the leak site. Scale divisions are 0.1 inch.**

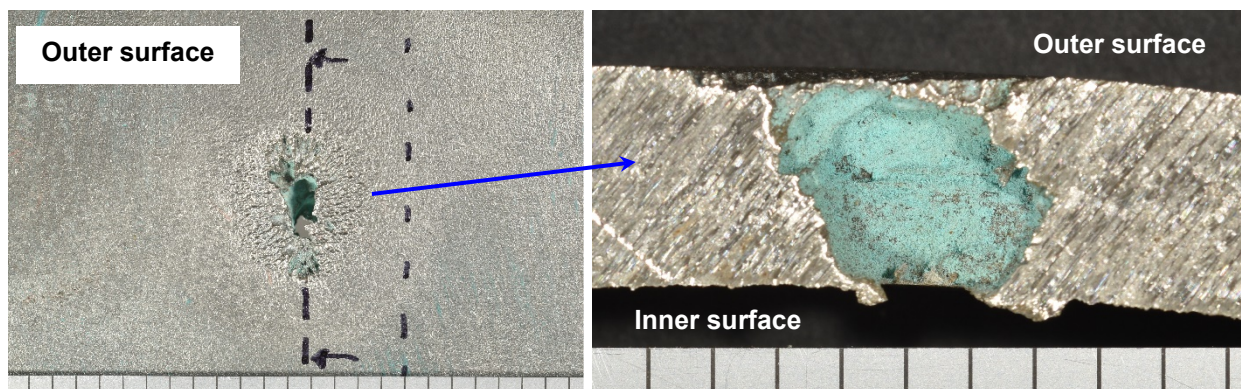
The pitted region was sectioned in the transverse direction as shown in Figure 7 to prepare a metallographic cross-section. The pit appeared to be tunnel-shaped, i.e., wider at the mid-wall region as compared to the inner/outer surface regions.

**Figure 7. Photographs of pipe body pit before and after sectioning. Scale divisions are 0.1 inch.**

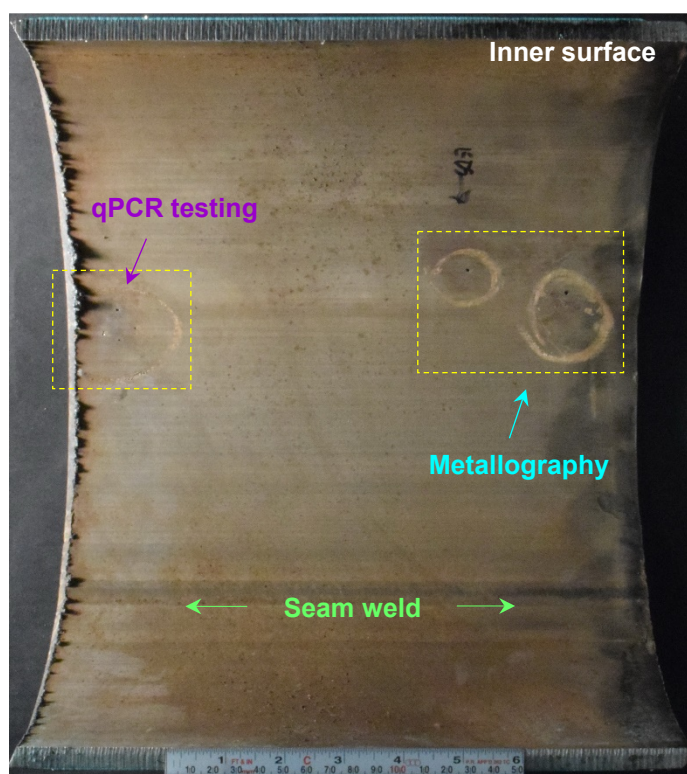
Similar sectioning was completed for the second pipe body section as shown in Figure 8. Close-up photographs of the inner surface pits were taken and are presented in Figure 9. One of the pits was sectioned in the transverse direction to prepare a metallographic cross-section as shown by the dotted line. Some of the corrosion products in these pits were retrieved and submitted for microbiological testing (see section below).

**Figure 8. Photograph showing the second pipe section's inner surface. Pits are indicated using yellow boxes. Numbered scale divisions are inches.**
