## **Stress Relaxation Cracking of Thin Alloy 800/800H Electric Heater Tubular Heating Elements**

Iyad Al-Buraiki  
Saudi Aramco, Dhahran, 31311  
Kingdom of Saudi Arabia

### **ABSTRACT**

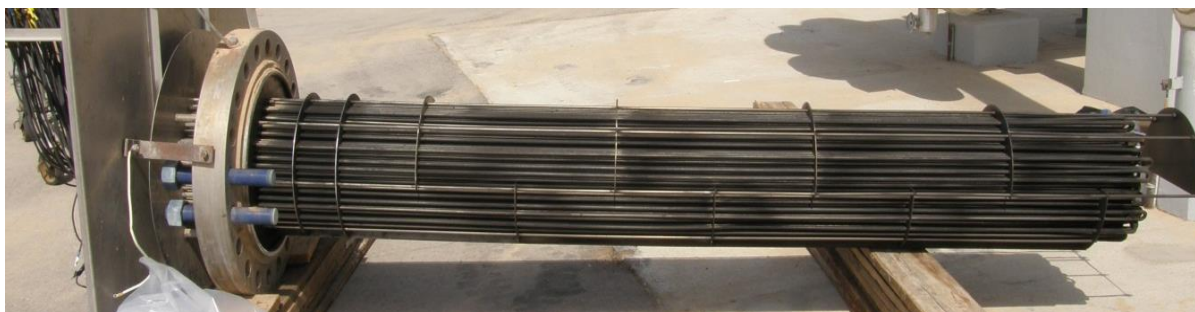
The first failure (Case 1) occurred in a regeneration gas electric heater at a natural gas liquid (NGL) recovery plant. The operator reported noticing gas leaking from the process side of the electric heater. Both the terminal box and the heater were then opened for internal inspection (Figure 1). Upon inspection, it was also observed that the heating elements experienced failure of the sheaths (tubes) at several of the hairpin (U-shape) bends. These failures had occurred several times prior to this investigation at the same locations and were replaced in-kind by the manufacturer.

**Figure 1: Electric heater bundle (Case #1)**

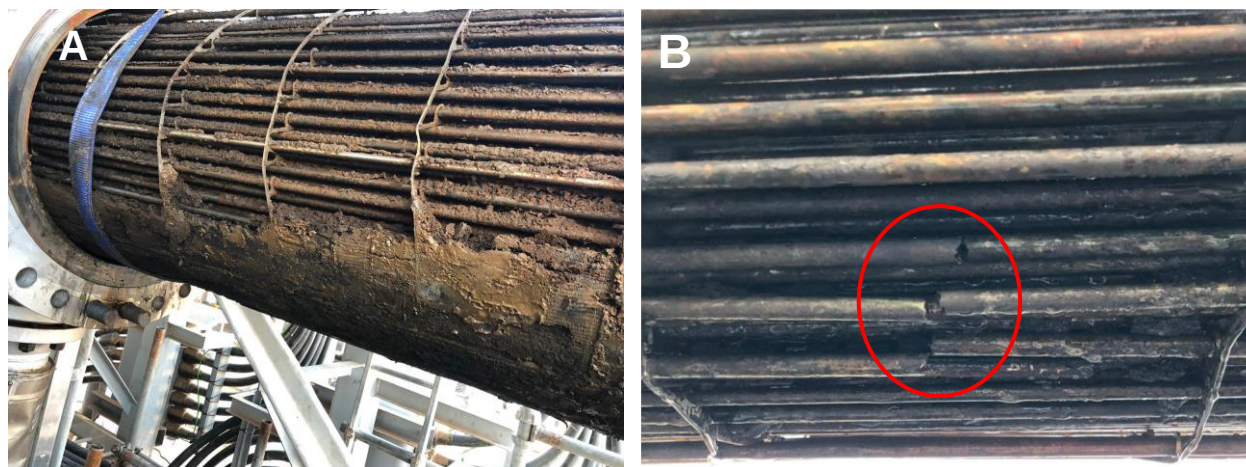
The second failure (Case 2) occurred in a condensate stabilizer reboiler electric heater at an upstream gas processing plant. The condensate stabilizer re-boiler had suffered from frequent tripping due to electrical grounding fault. The heater was opened for internal inspection and heavy deposits were observed (Figure 2). It was also reported that the heating elements experienced failure at the bottom section.

**Figure 2: (A) Sludge accumulation at the bottom of the bundle. (B) Cracked tubes (Case #2)**

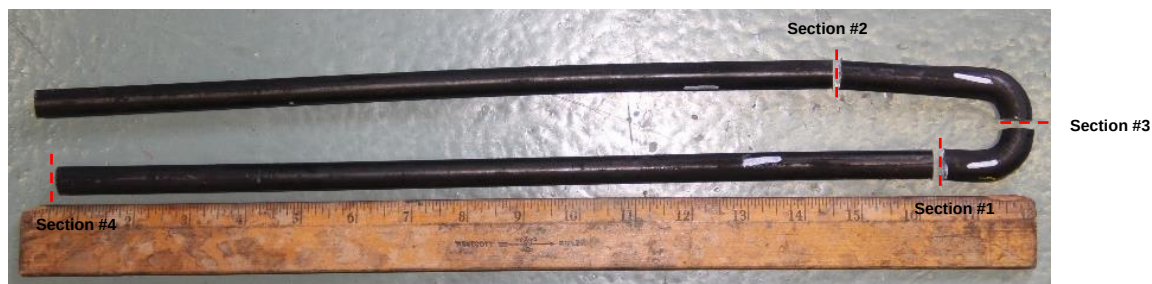
Three tubes (heating elements) were submitted for analysis. All the failed tubes analyzed showed similar findings. For the purpose of this paper only one bend was examined in details. Figure 3 shows the tube sample of an electric heater that was sent for failure analysis. The sample was visually examined thoroughly. The heating elements consisted of a heating resistance wire embedded within compressed powder (acting as insulator and heat conductor) inside a sheath (tube). Two portions could be noticed for each heating element; namely the straight portion and the hairpin bend portion.

**Figure 3: photograph of failed sample (Case 1)**

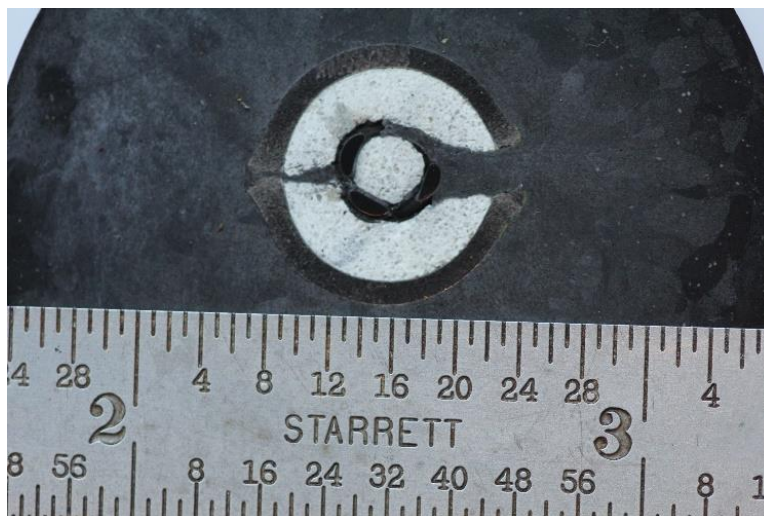
The tube failed at the hairpin bend portion on both the extrados and intrados as shown in Figure 4. The tube failure manifested itself as a crack extending only along the weld-like protrusion. On the extrados, the crack was relatively wide open as the heating resistance wire could be clearly seen. Figure 5 shows the extrados crack extension along the hairpin bend, focusing on crack ends. However, the crack on the intrados was narrower and the heating resistance wire could not be seen through the crack. It was observed that a small amount of MgO fell out of the tube as the crack opened.

**Figure 4: A cross-section view of tube #1 showing both extrados (right) and intrados cracks (left) of the hairpin bend portion.**

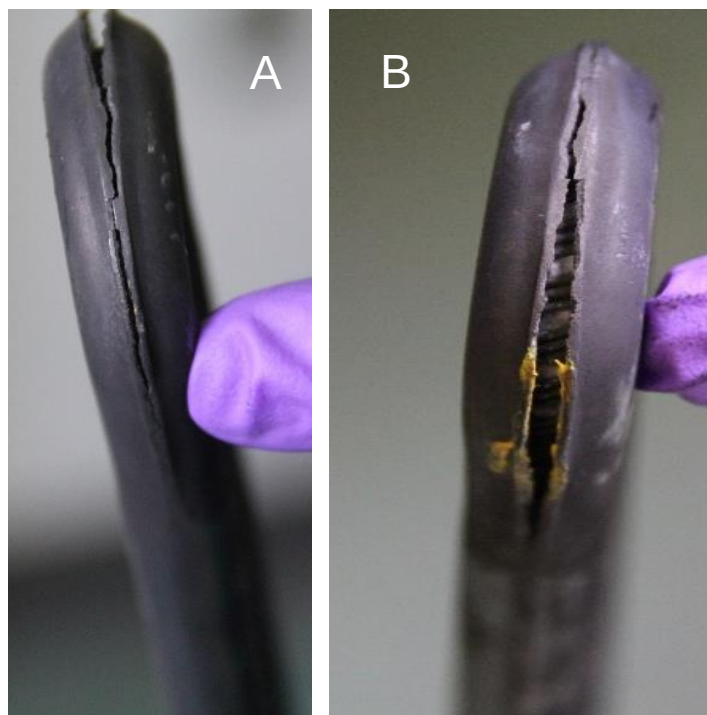
**Figure 5: Views on extrados crack extension of tube #1, close-up on section-1 (A) and section-2 (B) crack end.**
