## **Cracked High Pressure Steam Superheater Alloy 800 Piping of A Thermal Oxidizer from a Gas Plant SRU**

Yousif A. Al Rabie  
Saudi Aramco, Dhahran, 31311  
Kingdom of Saudi Arabia

### **ABSTRACT**

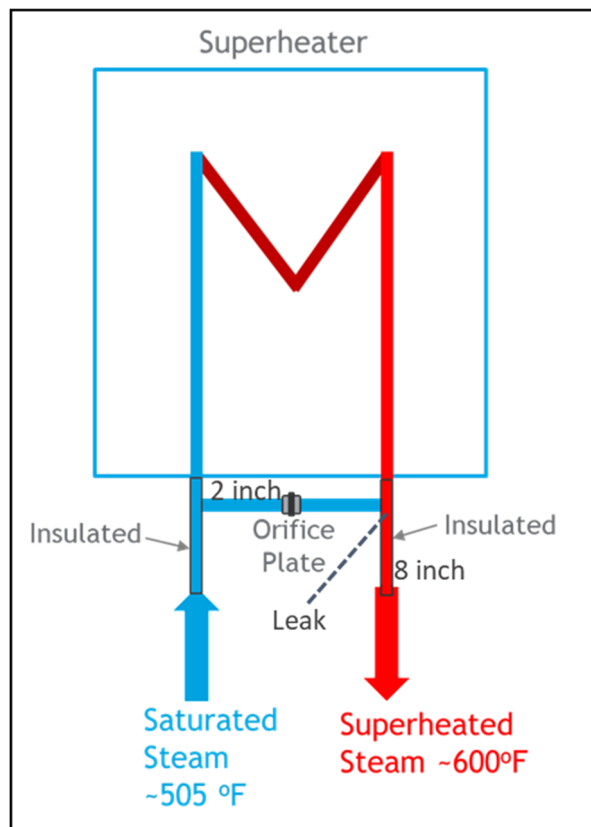
the superheated steam exits through an 8 inch pipe which connects to a 2 inch un-insulated pipe. The other end of this 2 inch pipe is the saturated steam that fed to furnace. This 2 inch line is connected to pressure differential pressure transmitter. The failure of the 8 inch downstream piping is located just after the 2 inch pressure balance line as shown in Figure 1. Different chemicals were injected into the system at earlier stage before reaching the HP Steam Superheater such caustic soda, neutralizing amines, oxygen scavenger and anti-scalant.

**Figure 1: HP Steam Superheater diagram.**

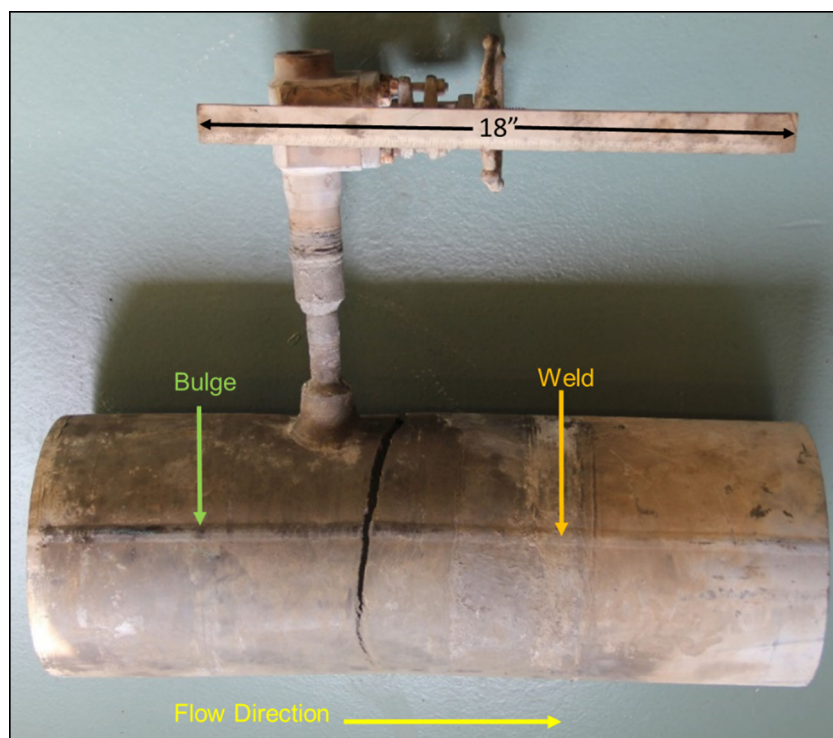
Figures 2 and 3 show photographs of the as-received cracked pipe. The pipe was visually examined externally. There was no evidence of corrosion found on the pipe external surface. Close examination revealed nearly the entire circumference was cracked from 7 O'clock to 5 O'clock position as shown in Figure 2. The crack grown with time. Also, the pipe was found to be longitudinally welded.

**Figure 2: A general, as-received photograph of the failed pipe.**

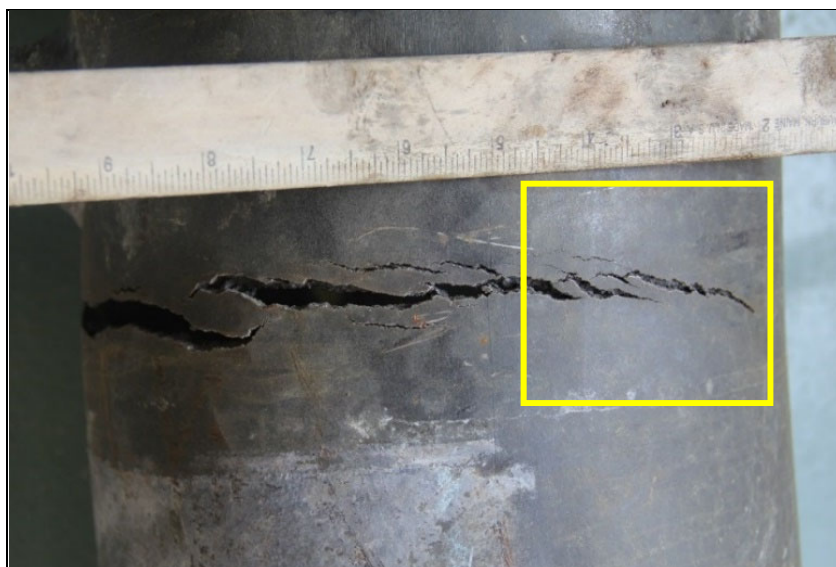
**Figure 3: Close-up image of the crack.**
