## **A Case Study on Carbon Dioxide and Microbiological Corrosion Issues in Oil Producing Well Flowlines**

Amer Jarragh, Sandip Kuthe, Sharad Londhe, Akhil Jaithlya, Abeer Rashed,  
Nadine El-Kaouri  
Kuwait Oil Company (K.S.C.)  
P.O. Box 9758 Ahmadi  
61008 Ahmadi, Kuwait

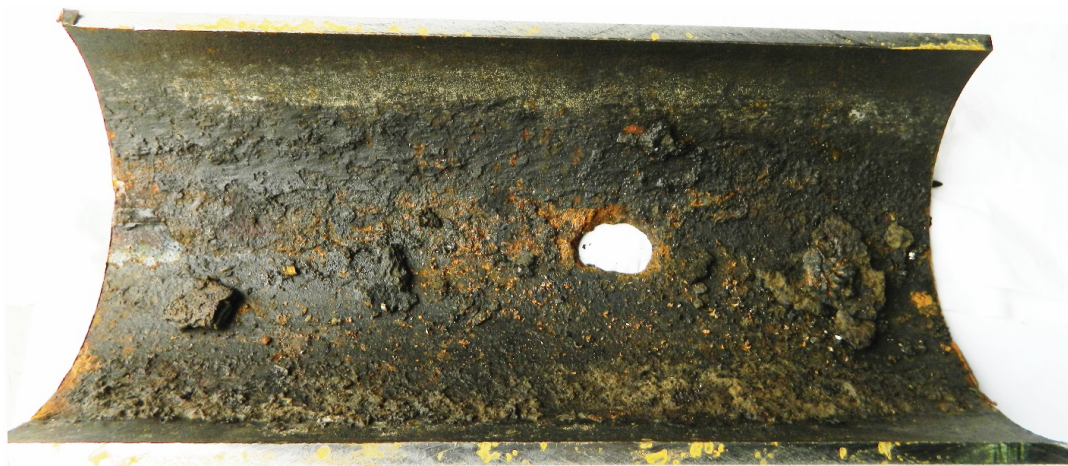
**Figure 1: Brown-orange deposit near perforation and thick black loose deposits away from perforation (5 to 7 o'clock) observed on FL1. SRB's were detected in the black deposit**

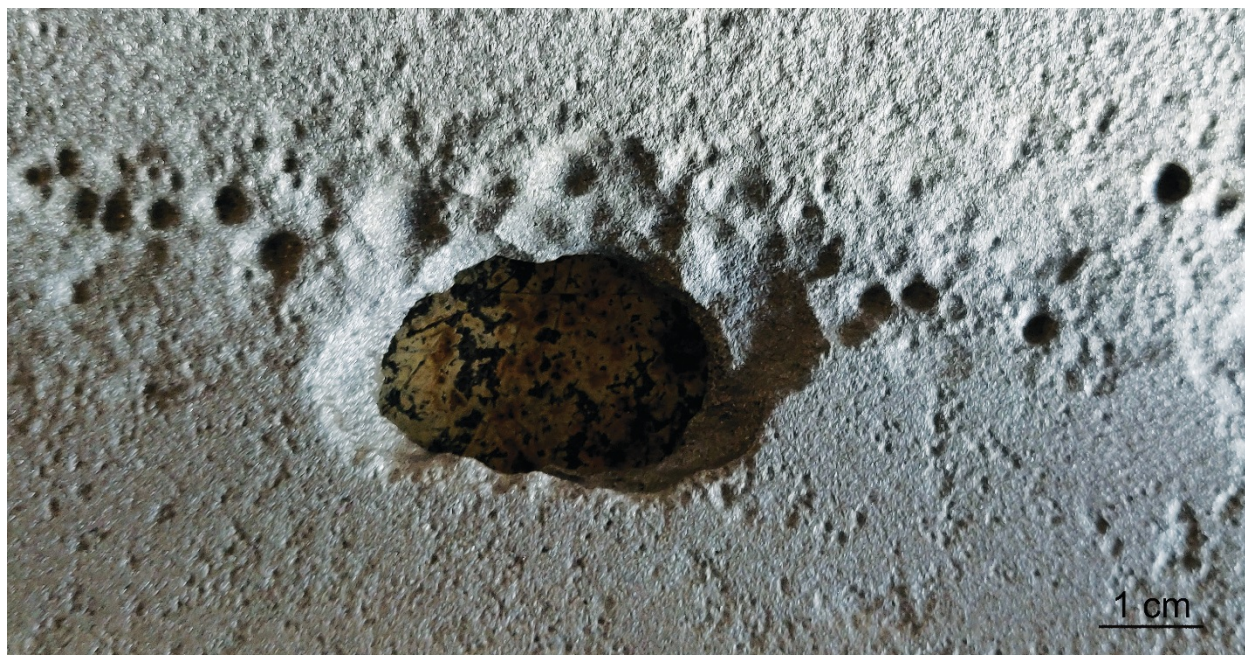
**Figure 2: Close-up photograph showing several deep pits surrounding perforation on FL1**
