## **Corrosion Management Learnings for Storage Tanks**

### **ABSTRACT**

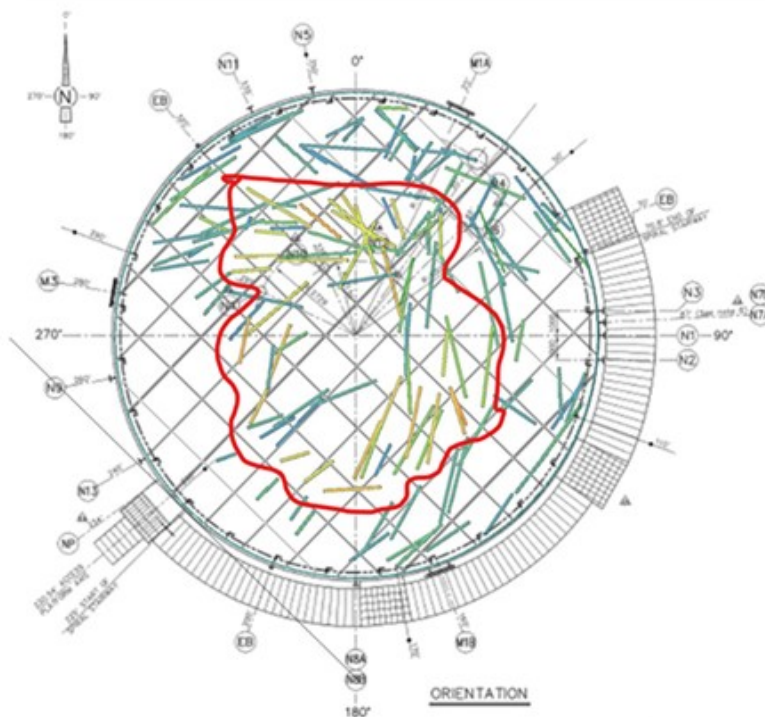
Tank A- Material loss has been noted during the analysis of the data. A minimum thickness of 5.2mm has been recorded. No liner damage was recorded, and all thickness variations were from the soil side of the tank floor plate (Figure 1).

**Figure 1: Tank “A” 0%-42% metal loss (minimum remained thickness 5.2mm out from nominal 9mm) from soil side (highlighted in red corroded area)**

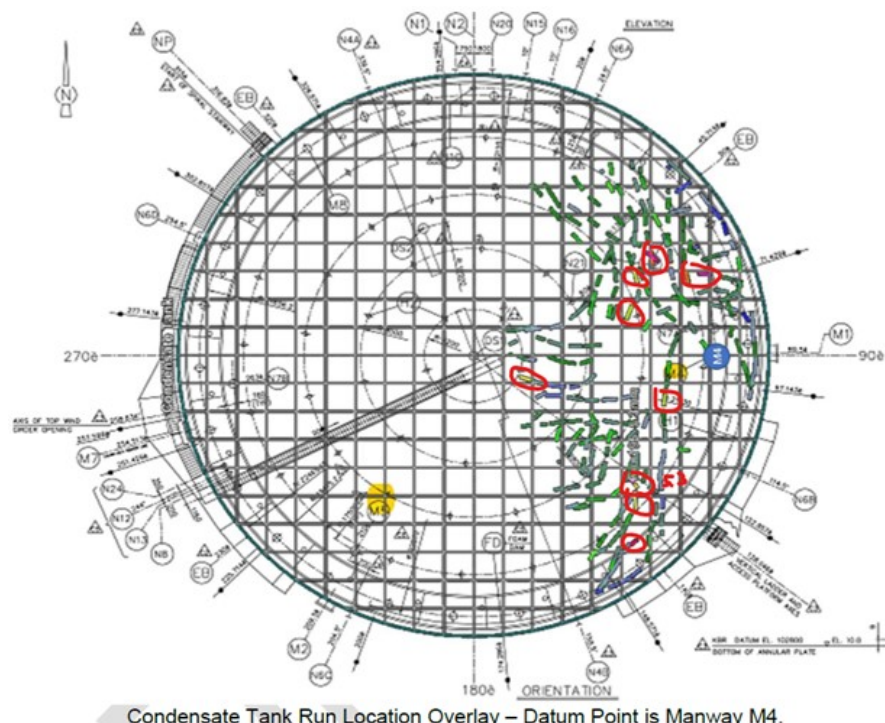
Tank B- It has been detected 0% to 42% wall loss against a nominal thickness of 9.0mm. A minimum thickness of 5.3mm has been noted iThe following figure each run and their minimum remaining wall thickness. (Figure 2).

**Figure 2: Tank “B” 0%-41% metal loss (minimum remained thickness 5.3mm out from nominal 9mm) from soil side (highlighted in red corroded area)**

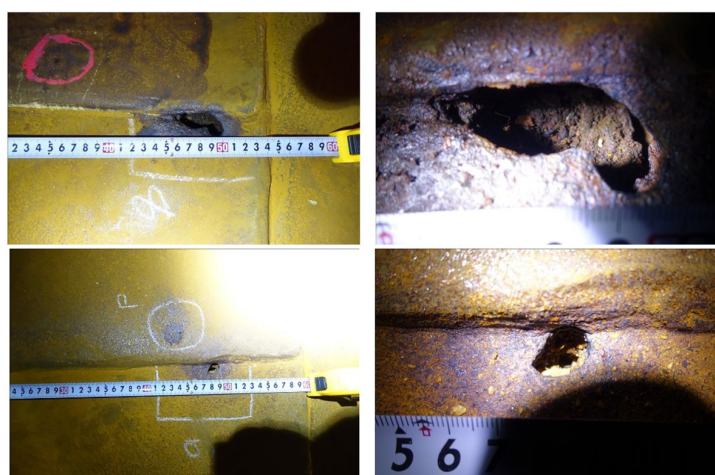
Tank “C” is a 21-meter nominal diameter, 8 strakes, fixed dome self-supporting tank, commissioned in mid-2000s and built under API<sup>(1)</sup> 620 standards (Figure 3).<sup>1</sup> The tank is internally and externally coated and installed on a concrete ring within boundary area. External corrosion cathodic protection was ensured by under floor grid type impressed current. Inspection and assessment were carried out in accordance with the requirements of the API<sup>(1)</sup> 653 standards,<sup>2</sup> and API<sup>(1)</sup> RP 575 standards<sup>3</sup>.

**Figure 3: Example of corroded areas (perforations)- Tank “C”**
