## **Aesthetic Issues with Spray-Applied Fluoropolymer Coating System**

Kimberly Steiner  
Wiss, Janney, Elstner Associates, Inc.  
330 Pfingsten Road  
Northbrook, IL 60062  
USA

### **ABSTRACT**

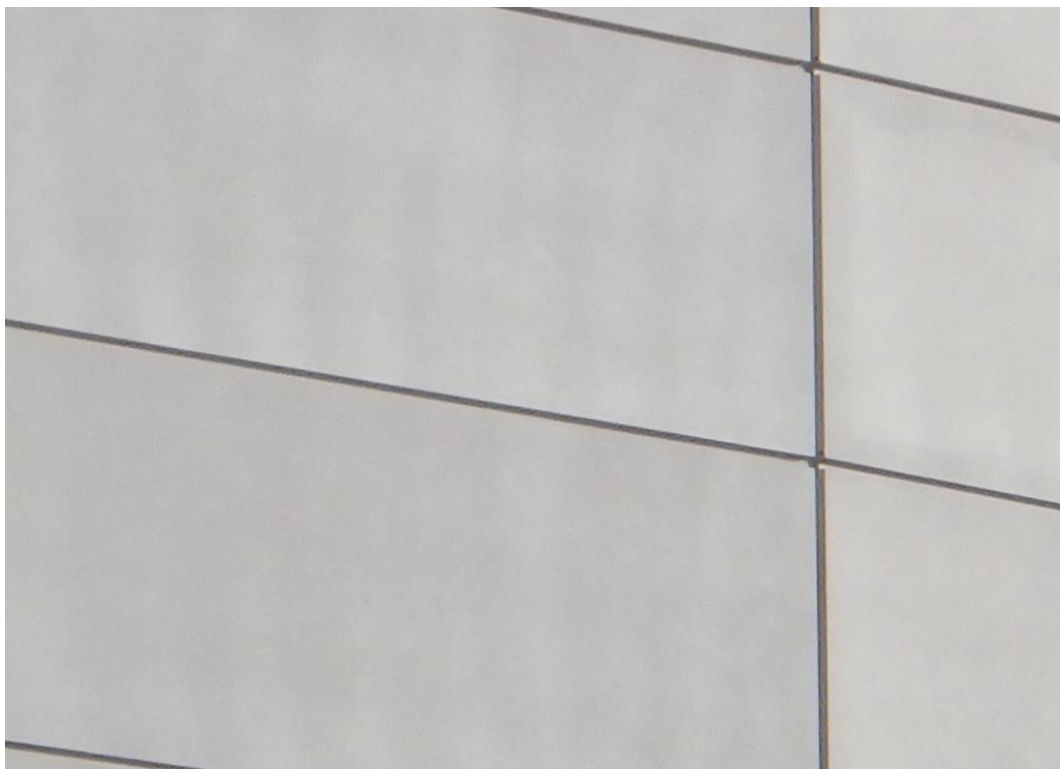
At the time of the site visit, panels had been installed on less than one-quarter of the façade. A streaky appearance, running vertically, was observed on many of the installed panels (Figure 1). Where present, the streaks typically appeared in a similar repetitious pattern (i.e., the streaks had the same general spacing). However, most panels did not exhibit streakiness that was uniform along the height a

given panel; instead, the height of the vertical streaks varied from top to bottom of a panel, or the appearance of the streaks was more apparent on one end of a given panel compared to the other. The streaky appearance was more noticeable during the early morning hours and when the panels were under shadow.

**Figure 1: A photograph of the streaky appearance of the façade panels.**
