## **Implication of Fractographic Analysis of the Crack in an Above Ground Pipeline – Potential Role of Hydrogen**

### **ABSTRACT**

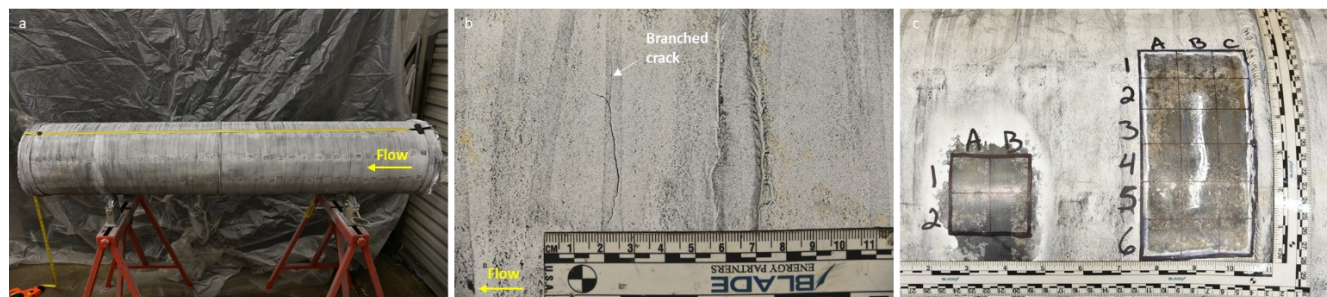
A 1.72 m pipe section with the circumferential crack shown in Figure 1a was cut and retrieved from the existing pipeline. Magnetic particle inspection (MPI) was done to verify the location and the length of the OD surface crack (see Figure 1b). Prior to excising the crack from the pipe section, the hardness within the vicinity of the crack and away from the crack were determined using ultrasonic contact impedance

(UCI), in order to determine if there is hard spot that may have caused the crack to initiate. A grid composed of 25.4 mm x 25.4 mm (1 in. x 1 in.) squares was made around the crack. Triplicate measurements were made for each square. UCI hardness measurements were also done in triplicates in a grid of four squares away from the crack. Figure 1c shows the location of the grids near the crack and away from the crack.

**Figure 1: a. Pipe Section, b. OD Circumferential Crack, c. Location of UCI Hardness Measurements**

The average values of UCI Vickers hardness near the crack for columns A, B, and C are 204.56 HV, 205.94 HV, and 205.5 HV, respectively (Figure 1c). The average values of UCI Vickers hardness measured ~110 mm away from the crack for columns A, and B are 200.5 HV, and 199 HV, respectively (Figure 1c). These measurements indicate that there is no hard spot in the vicinity of the crack in accordance with API 5L (2007) hard spot definition of  $HV \geq 345$  [4]. Vickers hardness values were verified using indentation of mounted specimen with 0.5 Kg load. Two samples obtained near the crack (Mount 1 crack mouth and Mount 2 crack tip) and one sample 180° away from the crack (Mount 3) were mounted, polished and etched. Hardness measurements were obtained in the OD, ID, and mid-wall. Table 1 shows the values obtained for the three (3) mounted samples. There is no significant difference from the OD Vickers hardness values for Mount 1, Mount 2, and Mount 3. This supports the previous finding that there is no hard spot in the vicinity of the crack.

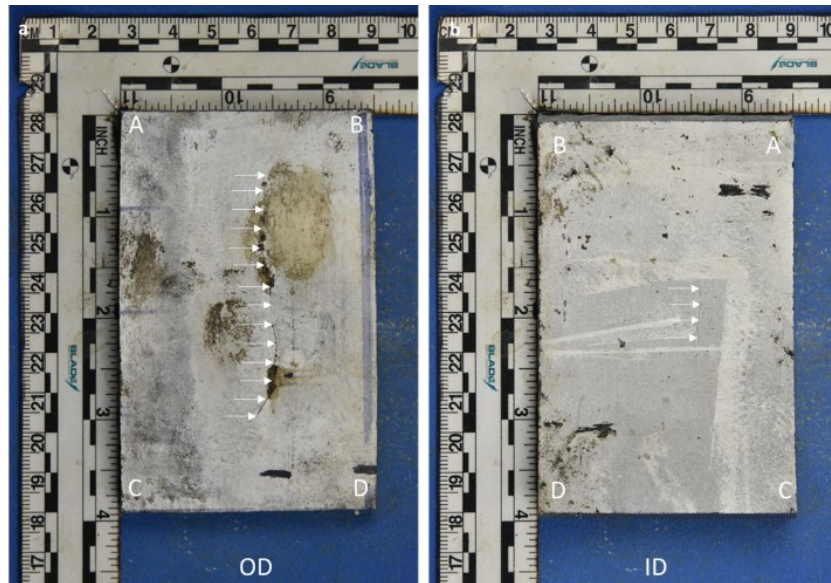
The circumferential crack on the OD surface is slightly curved (as shown in Figure 1b), and is ~35–40 mm away (downstream) from the girth weld. The crack on the OD surface is ~62 mm long including the branched crack. The length of the crack on the ID surface is about ~16 mm long, much shorter than the same crack on the OD surface (~62 mm long). Figure 2 is a side-by-side comparison of the length and location of this through-wall crack on OD and ID surfaces, showing about 16 mm difference between the location of the crack on OD and ID surfaces with respect to the BD edge (see Figure 2, the BD edge served as a common reference for the through-wall crack on OD and ID surface). This means that crack initiates from the OD side and propagates toward the ID in an inclined manner.

**Figure 2: Crack in the a. OD Surface, and b. ID Surface**

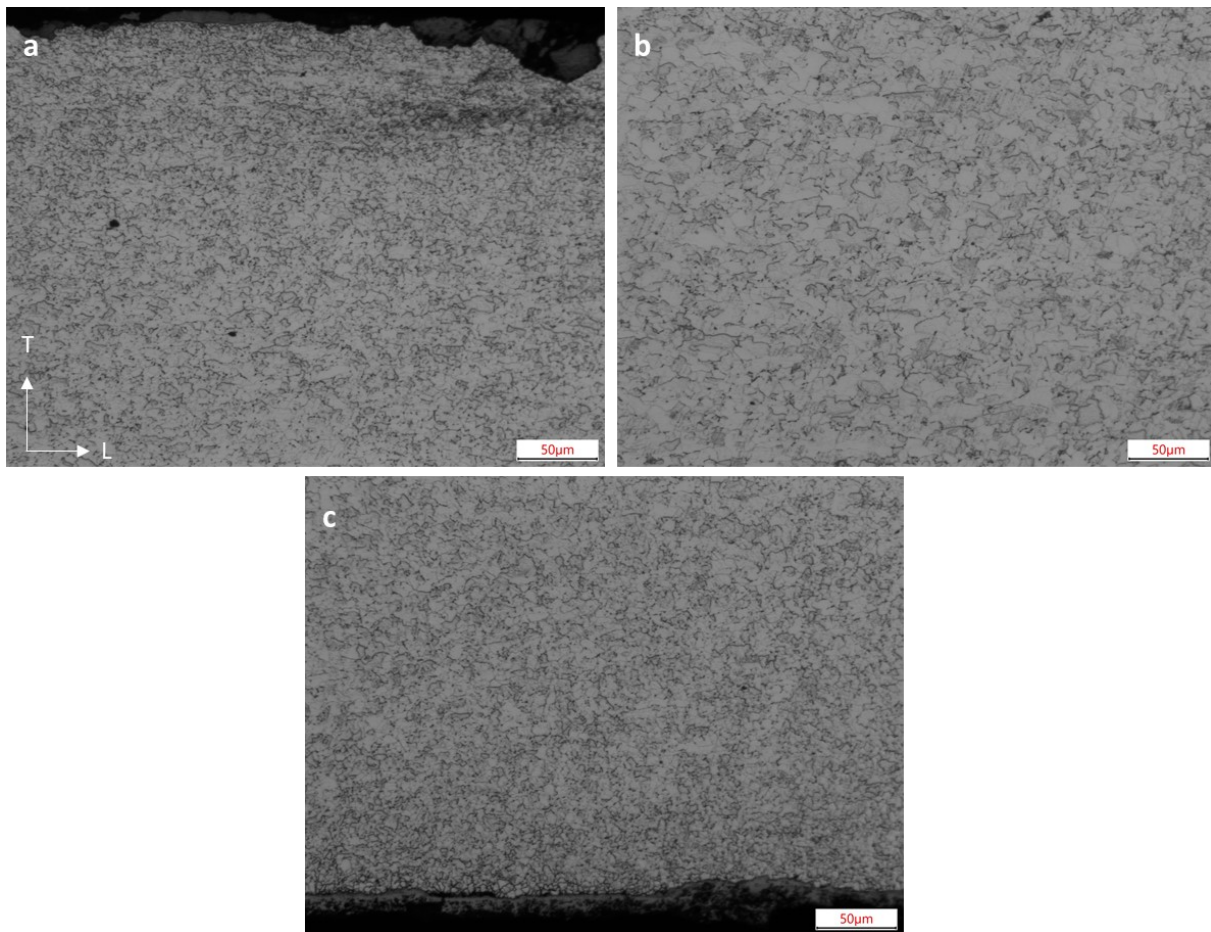
From Table 1, the hardness in the OD is higher compared to the values obtained from mid-wall and ID. This can be explained by the difference in microstructure along the through wall thickness of the specimens. Figure 3 shows the microstructure of Mount 1 observed under 200 $\times$  magnification. The region near the OD contains fine ferrite, pearlite grains. The mid-wall has coarse ferrite, pearlite grains, while the ID has mixed fine and coarse ferrite, pearlite grains.

**Figure 3: Microstructure of Mount 1 Crack Mouth at 200× a. OD, b. Mid-wall, c. ID**

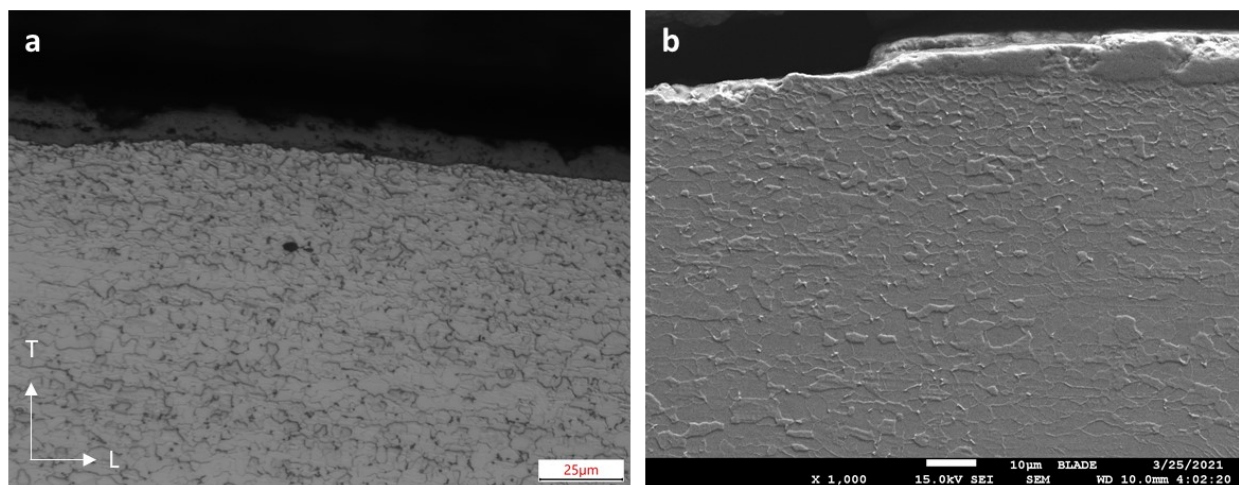
Figure 4 shows OD surface of the Mount 1 viewed at 400× under optical microscope (Figure 4a) and at 1000× in the SEM. The images show that there is no decarburized layer present in the OD surface in the vicinity of the crack.

**Figure 4: High Magnification Images of Mount 1 OD Surface a. 400× Optical Image; b. 1000× SEM Image**
