## **Detection and Location of Coating Delamination and Anomalies on Buried Pipelines with Electromagnetic Reflectometry**

### **ABSTRACT**

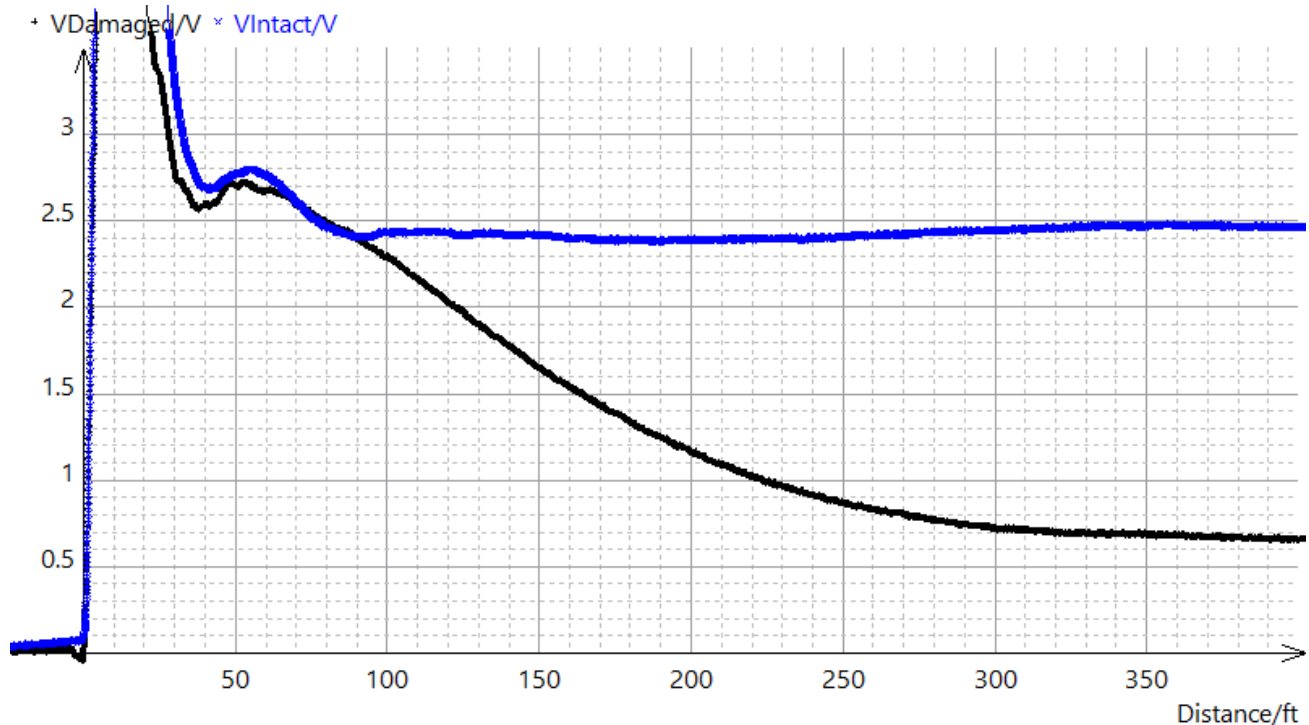
**Figure 4: Reflectometry profiles comparison of an intact and a damaged section**

In accordance with the theoretical framework, in the case of a pipeline section with intact coating, the voltage measured was found to be relatively flat after the initial impedance transition reflection (due to the impedance mismatch between the cables and the pipeline transmission line). Conversely, a coating locally damaged will induce a signal reflection at that location that will be seen from the measurement point with a time lag. For ease of interpretation, the x axis can be converted from a time scale to a distance scale by dividing it by twice the signal propagation velocity (since the signal has to travel forth and back). We call the resulting plot the reflectometry profile of a surveyed pipeline section. On figure 4 the reflectometry profiles of two equivalent manholes of a section coated with coal tar are plotted together, one with intact coating and one with damaged coating close to the measurement manhole.

The “bump” seen approximately between 35 and 85 feet is not due to local changes in the coating but to the pipelines moving closer together near the manhole (see figure 5).
