## **Microbiologically Influenced Corrosion in Drinking Water Pipelines – Old Deposits or Active Process?**

Elsiemiek Croese  
Microbial Analysis B.V.  
Rozenburglaan 13  
9727 DL, Groningen  
The Netherlands

Eelco Trietsch  
Vitens N.V.  
Oude Veerweg 1  
8001 BE Zwolle  
The Netherlands

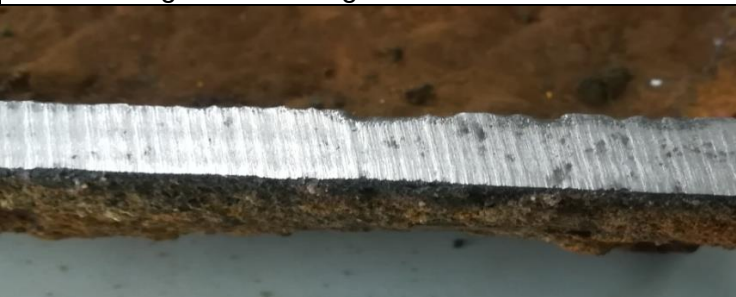
| <b>High flow rate, low organic matter, complex treatment (EWD) – diameter pipe 15 cm</b> | |
|---|---|
| | Clear damage is visible on the internal side of the pipe. |

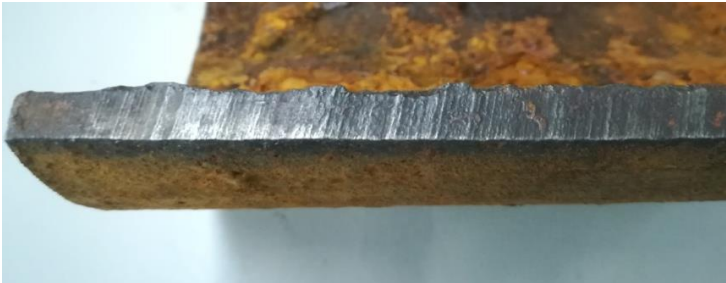
| Low flow rate, high organic matter, complex treatment (EWO) – diameter pipe 15 cm | |
|---|---|
| | <p>Clear damage is visible on the internal side of the pipe.</p> |

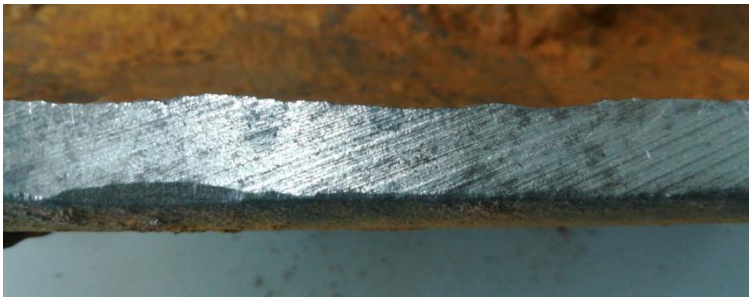
| Low flow rate, high organic matter, complex treatment (EWO) – diameter pipe 15 cm | |
|---|---|
| | <p>Clear damage is visible on the internal side (top side) of the pipe and on the external (bottom side)</p> |

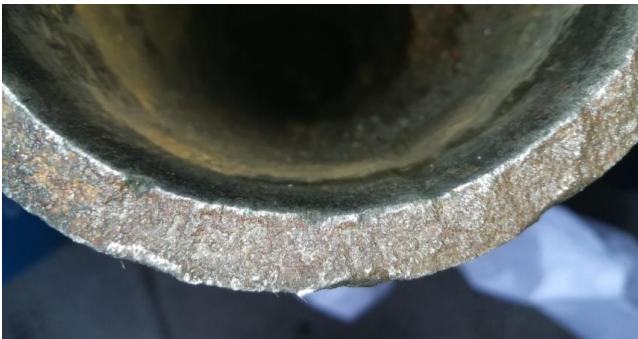
| Low flow rate, high organic matter, complex treatment (EWO) – diameter pipe 15 cm | |
|---|---|
| | <p>Clear damage is visible on the internal side of the pipe and on the external side.</p> |
