**The History of Hydrogen Induced Stress Cracking (HISC) Failures Due to  
Cathodic Charging of Duplex Stainless Steels (DSS)**

**ABSTRACT**

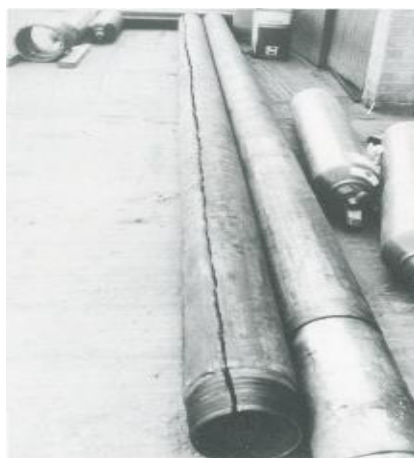
**Figure 1: Cracking in the 22% Cr DSS Cold Worked Tubulars<sup>7</sup>**

The tubes had been in service for 3 years and had suffered cracking when pulled from the well and dropped on to the deck. It was noticed that the crack length slowly grew while the joints were lying on the deck (such delayed cracking behavior being indicative of hydrogen embrittlement). It was concluded that the failure mode was indeed hydrogen embrittlement due to cathodic charging with hydrogen as a consequence of corrosion of the carbon steel casing<sup>7</sup>. Improved inhibition of annulus fluids and better tube handling procedures allowed the continued use of the 3,300m of tubing successfully.

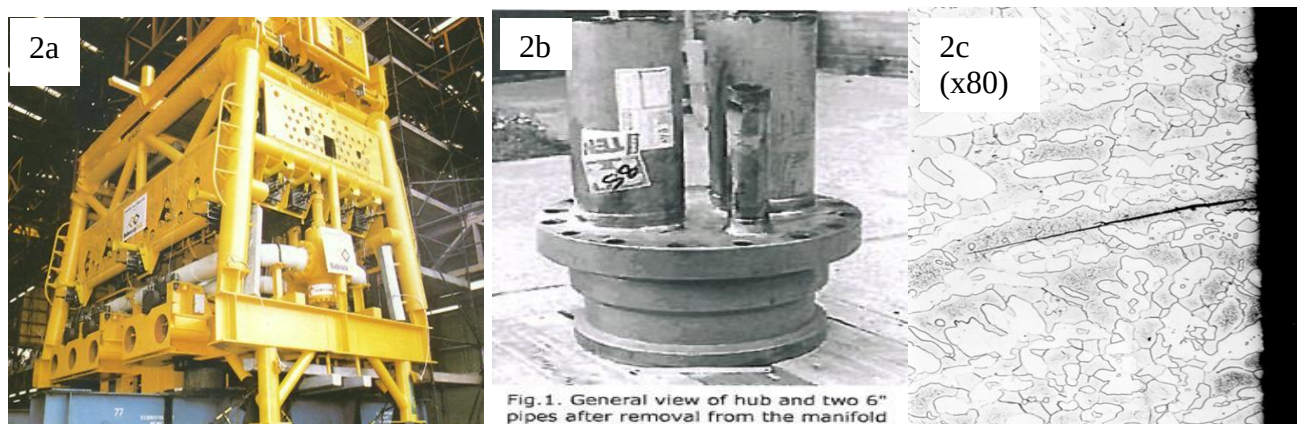
**Figure 2a: the manifold, b: the forged connector, c: the microstructure of the nipple showing cracking through the ferrite and chromium nitrides inside the ferrite grains<sup>12</sup>**

The cracking ran through the thickness of the nipple, down large ferrite grains and was uninhibited by austenite because the nipples had been machined across the grain flow of the forging. The ferrite grains in the forgings were also found to contain many chromium nitride precipitates (Figure 2c). At the time these precipitates were not considered to have contributed to the cause of the failure.

After a prolonged and technically challenging investigation the metallurgists involved were able to reproduce the failure mechanism and prove that the cracking was due to hydrogen generated by the CP system. Further, the threshold stress/strain for the initiation of HISC was determined using constant load tensile specimens and this was proved to be applicable to hub forgings by several full scale tests.

Other counter measures included improvements in the type and extent and degree that insulation coating systems were applied to “shield” the material from CP and encapsulation of nipple areas in polyurethane. The initial investigation noted that the coatings were, in some cases, already dis-bonded, even before the manifold had gone into service and were serving no function at all. This analysis and remedial action gave the operators the confidence to start production using the 194 existing hub forgings along with replacements for the 2 that failed. To date there has been no re-occurrence of the problem on this project.

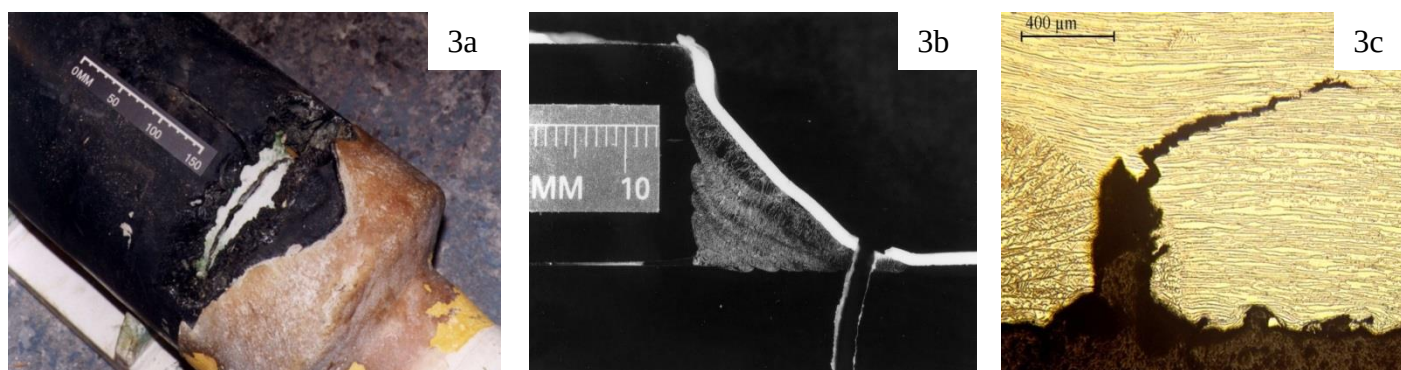
It was found that the location of the seabed had been misjudged and the foundation support was less than the design case. Also, the tie-in spools had been cut short and as such were unsupported. The intended 600mm depth of rock dumping was 3 meters deep. This rock dump loading caused plastic deformation of the tie in spools, and all of them were bent downwards. Stress analysis indicated that the tie in spools may have been subjected to 10% strain.

A failure investigation revealed that the microstructure and properties of the pipes and plates used were good. Both primary and secondary cracking was found in the fillet weld. The primary crack was in the cap of the fillet weld joining the wrapper plate to the pipe, close to, but not at, the toe of the weld on the pipe side of the joint. The crack mouth had opened up indicating high stress levels. Figure 3c shows evidence of significant plastic straining, opening and blunting the crack, but with continued crack propagation out of the plane of bending and running down the grain flow of the parent pipe. The fillet had an unusually smooth appearance; indicative of a cosmetic weld repair (Figure 3b). Examination of the fillet weld cap microstructure (Figure 4) showed it to have a coarse grained columnar structure, containing 70% ferrite. Secondary cracking across the columnar grains was also found. Its step wise appearance was more like conventional hydrogen cracking in weld metal than HISC. Also, in some areas of the pipe, insulation coating was found to be intact and covering over some of the secondary cracks. In other areas coating residue was found on the sides of the fracture faces of cracks. This indicated that they occurred during fabrication, prior to insulation coating. So their initiation was not associated with hydrogen due to CP.

**Figure 3a: location of primary cracking, b: macrostructure through the fillet weld and c: microstructure through which the primary crack propagated<sup>14</sup>**

be identified and the risk of similar defects remaining elsewhere in the spools eliminated. The original design case was revisited and as a result the cracked spool was replaced and production resumed under the original design conditions without further problems.

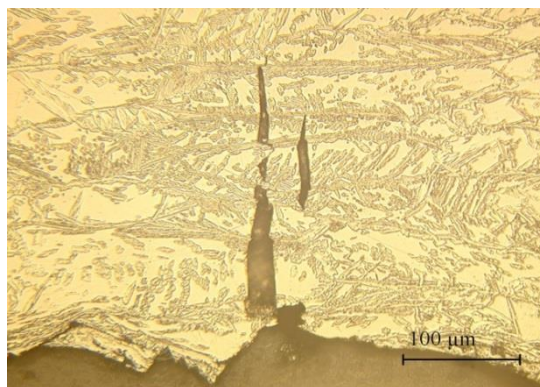
**Figure 4 : Showing the ferritic weld metal microstructure and “step wise”, transgranular, cracking that was adjacent to the primary crack<sup>14</sup>**

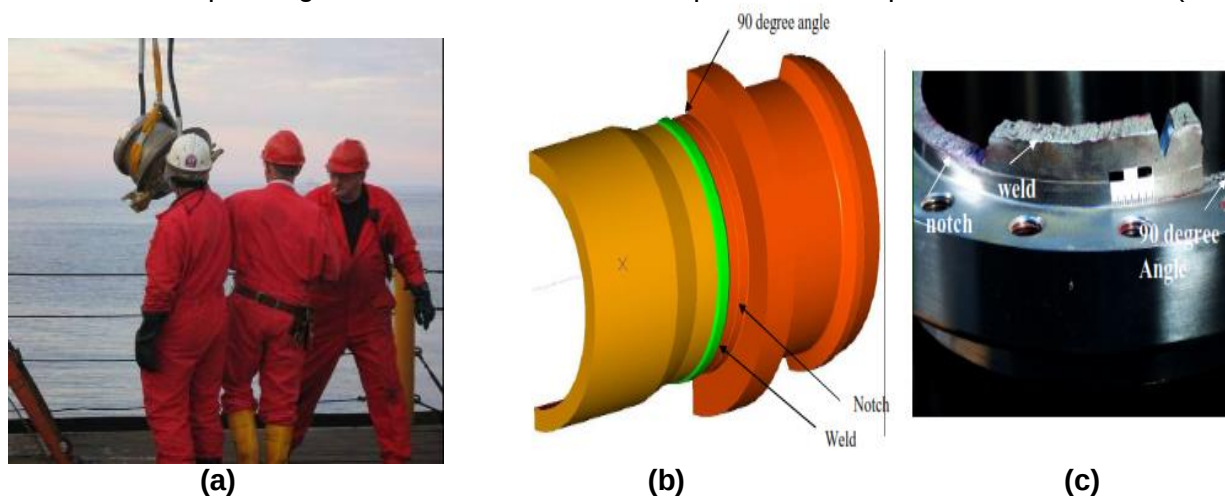
**Figure 5: a) recovery of the detached hub, b) design detail of the hub, c) crack initiation sites<sup>16</sup>**

In this case the hub had fully detached from the structure (Figure 5a) during a planned startup. There was no insulation coating applied to the part in the area of the failure. This is believed to be because this particular hub was mounted in a sliding support structure, fixing the part only at one end. This was unlike other, similar hubs, that that did not crack, which were fixed at both ends.

Sites of crack initiation were found at machined in details that formed, sharp angles and at weld toes (Figure 5b and 5c), all points of stress concentration. The cracking was found to run through the ferrite phase and appeared to be deflected off its path when it encountered austenite grains (Figure 6). Although not explicitly stated in the reports of the failure, looking at the microstructural detail presented, there is evidence of chromium nitride precipitation within the ferrite grains. This is in common with the first hub failure discussed.
