## **Case Study Based on Coating Failure Analysis of Cargo Container**

Syed Umair Niaz Bukhari

Bureau Veritas

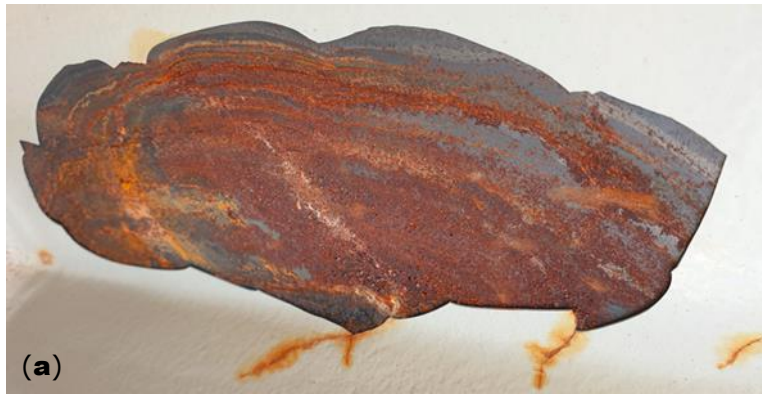
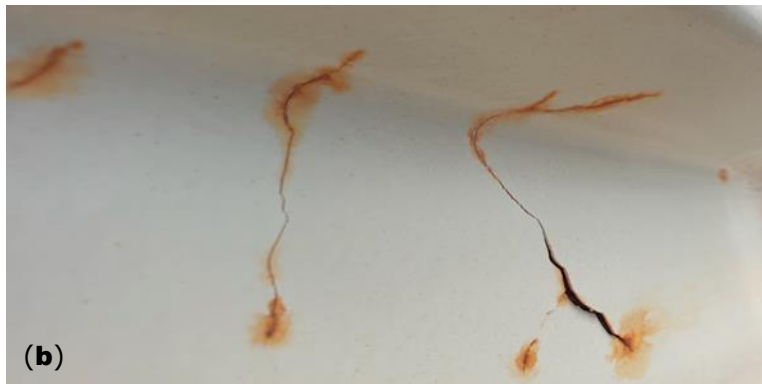
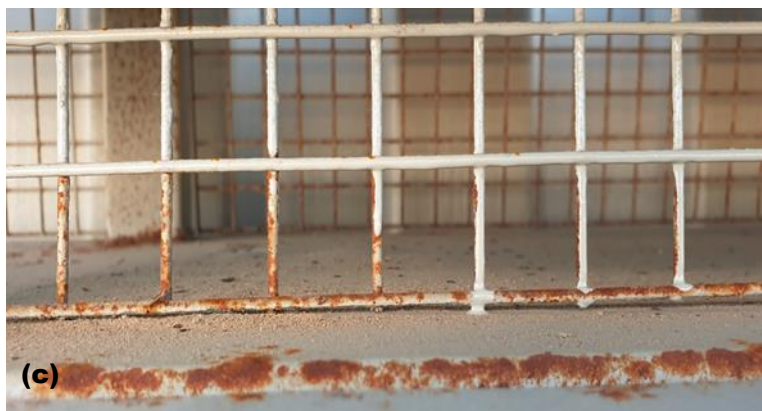
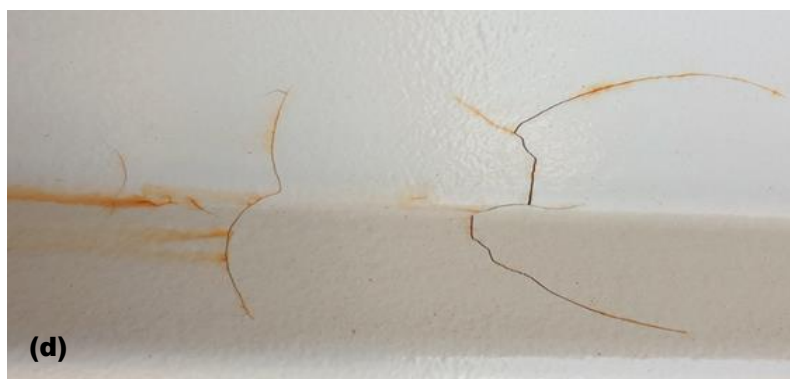
Coating failure of a steel cargo container (having dimensions of Length: 10', Width: 8', and Height 8.5') was observed in the form of cracks, and rust stains were also seen on the surfaces of the container. Container coating was noted to be very rigid and showed evidence of almost no flexibility which was not in compliance with the claims in technical data sheet of the paint manufacture. Evidence of failure of coating flexibility test even with a minor bending supports this conclusion Rust stains were noted below coating at few locations which implies that the surface finish requirements for coating were not fully complied to during the coating application. Below photos are self-explanatory in terms of visual appearance.
