## **Comprehensive Laboratory Analysis of AC Coupon Test Stations**

### **ABSTRACT**

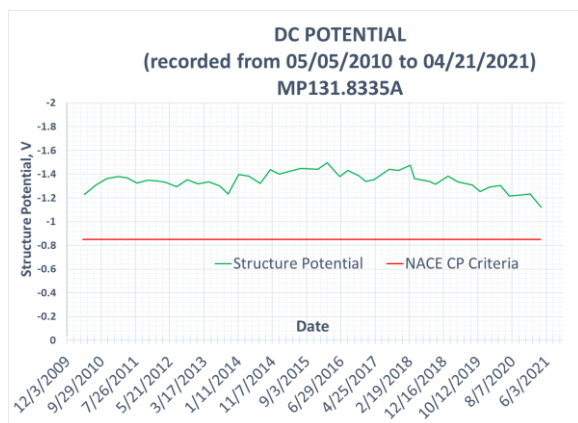
**Figure 4:** Plot showing structure ON-potential data of the CTS at location MP131.8335A recorded from 05/05/2010 12:00 to 04/21/2021 12:35. From the plot, it is evident that potential reads meet the -850mV minimum NACE CP criterion for the entire part in service.

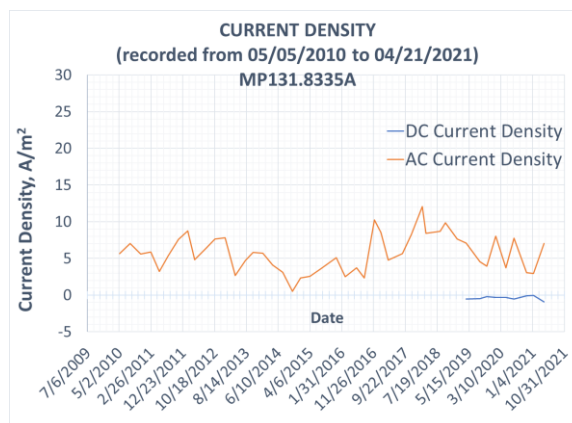
**Figure 5:** Plot showing measured AC and DC current densities of the CTS at location MP131.8335A recorded from 05/05/2010 12:00 to 04/21/2021 12:35. From the plot, it is evident that DC current density is below 1 A/m<sup>2</sup> and AC current density has not exceeded 30 A/m<sup>2</sup>.

- The average DC current density of CTS location MP131.8335A did not exceed 1 A/m<sup>2</sup>; therefore, the AC current density can be controlled to less than 100 A/m<sup>2</sup>.

- DC current density was measured beginning in 2019. Both average and maximum AC current density values from 2019 were under 30 A/m<sup>2</sup>, indicating a low risk of AC corrosion given existing AC mitigation.

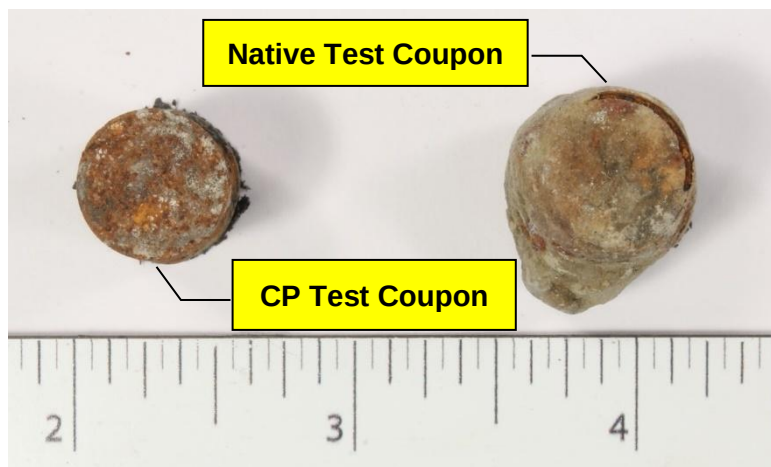
The test coupons were sectioned from the AC test station for visual examination. Figure 6 shows that the top face of the native coupon was covered with firmly adhered soil, and the top face of the CP coupon exhibited reddish-brown deposits. Figure 7 shows the side faces of the native and CP test coupons. The features on the top face and the sides of the test coupons are similar, i.e., the side of the native coupon was covered with firmly adhered soil, and the top face of the CP coupon exhibited reddish-brown deposits.

Figure 6: Photograph showing cut sections of the CP & native test coupons from the test station.

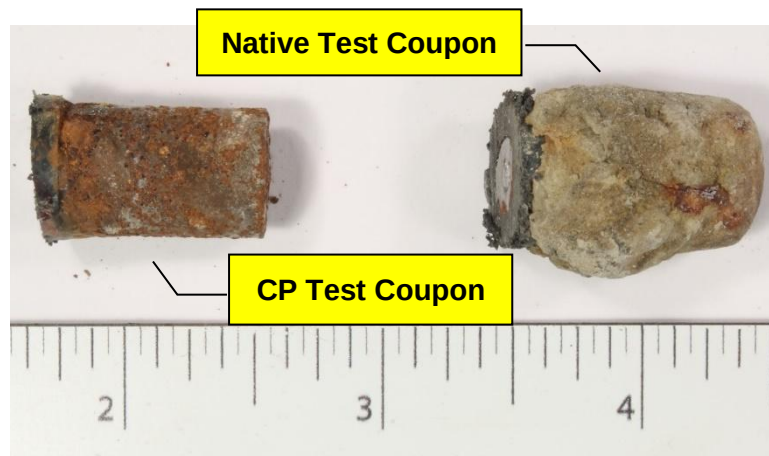
Figure 7: Photograph showing cut sections of the CP & native test coupons from the test station.

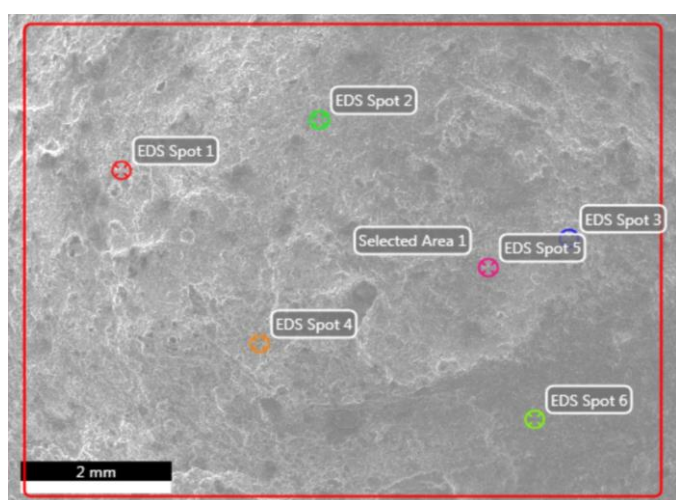
- Selected Area 1 on the deposits at the *top face of the native test coupon* showed calcium (earth alkaline cations); sodium and aluminum (both soil alkaline cations); along with iron. Silicon and oxygen (representing earth's crust) were also detected, plus sulfur and significant amounts of chlorine (Figure 8).

**Figure 8: EDS data (selected area 1 – red box) taken on the soil deposit present at the top face of the native test coupon showing calcium (earth alkaline cations), sodium, and aluminum (soil alkaline cations) along with iron. Silicon and oxygen (Earth's crust) were also detected. Sulfur and significant amounts of chlorine were also detected.**

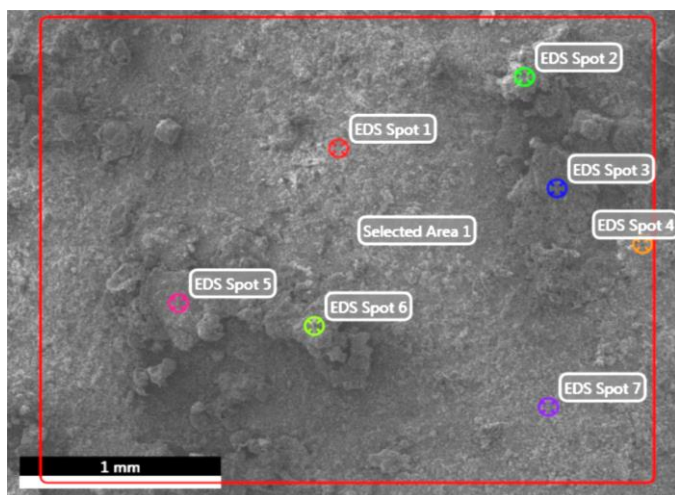
(a) The presence of chlorine (chloride ions) on the top face of the CP coupon suggests that it may not have received CP at some point in service. However, absence of significant metal loss and no readily apparent pitting indicates that CP in place was effective for much of the time. Also, it is possible that the CP coupon became soaked and contaminated with adjacent chloride-rich soil as it rained during the excavation. The other reasonable possibility was that the soil surrounding the coupons was wet much of the time due to a high groundwater table.

- Selected Area 1 located on the deposits at the *top face of the CP test coupon* contained calcium, magnesium, sodium, aluminum, potassium, iron, silicon, and oxygen. Chlorine was also detected (Figure 9).

**Figure 9: EDS data (selected area 1 – red box) taken on the deposits at the top face of the CP test coupon showing calcium and magnesium (earth alkaline cations), sodium, aluminum, and potassium (soil alkaline cations) along with iron. Silicon and oxygen (Earth’s crust) were also detected. Noticeable presence of chlorine was also detected.**

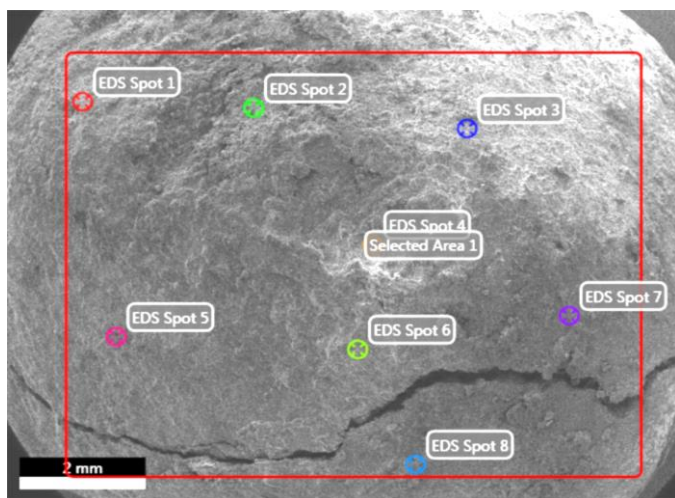
- Selected Area 1 on the deposits at the *side of the native test coupon* contained calcium, magnesium, sodium, aluminum, potassium, iron, silicon, and oxygen, plus sulfur and significant amounts of chlorine (Figure 10).

**Figure 10: EDS data (selected area 1 – red box) taken on the deposit from the side of the native test coupon showing calcium and magnesium (earth alkaline cations), sodium, aluminum, and potassium (soil alkaline cations) along with iron. Silicon and oxygen (Earth’s crust) were also detected. Sulfur and significant amounts of chlorine were also detected.**

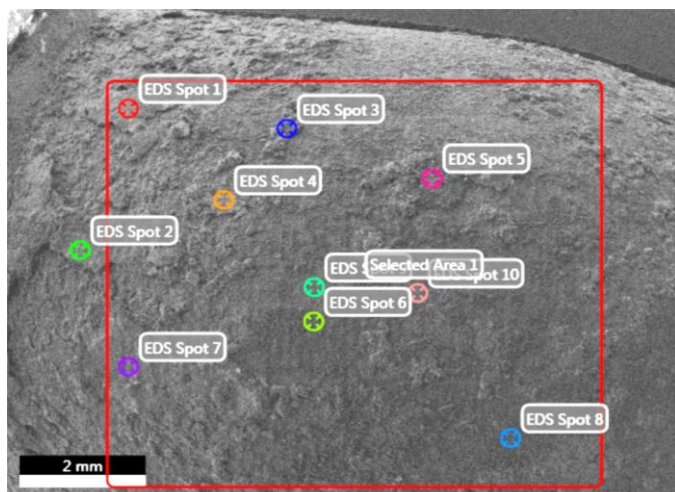
- Selected Area 1 located on the deposits at the *side of the CP test coupon* contained calcium, magnesium, sodium, aluminum, potassium, iron, silicon, and oxygen. Sulfur and chlorine were also detected (Figure 11).

**Figure 11: EDS data (selected area 1 – red box) taken on the deposits from the side of the CP test coupon showing calcium and magnesium (earth alkaline cations), sodium, aluminum, and potassium (soil alkaline cations) along with iron. Silicon and oxygen (Earth's crust) were also detected. Traces of sulfur and noticeable presence of chlorine were also detected.**

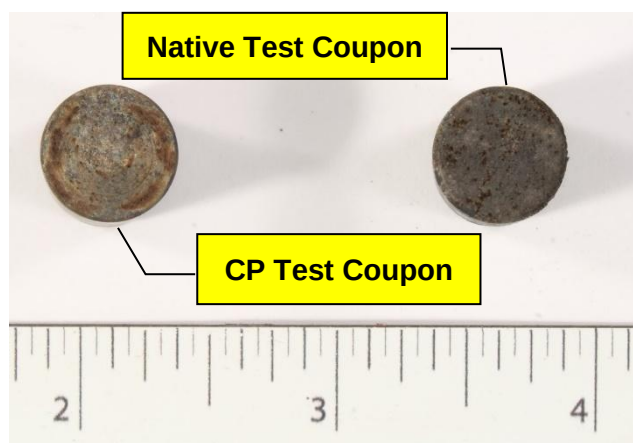
Figures 12 through 13 show the condition of the test coupons after ultrasonic cleaning. The coupons were cleaned to remove firmly adhered corrosion deposits and perform EDS on the cleaned coupons. Figure 12 shows corrosion attack on the top face of the native test coupon, whereas the CP test coupon was relatively unaffected because CP was protecting it. However, staining due to corrosion attack was noted on the top face of the CP test coupon. Figure 13 shows the condition of the test coupon sides after cleaning. The native coupon was significantly corroded, while only superficial corrosion attack was observed on the side of the CP coupon.

**Figure 12: Photograph showing cut sections of the CP & native test coupons from the test station after ultrasonic cleaning.**

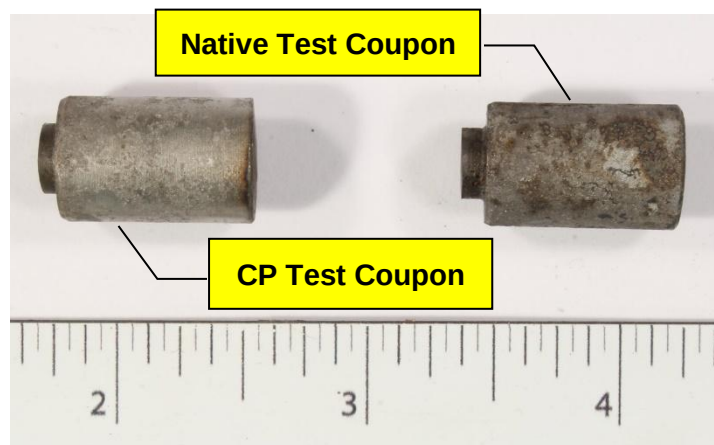
**Figure 13: Photograph showing cut sections of the CP & native test coupons from the test station after ultrasonic cleaning.**
