## **Coating Failure by Design**

### **ABSTRACT**

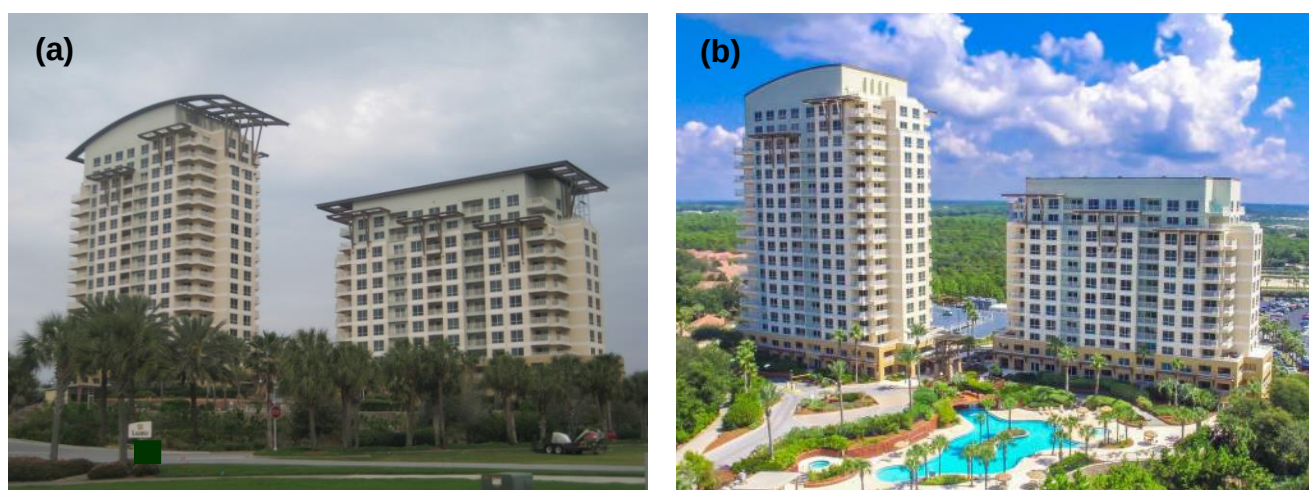
environmental conditions is critical in avoiding the potential “failure by design”. The case study presented will focus on the *coating failure by design*, that could have been avoided by the original design and construction team and resulted in costly litigation and eventually the complete removal of a key architectural element on two high-rise condominium buildings located along the Florida coastline (Figure 1).

**Figure 1. - (a) Towers 1 and 2 with roof canopies (b) Towers with roof canopies removed<sup>(1)</sup>**

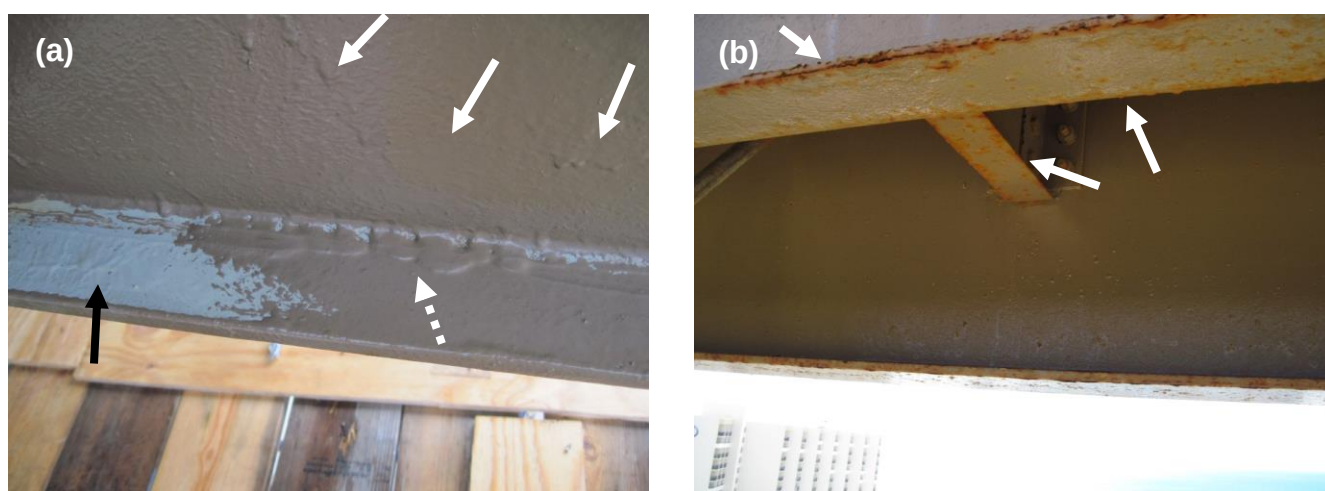
Reportedly the canopies were recoated at least once since their original installation, and poor workmanship was evident throughout the work. Heavy roller marks, runs, and sags were common in the recoated areas. The runs and sags were sufficiently heavy that the coating had partially ponded onto the top of bottom flanges. Moreover, the coating finish was missing in some areas ("finish-coat holidays"). Runs, sags, pooling, and finish coat holidays are depicted in Figure 2(a). Many of the upward facing surfaces of the structural steel framing were covered by the corrugated metal decking and would limit or prevent access to these surfaces and a continuous application of the remedial coating. Similarly, at bolted connections, mating surfaces were also inaccessible.

members, nuts, and bolt heads; edges corrosion of structural steel members is illustrated in Figure 2 (b). Extensive corrosion and lifting (peeling) of the coating system from the top of the bottom flanges was also observed (Figure 3 (a)). To a lesser extent, corrosion was also observed at localized areas of webs often leaching from cracks in the web coating. Blisters and under-film corrosion also were present at the underside of some steel components.

**Figure 2. - (a) Sagged remedial coating (solid white arrows) on web, and pooled coating on flange (white dashed arrow), and area of missing topcoat (solid black arrow), (b) Area where corrosion is predominantly at edges of steel (white solid arrows)**

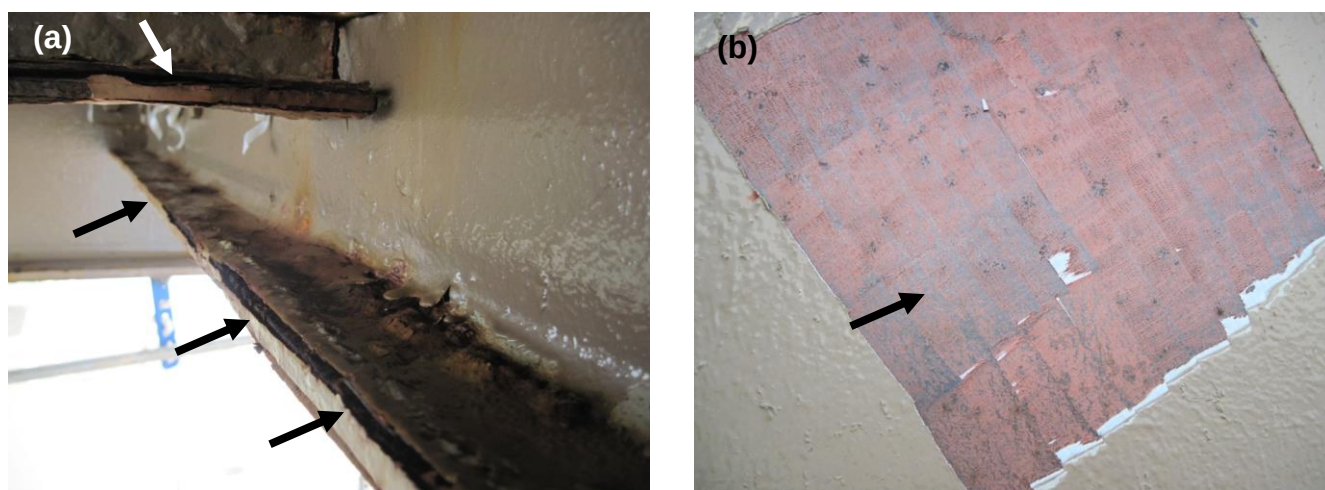
Coating was removed from selected intact areas of webs to expose and evaluate the condition of the substrate. Partial removal of original reddish-brown primer at a selected, seemingly intact, non-rusted area, revealed smooth, non-scarified, black, mill scale surface as depicted in (Figure 3 (b)). Pull-off adhesion testing (detailed later) in this area, revealed small spots of under-film corrosion. The presence of mill scale alone suggests that substrate surfaces were prepared no better than SSPC SP2 or SP3 since these methods do not require the removal of firm, intact, mill scale and rust, and the lack of

**Figure 3. - (a) Extensive corrosion of the top of bottom flanges and lifting (peeling) of coating system (b) Smooth mill scale surfaces were present beneath the reddish-brown primer (arrow)**

scarification of the substrate further suggests that substrate surfaces may not have been prepared by these methods at all.

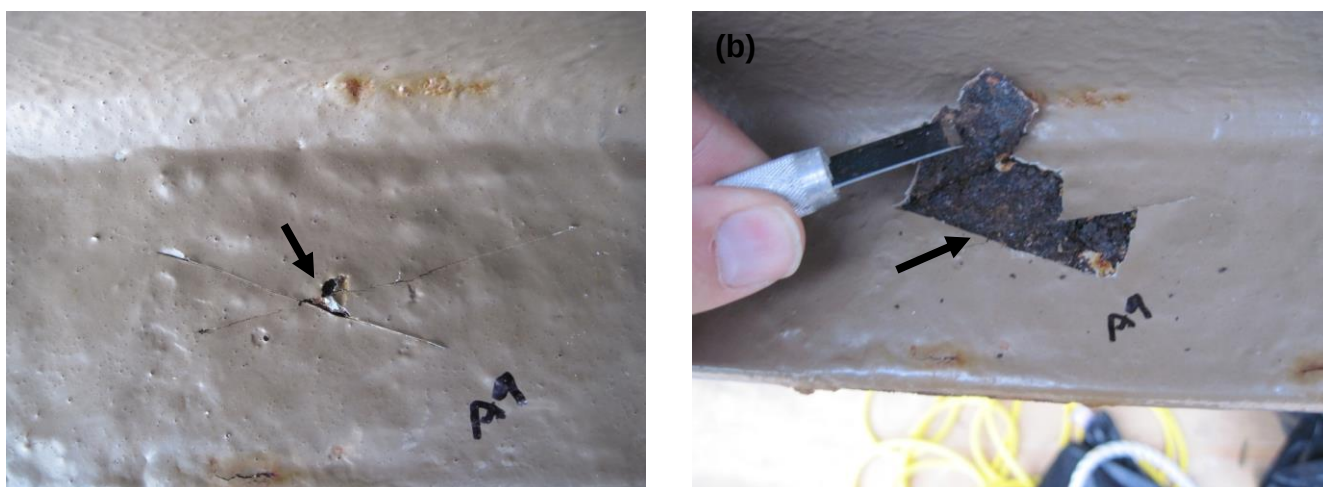
Areas of seemingly intact coating were tested at eleven locations and the results of tape adhesion tests ranged from 2A to 5A. Fifty five percent (55%) of the adhesion tests performed were indicative of good adhesion (i.e., 4A or 5A), 36% were marginal (3A), and 9% represented poor adhesion (2A or less). The ASTM D3359 ratings were categorized by relative quality of good, marginal and poor adhesion based on the authors' collective experience in performance of this type of coating adhesion test. Those tests indicating marginal to poor adhesion occurred in areas where the test revealed under-film corrosion. However, some test areas showed higher adhesion ratings even though the substrate was corroded (Figure 4).

**Figure 4. (a) X-cut adhesion test with a marginal rating (b) The same adhesion test area showing corrosion and mill scale beneath the coating that was easily removed from the substrate.**
