## **Failure Analyses On A Super Duplex Stainless Steel Tube Material Before And After Slow Strain Rate Testing In Sour Conditions – Part 2: A Case Study On Local Corrosion**

### **ABSTRACT**

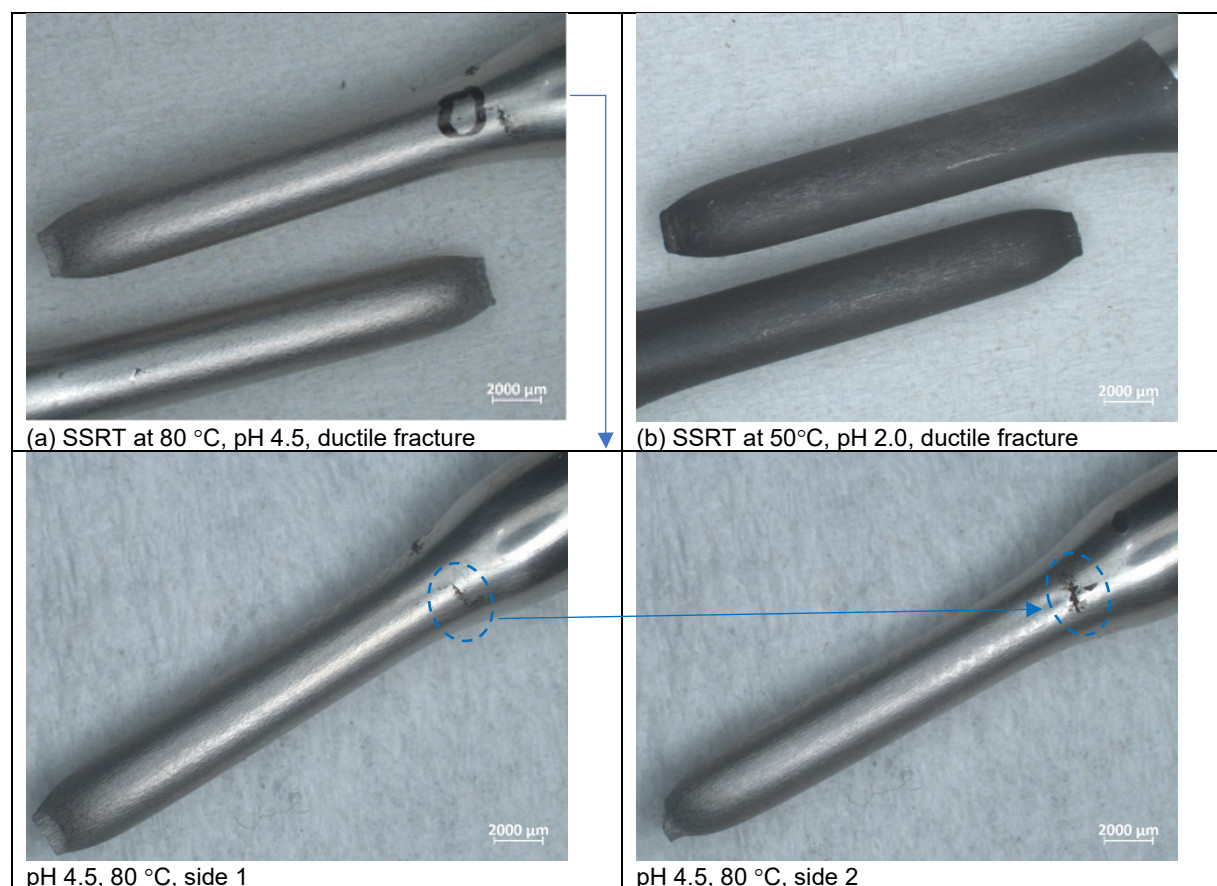
All the SSRT specimens have been observed using an optical stereo microscope. The specimens with local corrosion shown in **Figure 2**, are included in case study using SEM-EDS and EBSD in this case study. Although the high ductility ratios, corrosion has been observed on specimen surface tested at 50 °C, pH 2.0; whereas, localized corrosion has been observed on the specimen tested at 80 °C, pH 4.5, in one of the specimen shoulders, including two parts of circumferential corrosion lines, no corrosion observed on the fracture surface and gauge section.

**Figure 2: Although high ductility, no SCC has been observed on two SSRT specimens tested in the sour environment at 80 °C, pH 4.5 (a) and 50 °C, pH 2 (b), localized corrosion has been observed on one specimen shoulder (a) and uniform corrosion on specimen surface (b).**

Although the high ductility ratios and no corrosion has been observed on the fracture surface and gauge section, the localized corrosion observed on the one side of specimen shoulder has been investigated in order to find out how corrosion was initiated and if any cracking initiated underneath the corrosion area. SEM observation and EDS point analysis showed that the circumferential corrosion lines observed in the shoulder consist of some thick corrosion products and thin corrosion with selective dissolution in the lower part nearby the thick corrosion products. See images in **Figure 4**. Compared to the non-corroded area as reference matrix, the thick corrosion products are Fe-S-O rich while the thin corrosion area contains more Ni-S-O. Trace chloride has been identified in the thin corrosion area.

With consideration of the circumferential linear corrosion damage in one shoulder area observed on specimen tested at 80 °C, pH 4.5, half-immersion of dry-wet condition might be supposed. The half-immersion condition would not be the same as the testing condition in the bulk solution, where local concentration of chloride and H<sub>2</sub>S could be high in the dry-wet condition in thin liquid layer.

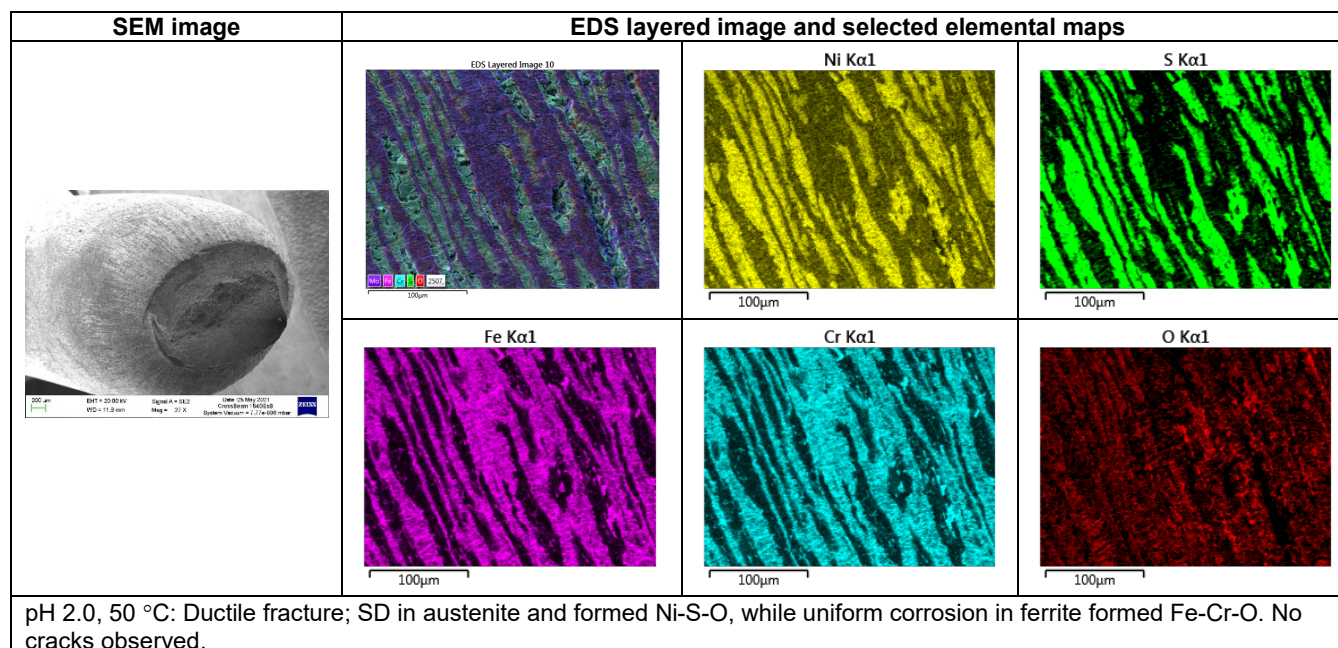
SSRT specimen after testing in pH 2.0 at 50 °C showed ductile fracture with high ductility ratios and no secondary cracks. However, the specimen was covered by black corrosion products, see image (d) in **Figure 2**. SEM images show that both uniform corrosion and selective corrosion have occurred, no secondary cracks observed. EDS elemental mapping confirms that selective dissolution occurred in austenite and Ni-S-O formed on austenite; while uniform corrosion is observed on ferrite and formed Fe-Cr-O corrosion products on ferrite, see in **Figure 3**.

**Figure 3: EDS elemental mapping on SSRT specimen surface after testing in the sour environment at 50 °C, pH 2.0.**
