# **Material, Fabrication, and Repair Considerations for Austenitic Alloys Subject to Embrittlement and Cracking in High Temperature 565 °C to 760 °C (1050 °F to 1400 °F) Refinery Services**

API TECHNICAL REPORT 942-B  
FIRST EDITION, MAY 2017

AMERICAN PETROLEUM INSTITUTE

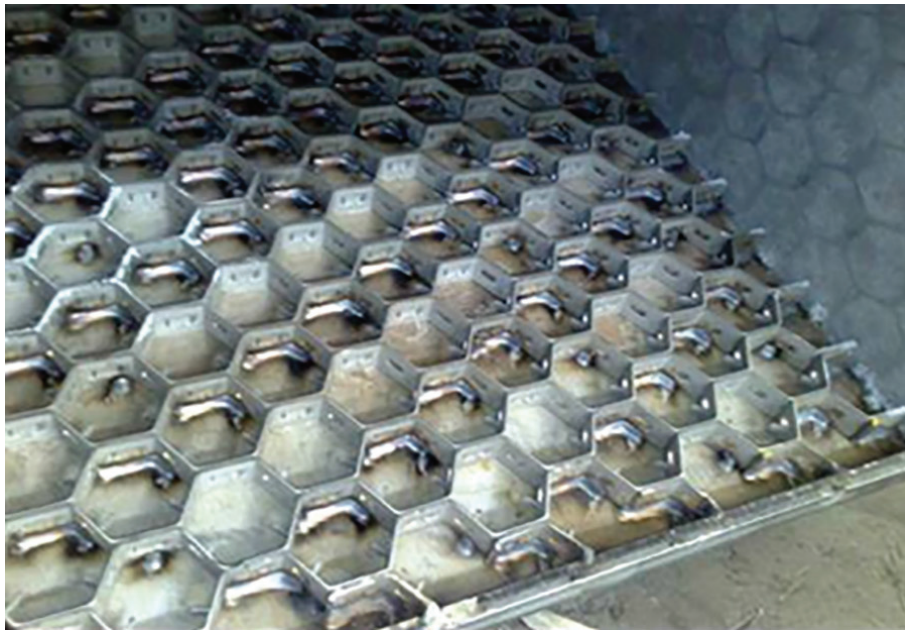
**Figure 3—Example of New Hexagonal Mesh Welded Inside a Regenerator Cyclone**

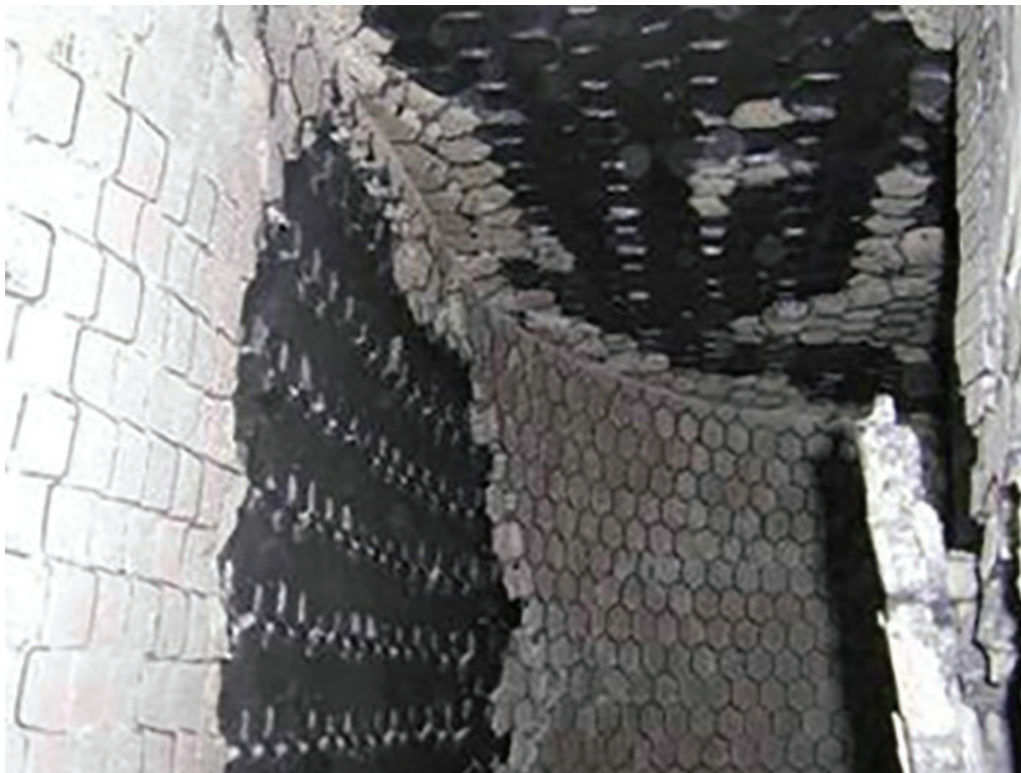
**Figure 4—Large Areas of Internal Hexagonal Mesh and Refractory that Failed in a Brittle Manner**

There have been a significant number of recent (2008 through 2011) Type 304/304L and Type 321 stainless steel hexagonal mesh failures that have caused loss of internal refractory resulting in plugged cyclones. This has forced shut downs of the units and caused significant reliability issues.

- When it occurs, the damage mechanisms generally cause refractory systems to fail in approximately 4 to 6 years, though there has been a case where failure occurred after only two years [4].
- Since embrittlement and corrosion occurs behind the refractory, damage is often not obvious from visual inspection.
- Cases have been reported in both complete and partial combustion units.

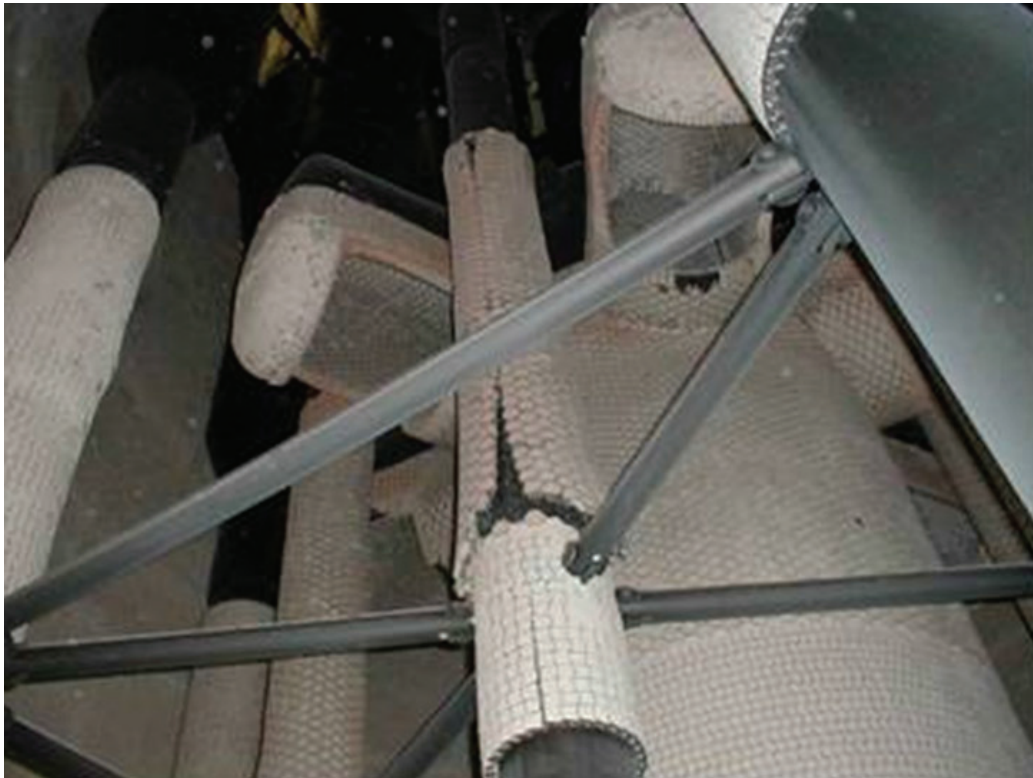
**Figure 5—Example of External Refractory that Failed After a Short Time in Service**

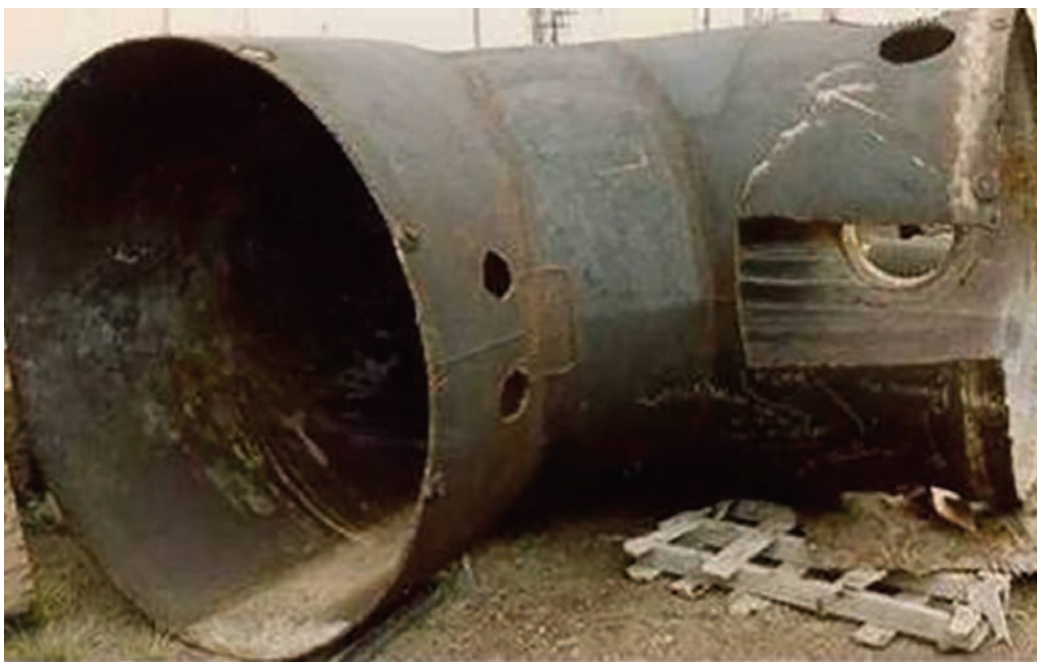
Figure 6 [9] shows an example of a large diameter Type 304H stainless steel flue gas mitered elbow joint that was replaced after 11 years of service due to severe distortion and cracking. It operated at an average temperature of 715 °C (1320 °F) and suffered chronic cracking at the welds on the intrados that seemed to occur each time the unit was shut down and the piping was cooled to ambient temperature. The cracking was attributed to sigma phase embrittlement and required lengthy repairs involving crack removal and re-welding. On occasions, the old weld had to be removed as a window which encompassed both sides of the weld and replaced with inserts and a new weld. In another refinery with similar problems, the mitered elbows were replaced by formed elbows.

**Figure 6—An Example of a Mitered Joint After Removal From Service**

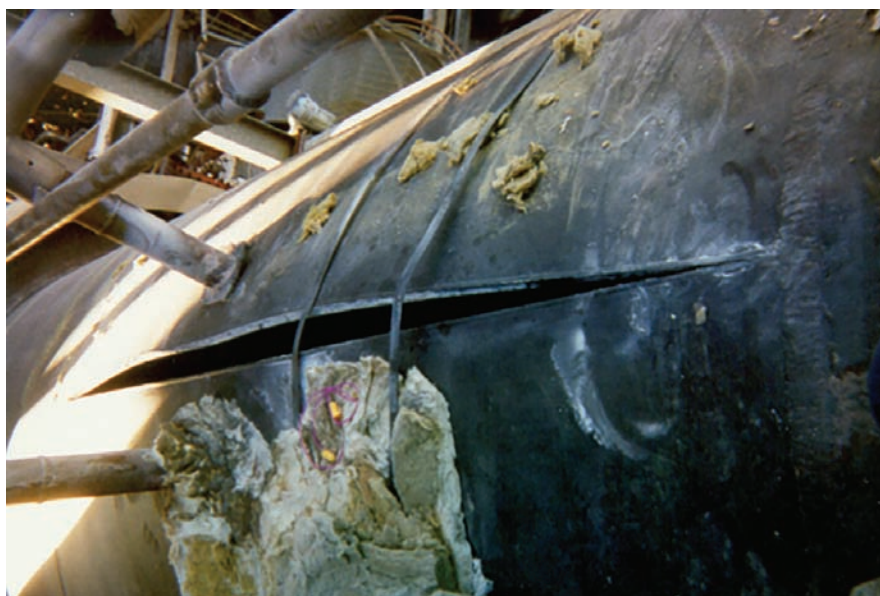
In a case [10] of creep cracking shown in Figure 7, Figure 8, and Figure 9, a crack 2.4 m (8 ft) long developed in a longitudinal weld seam in a 180 cm (72 in.) diameter Type 304H stainless steel duct that was flux-cored arc welding (FCAW) with Type 308H stainless steel consumable.

**Figure 7—Creep Failure on a FCCU Regenerator Overhead Line**

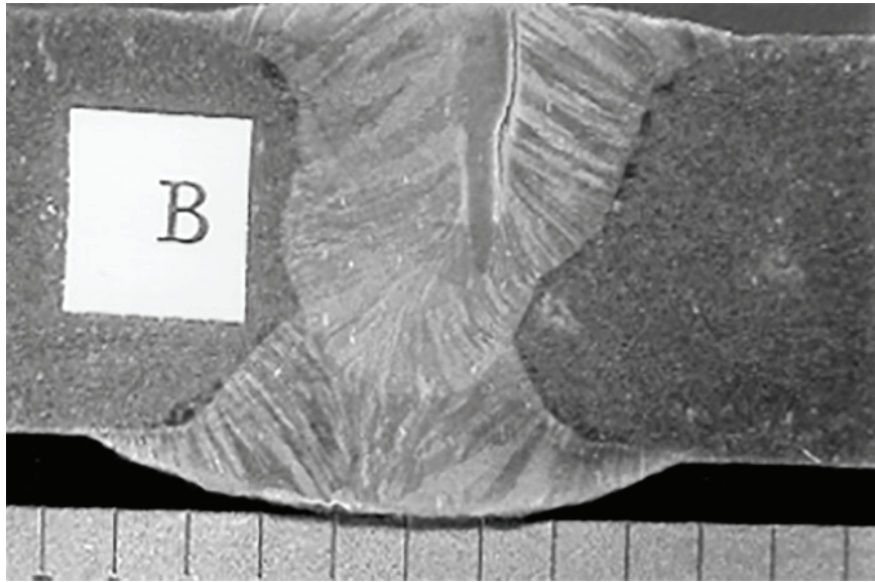
Interdendritic creep cracking was found in the large welds at the outside diameter (OD) of the piping. The pipe longitudinal seam welds appeared to have been welded with a two pass submerged arc weld procedure. Test of material removed from the weld showed high levels of sigma phase and that the weld had half the remaining creep life of the base metal.

**Figure 8—A Two Pass SAW Weld Was Found with Creep Cracking in the Outside Weld Bead**

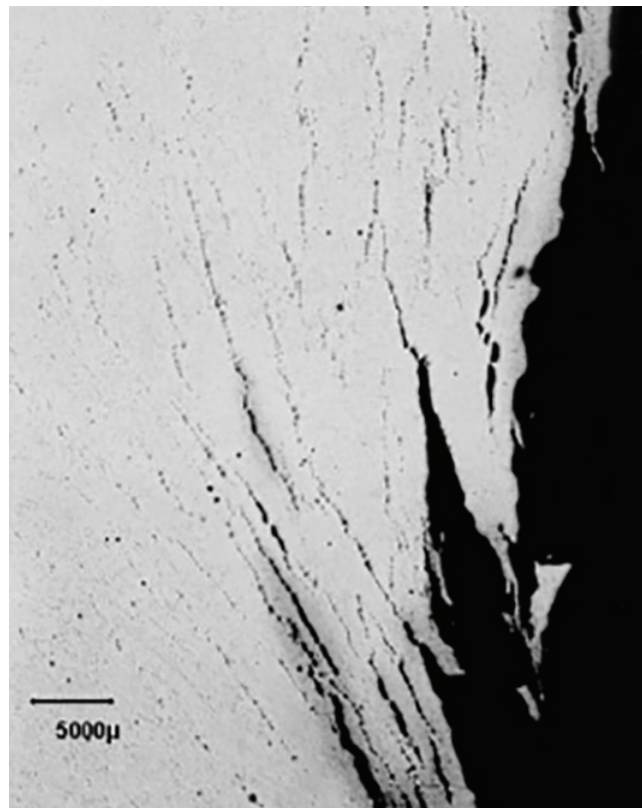
**Figure 9—Interdendritic Creep Voids and Cracking in a Weld Cross Section**

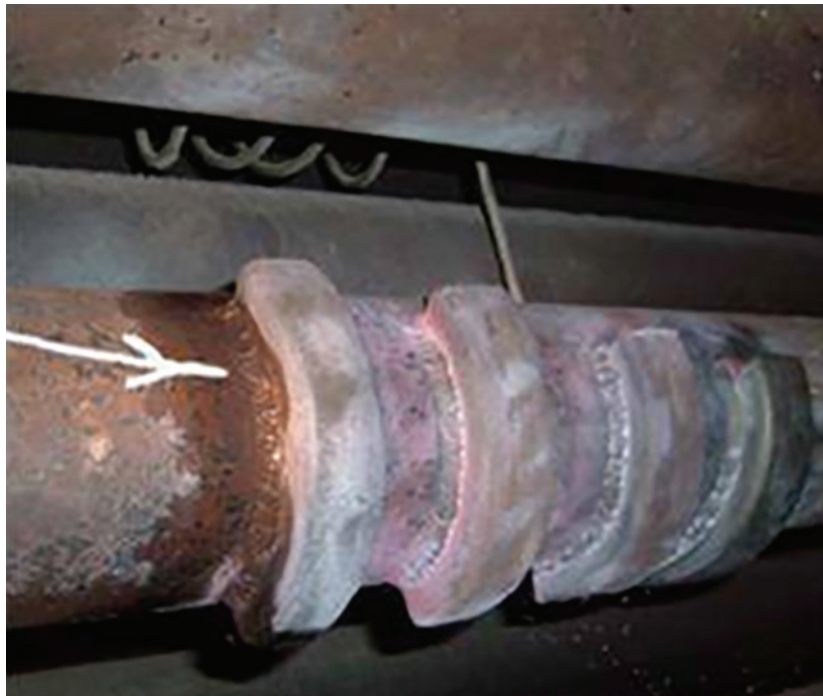
In another case, circumferential cracking was observed after three months of service in Alloy 800HT® steam superheater coil welds in a hydrocracker heater. Subsequent investigation revealed intergranular fissuring and oxidation with intergranular and transgranular penetration on both the tube ID and OD. The average operating temperature was 616 °C (1140 °F), with occasional excursions to 766 °C (1412 °F).

**Figure 12—Multiple T/C Shields Welded to an Alloy 800H Superheater Tube**

Details for avoiding SRC and repair procedures are given in Section 4. Typically, repairs include the use of a solution annealing procedure to improve ductility while welding followed by a stress relief procedure to reduce the potential for future cracking.

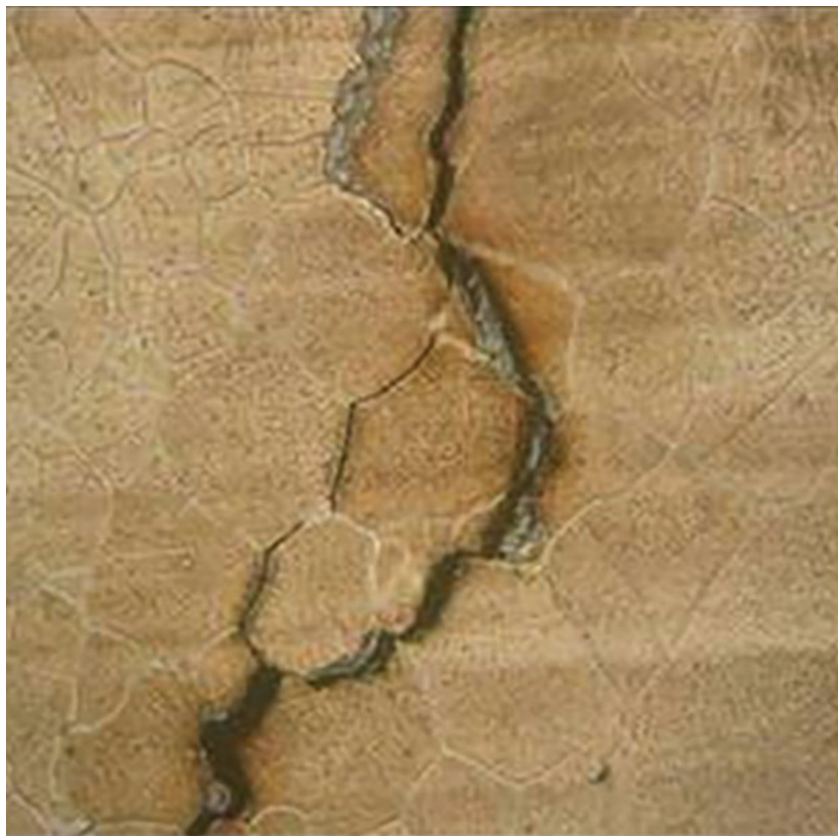
**Figure 13—Cross Section of a Crack at the Toe of One of the TC Shields Showing Intergranular SRC**

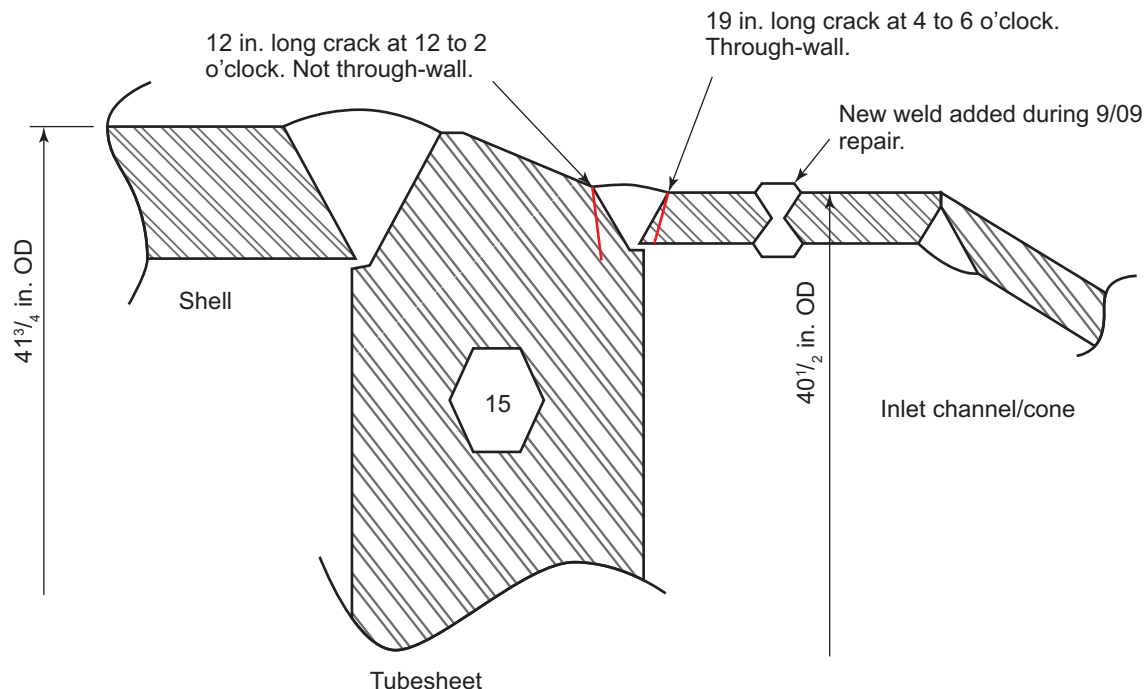
Figure 14 [13] shows the inlet channel of a reformer effluent heat exchanger with syngas on the tube side and superheated steam [2.7 MPa (400 psig)] on the shell side that cracked during service. The inlet channel and tubesheet that were fabricated from Alloy 625 while the tubes were 2<sup>1</sup>/<sub>4</sub>Cr-1Mo with Alloy 601 ferrules installed at the inlet. The tubes were strength welded to the tubesheet with Inconel 52 filler metal, AWS A5.14, and ERNiCrFe-7. The shell was fabricated from A516-70 carbon steel in 1999.

**Figure 14—Tubesheet-to-Inlet Channel Cone that Cracked in Service**

After 10 years of operation, the channel was cut off to repair ferrules at which time it was also discovered the tubes had suffered metal dusting. A new weld was added to re-install the channel and the exchanger was placed back in service. Approximately two months later, the inlet channel leaked, causing a fire.

The existing channel and stub were removed and the existing tubesheet was heated to 482 °C (900 °F) for 7 hours to bake out any residual hydrogen. Alloy 625 full penetration tubes to tubesheet strength welds were made. A new annealed Alloy 625 channel was installed, and the unit was brought online.

To reduce the hot inlet channel outer diameter skin temperature by approximately 110 °C (200 °F), a band of insulation on the inlet channel was removed and a steam ring was added at the tubesheet.

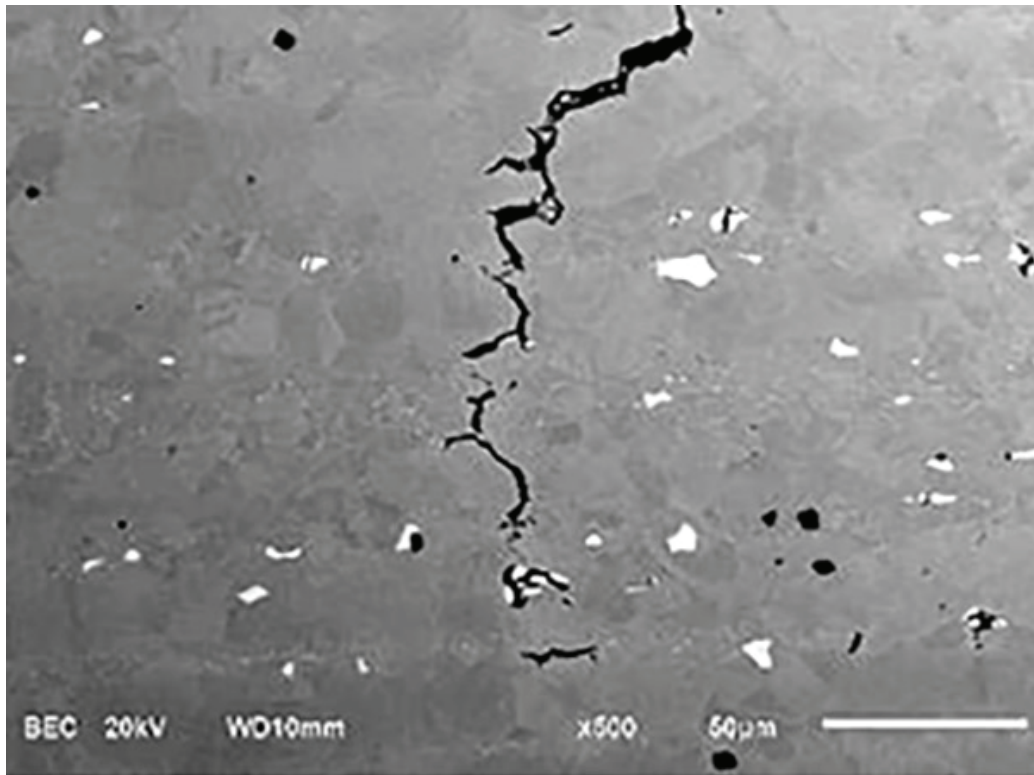
**Figure 15—Cracking From the OD Was Intergranular and Was Attributed to SRC**
