# **SEVESO**

## **LIST OF RELEVANT ACCIDENTS AND INCIDENTS**

**Doc 60.1/25**

***EUROPEAN INDUSTRIAL GASES ASSOCIATION AISBL***

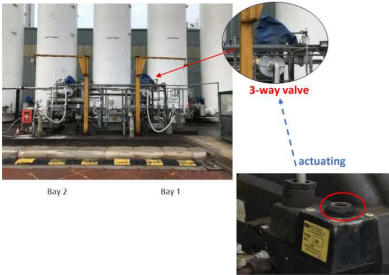
| Kind of event that could happen | Example Incidents – Air Separation facility including storage and tanker loading | Key lessons learned | EIGA Doc |
|---|---|---|---|
| | <p><b>167.05.01</b> In an ASU at one of the truck loading-bays an unintentional release of 39 t of LOX occurred from a storage tank due to a malfunctioning pneumatic valve. It had been affected by cold rainy and stormy weather. Major release of liquid oxygen. No injuries or further damage caused. [TP INC 43]</p> | Weather protection needs to be regularly checked/maintained. | |

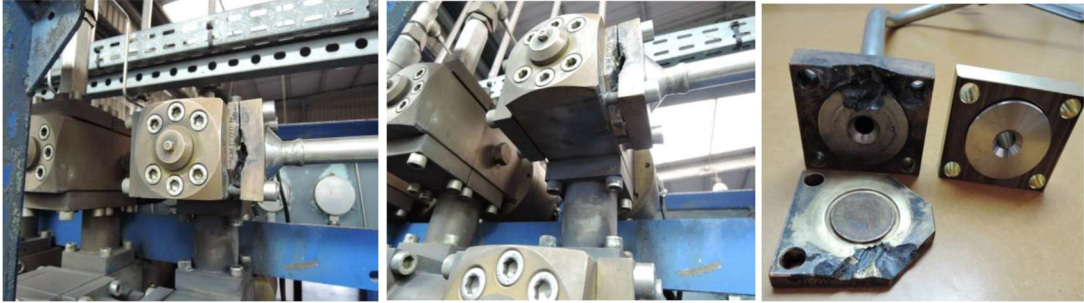
| Kind of event that could happen | Example Incidents – Packaged Gases cylinder filling facility (excluding Acetylene) | Key lessons learned | EIGA Doc |
|---|---|---|---|
| | <p><b>143.13.01</b> During the filling of medical oxygen an oxygen burn out occurred on the intentionally blocked control valve at the automatic HP control valve built into the valve cabinet. [Photo TP INC 20]</p> <p><b>173.11.01:</b> During the preparation of a specialty mixture cylinder, after the filling of the first component (CO<sub>2</sub>), the operator started the purging procedure of the line to prepare the filling of the second component (O<sub>2</sub>). The purging is performed by pressurising and venting the line more than one time. After purging procedure completion, the cylinder valve was opened, scales were tared, and operator started the second component filling by opening the ball valve. Approximately 2 seconds later the ball valve got fire. The operator immediately shut off the main oxygen supply and the flames self-extinguished within few seconds.</p> <p><b>170.02.02:</b> The operator was performing a purge sequence on the oxygen filling ramp, when opening the third cylinder in the sequence, there was a flash fire between the connector and the flexible hose. The operator wore correct PPE including flame retardant clothing, despite this the operator received burns to 35% the body and was hospitalised.</p> <p><b>163.14.01:</b> The operator was filling an oxygen bundle. At the end of the filling process (ca. 190 bar) the operator recognized a leaking noise at the connection between the filling hose and the RPV adapter. He interrupted the filling process by stopping the pump, closing the bundle valve, the filling line valve and relieved the pressure. He tightened the connection between the filling hose and the RPV adapter, restarted the pump and re-opened the filling line valve. An oxygen burnout occurred at the connection between the filling hose and the RPV adapter. A darting flame and/or the filling hose hit the operator in the back (shoulder). The impact was attenuated by protective clothing (fleece &amp; jacket), causing bruise and abrasion and light burn injuries.</p> | <p>subject to quality control procedures.</p> <p>Maintenance personnel working on oxygen systems should be competent.</p> <p>Design of vacuum systems should prevent oil flow into process piping.</p> <p>Flash fire protective Clothing (FFPC) is not certified to protect against oxygen enriched fires, but it may provide some protection.</p> <p>The use of backflow prevention valve can prevent contamination into cylinders.</p> <p>Site emergency plans should outline actions to be taken in the event of fire and product release.</p> | |
