| Ref: | NR/GN/SIG/17902 |

# Guidance Note

## SSI Program and Data Problems

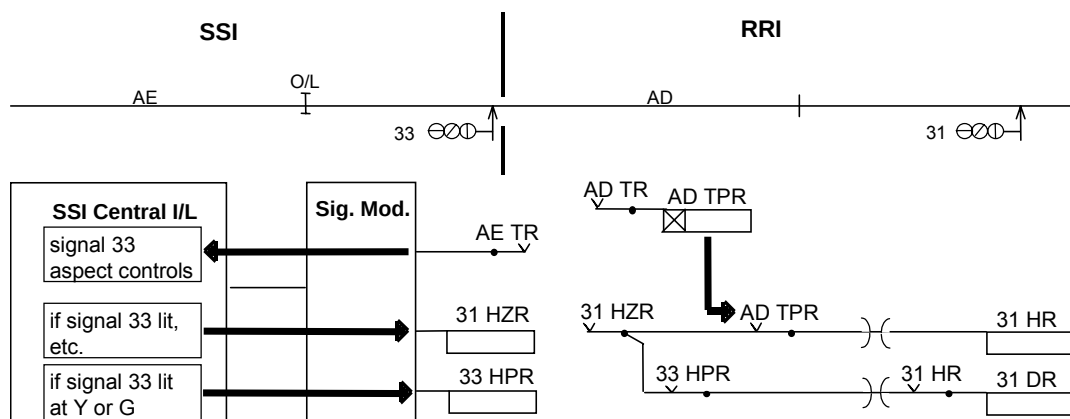
During April 1991 an incident was reported at Tollerton. This involved a short fast train passing from a relay controlled area into a SSI controlled area. The signal in rear of the train momentarily displayed an aspect less restrictive than the required single yellow. This in turn affected the displayed aspect of the signal in rear, this being observed by the driver of a following train (A similar incident also occurred at Watford in late 1992.)

The problem occurred whilst the train was crossing the boundary between relay and SSI controlled areas. This is illustrated by Figure 1 below, but using three aspect signals (note that the circuits are shown in schematic form, e.g. double cutting is not shown). Consider the train just clearing track circuit AD. This track circuit registers clear in circuit 31 HR of the relay controlled signal 31 in rear before the following track circuit AE, input via the SSI, can be registered as occupied in SSI controlled signal 33. As signal 31 clears, it momentarily displays a green, until relay 33 HPR is de-energised when this signal then changes to the required yellow.

This problem was accentuated at both Tollerton and Watford by the first SSI signal being controlled by Signal Module output relays rather than being driven direct by the module.

Both SSI8003 and SSI8500 have been changed to include the requirement that the relay controlled signal shall have the appropriate track circuit at the boundary proved clear twice in its aspect controls (i.e. in its HR or DR circuit), once direct via a TPR front contact and once via the SSI and a Signal Module output relay front contact. Figure 4 illustrates this for the problem detailed in Section 2.1.2. The other two problems are similarly dealt with.

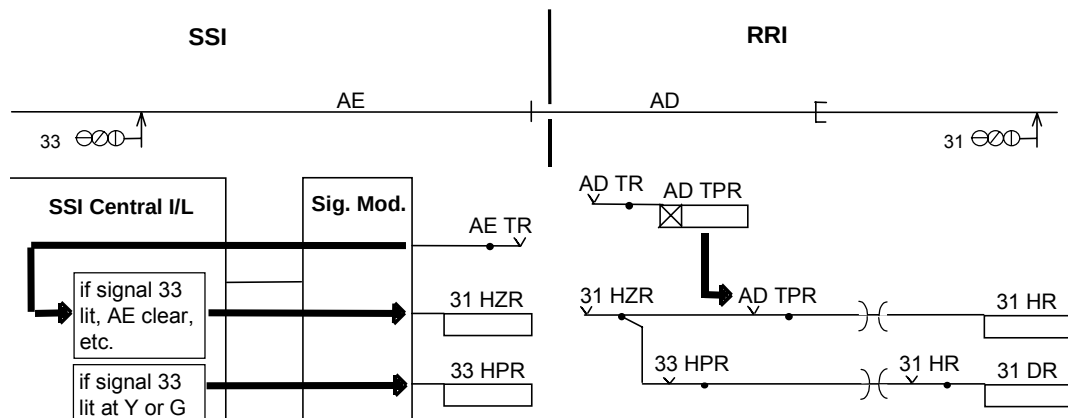
Figure 2 shows a typical arrangement. A relay controlled signal (31) has two or more track circuits in its aspect controls. One of these track circuits (AD) is proved clear via a TPR contact direct into the relay circuit (31 HR), whereas the next track circuit (AE) in the direction of travel, is input into the SSI and is proved clear in the relay circuit via the contact of a Signal Module output relay (31 HZR).

As the train passes between these track circuits, track circuit AD can pick and be proved clear in signal 31 via the TPR, before track circuit AE dropping can be registered by the breaking of the front contact of the Signal Module output relay 31 HZR. This allows signal 31 to momentarily clear from red.

This problem can arise if the relay controlled signal is automatic or semi-automatic, or if it is controlled and the signal is waiting to re-clear because of automatic working or oversetting.

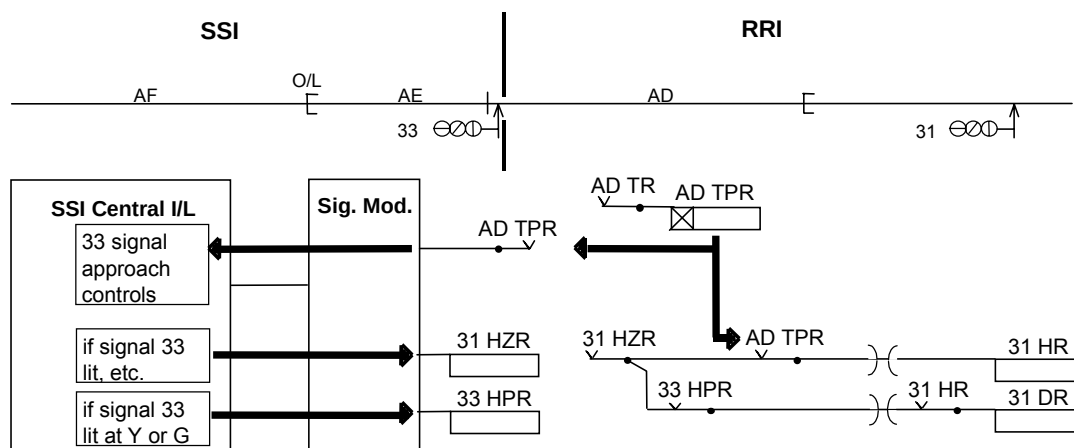
Figure 3 shows a typical arrangement. The first SSI controlled signal (33) has its berth track circuit (AD) input into the SSI for approach control (temporary or permanent). The relay controlled signal in rear (31) has this track circuit in its aspect controls proved clear via a TPR contact direct into the relay circuit (31HR).

With signal 33 ready to clear except for approach controls, track circuit AD fails and this signal clears. The failure now disappears, but signal 31 clears before signal 33 is replaced. This can result in the aspect sequencing briefly allowing signal 33 to display an aspect less restrictive than the required single yellow.

This problem will not arise if the relay controlled signal does not have both yellow and higher aspects. (This problem can also arise where both signals are SSI controlled - see Section 2.3.)

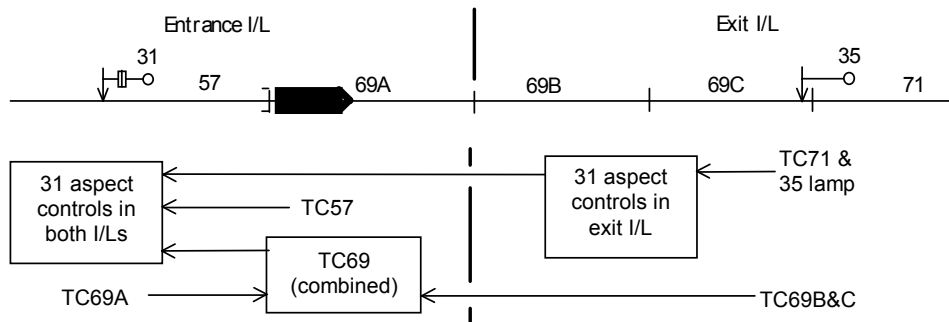
Figure 10

The only difference in delays, is at 69A/69B where 69B incurs one extra boundary crossing over 69A in being proved clear in signal 31.

With this solution applied, the new arrangement is as follows:

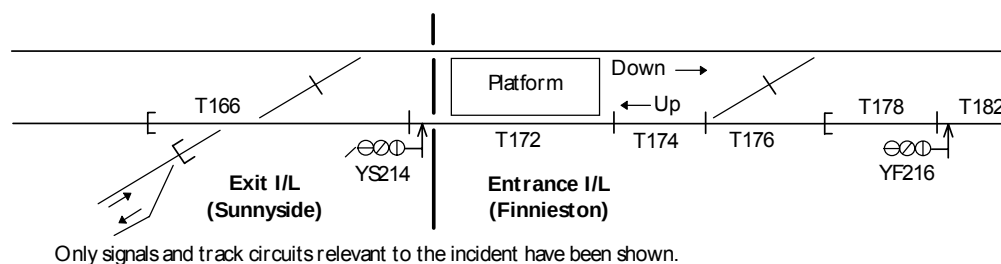
Figure 16

In January 1997, at Bellgrove in the Yoker control area, the double block working was removed and SPAD indicators added. Accordingly the warning class route for signal YF216 was reinstated and an addition made to the data to enable the green aspect for this route. On the day after these changes were commissioned, with this route set, a driver observed YF216 signal clearing from red to green for about a second before the aspect dropped back to yellow.

The aspect controls for route 216(W) only extend up to signal YS214, i.e. track circuit T166 is not proved clear. Signal YS214 is last-wheel replaced, thus with route 216(W) already set for a following train standing on track circuit T182, signal YS216 will clear

at the same time as signal YF214 is replaced by the previous train. There is potentially a 50% chance (depending on data order) that, on track circuit T172 being cleared, the data for signal YF216 will be processed before that for signal YS214. If so the aspect sequencing will lead to YF216 briefly displaying a green before adopting the correct yellow aspect.

This problem has long been recognised in SSI8003, thus the aspect controls for route 216(W) required track circuit T172 clear for two seconds - this guarantees at least a one major cycle delay, thus normally ensuring YS214 is replaced before YF216 clears. (Where Interlocking MPM main processor program issue SSI4303-D4 (or later issue) is installed, this data method is superseded by the program automatically delaying signals clearing direct to higher aspects by holding them at single yellow for one major cycle.) Uniquely, although intending to achieve the same objective, this data method does not strictly comply with the relevant SSP. Subsequently issued SSP62 section 2.2.4 requires, in these circumstances, the forward signal to have been proved replaced before the signal in question is allowed to clear.

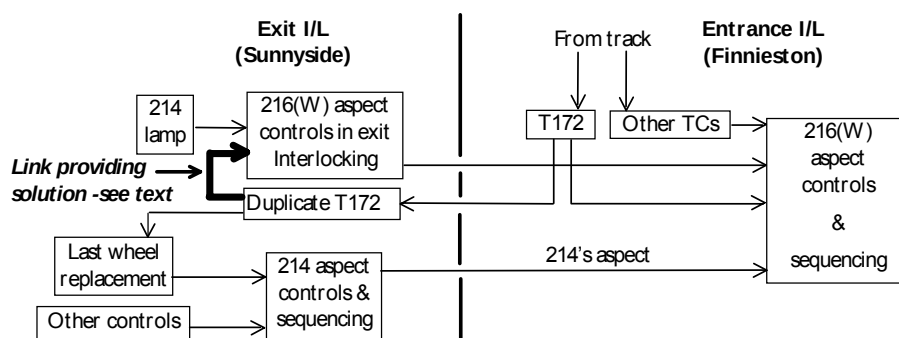
At Bellgrove, the problem was exacerbated by the delays introduced by the Interlocking boundary. The routes from signal YF216 crossed this boundary. Track circuit T172 was input into the Entrance Interlocking, this being directly proved clear for two seconds in the aspect controls for route 216(W). The state of this track circuit was copied across to the Exit Interlocking where it was used in the last-wheel controls (and any approach controls) of signal YS214. Information about the aspect of YS214 was then passed back to the Entrance Interlocking for use in the aspect sequencing of signal YF216. This is illustrated (less the bold item) in Figure 17 above.

The delays in passing information across the boundary more than equalled the induced delay in clearing signal YF216, thus this signal cleared before the information

that signal YS214 had been replaced could reach the Entrance Interlocking. The initial solution, shown in **bold** in Figure 17, was to apply what is sometimes called Raynes Park control. Thus track circuit T172 is also proved clear (also for two seconds) in the aspect controls of route 216(W) (and in route 216(M)) **in the Exit Interlocking**. This is so that the cross-boundary delay is also applied to the clearing of signal YF216.

SSI8003 has required such additional proving since 1991, with additional emphasis added in 1996 for where a signal and its berth track circuit are in different Interlockings. However, as a result of this incident, SSISPG considered that SSP62 section 2.2.4 should be strictly complied with. This requires that the clearing signal prove that the signal ahead is replaced. The method for achieving this has been added to SSI8003.

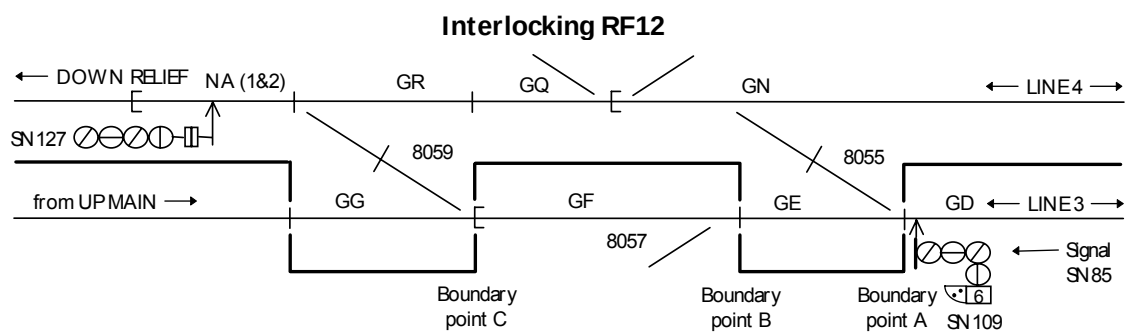
Figure 11

Just outside Paddington during June 1996, route 109C-1 was set by a Signaller at Slough Control Centre. Signal SN109 duly cleared, and when the train occupied track circuit GG, it was realised, because of the flooding of the track circuit indications, that the route locking was missing from track circuit GG onwards.

The signalling in the area is under the control of Slough IECC via two Solid State Interlockings, PADDMN02 & PADDRF12 (henceforth referred to as "MN02" & "RF12"). As shown in Figure 11, there are two alternative routes from signal SN109 to signal SN127. When the Signaller (but not ARS) sets a route between these signals, preference is given to the first alternative, the Interlocking being expected to attempt to set this one first. If this fails to be set, the Interlocking then attempts to set the second alternative. These are thus known as "chained" alternative routes. Chaining does not apply when ARS sets these routes - it simply selects which alternative it requires to be set. The preferred alternative route 109C-1(M) crosses thrice between the same two Interlockings at boundary points A, B & C (a "castellated" boundary). Note that 109C-2(M) and 85A(M) are also cross-boundary routes, the latter because its overlap crosses the boundary.
