| Ref: | NR/GN/SIG/19020 |

# Guidance Note

## Signalling Relays (SIGTAN 020)

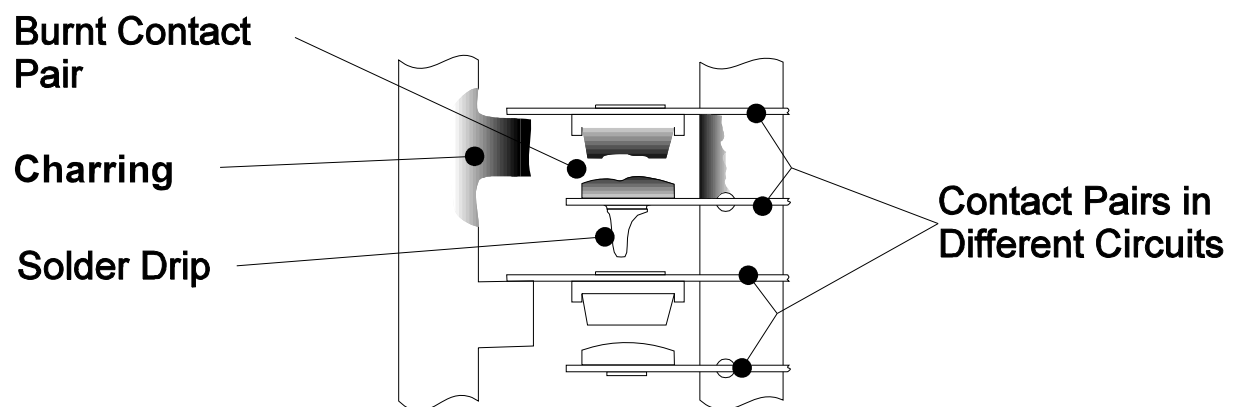
Figure A.1

When current passes through a contact, heat is generated. Where the current is high enough, the heat can melt the solder that secures the contact to the spring. Very occasionally, this has run down and formed a bridge to the next contact. See Figure 1.

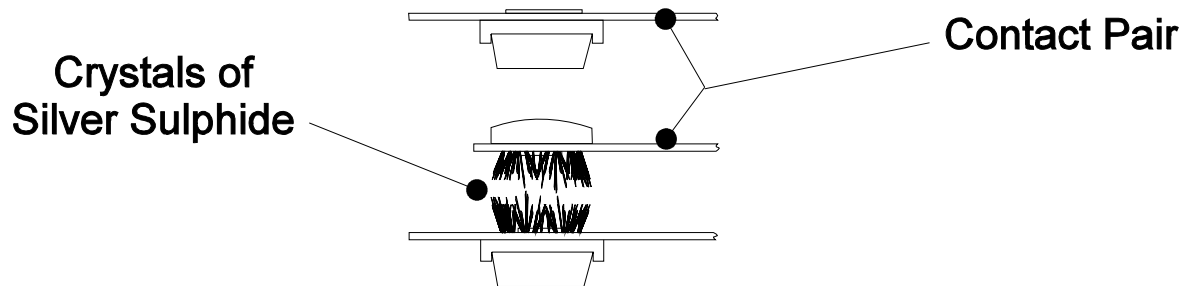
Figure A.2

Silver Sulphide crystals can grow on the contacts. These look like black iron filings on a magnet and are electrically conductive, see Figure 2. If they build up sufficiently, they could bridge contact pairs together. The cause of the problem is a chemical reaction between sulphur vapour (given off from the rubber insulation of coil connecting wires, or rubber pads between coil and relay frame, due to operating heat) and silver contacts.

Silver Sulphide has been observed in Westinghouse Q style (BR930) relays made between 1966 and 1970. Later relays used different (sulphur-free) insulation. Once any sulphur present in the rubber has dissipated the problem should not occur again. Relays made during this period which have been serviced should have had the offending wire / pads replaced. Silver Sulphide contamination has also been found in SGE full size plug-in relays and shelf type relays.

Some relays had a partial on site service to get rid of the silver sulphide problem and were marked with a blue dot. Over the years, however, dots may have fallen off. Any relays serviced will be okay and have had their dot removed.

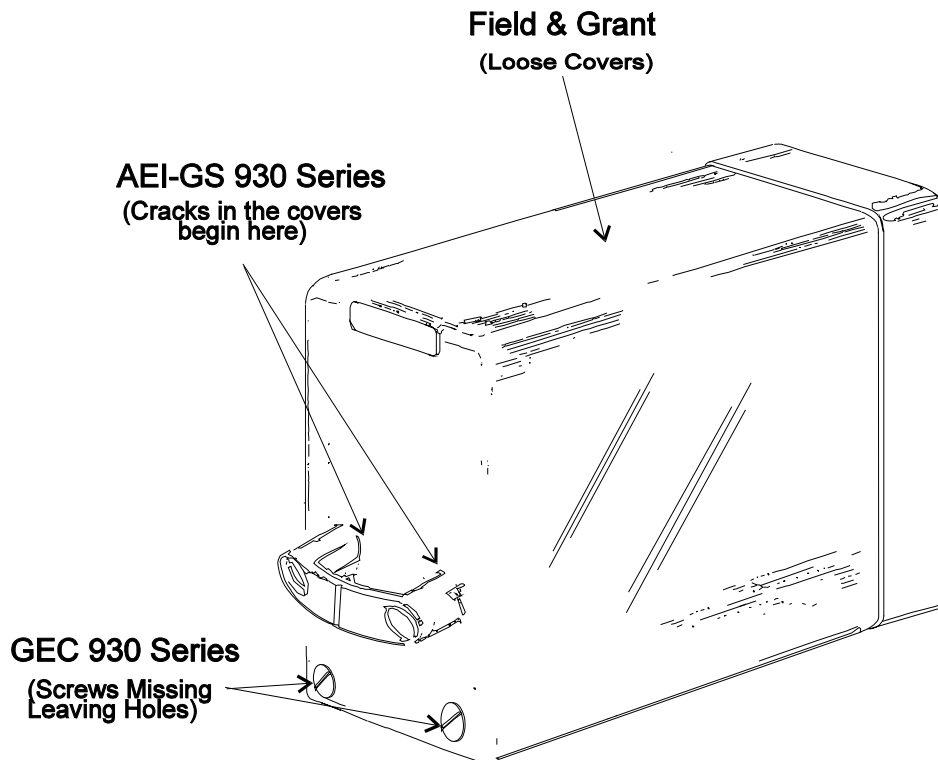
**Figure A.3**

Some relays made by Tyers, Zone Controls and AEI-GS, were manufactured without adequate internal support for the handle. Consequently, sustained or prolonged pressure on the handle by the retaining clip has caused their covers to crack.

The cracks start near the base of the handle and usually spread across the top and down the sides of the cover. One cover was found almost split in half.

The cracking occurs owing to the sudden shock caused when a tight fitting relay retaining clip is 'snapped' into position in the handle's clip recess. The continuing pressure from the clip then causes the cracks to spread. See Figure 3.
