| Ref: | NR/L2/ELP/27009/MOD C12 |

## OVERHEAD LINE CAMPAIGN CHANGES – DATA SHEET

### MODIFICATION OF SEIZED MECHANICALLY INDEPENDENT REGISTRATION (MIR) HINGE ASSEMBLIES

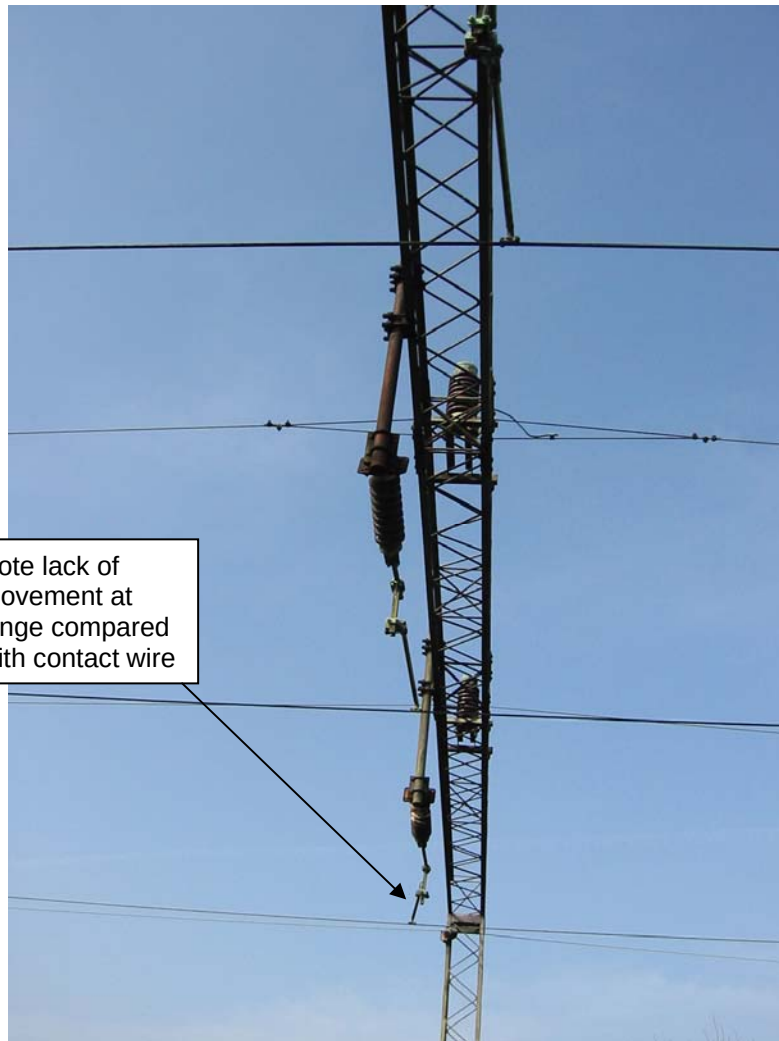
**COMPONENT** Seized hinges in “Mechanically-Independent Registration” (MIR) assemblies on portal structures.

**PROBLEM** Lack of available along track movement at the registration causes mechanical stressing of insulators and other components.

Note lack of movement at hinge compared with contact wire

| OVERHEAD LINE CAMPAIGN CHANGES – DATA SHEET | |
|---|---|
| <b>ACTION REQUIRED</b> | <ol style="list-style-type: none"> <li>1. Replace seized hinges with refurbished or fabricated brackets.</li> </ol><br> |
