| Ref: | NR/L2/ELP/27009/MOD C14 |

| OVERHEAD LINE CAMPAIGN CHANGES – DATA SHEET | |
| <b>14</b> | <b>REPLACEMENT OF BEARINGS IN TERMINATION &amp; SUPPORT PULLEYS PRONE TO SEIZURE DUE TO INSUFFICIENT CLEARANCE</b> |

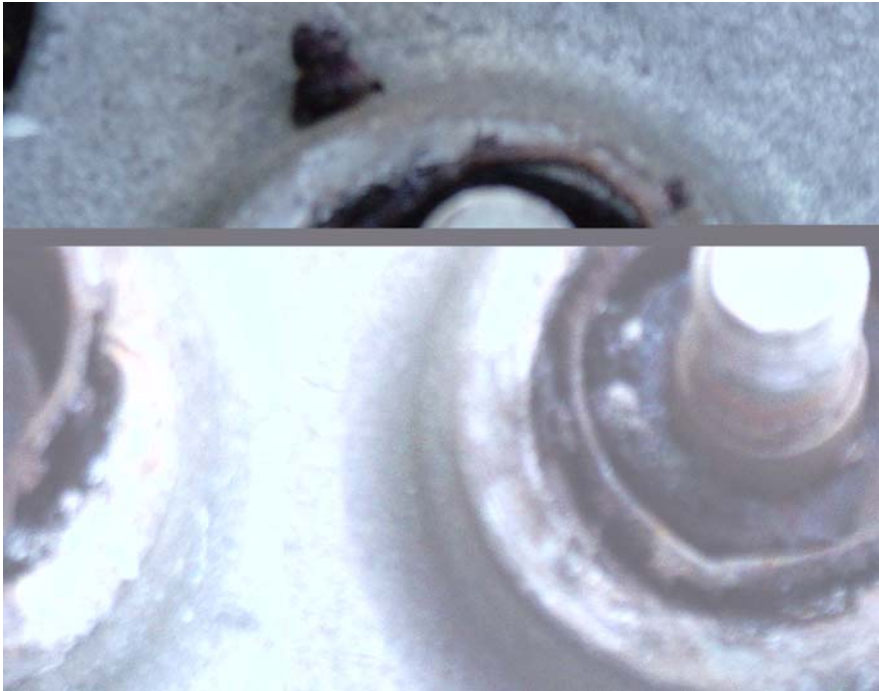
| OVERHEAD LINE CAMPAIGN CHANGES – DATA SHEET | |
|---|---|
| <b>COMPONENT</b> | Seized pulley wheels (both termination and support). |
| <b>PROBLEM</b> | Pulley wheels were prone to seizure, fatigue and wear because of insufficient clearance for the ball bearings. This leads to poor current collection parameters and over stressing of hard drawn copper conductors and other components. |

| OVERHEAD LINE CAMPAIGN CHANGES – DATA SHEET | |
|---|---|
| <b>ACTION REQUIRED</b> | <ol style="list-style-type: none"> <li>1. Refurbish pulley bearing to new tolerance, or</li> <li>2. Replace the pulley wheel with a new assembly.</li> </ol> <div data-bbox="442 705 1240 1375"> </div> |
