| Ref: | NR/L2/ELP/27009/MOD C46 |

## OVERHEAD LINE CAMPAIGN CHANGES – DATA SHEET

### FLASHOVER DAMAGE TO CERAMIC BEADS 'EARTH END' IN SKIDLESS NEUTRAL SECTION ASSEMBLIES

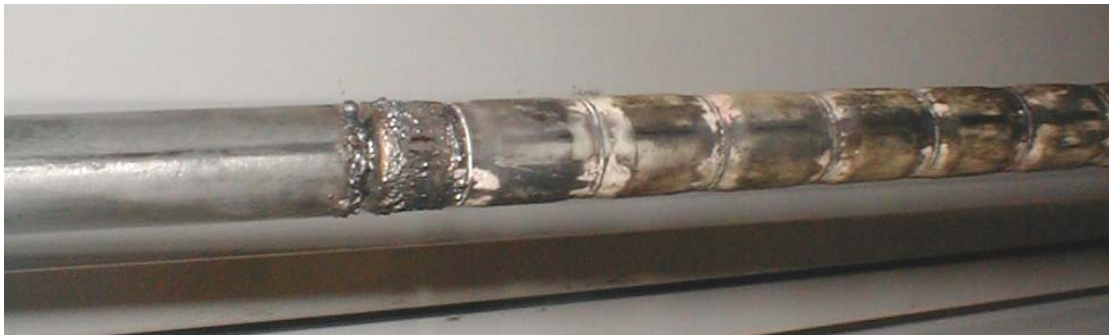
**PROBLEM** Where there is no arcing horn on the earth end of the ceramic bead insulator, neutral section flashover rapidly causes electrical erosion of the stainless steel end ferrule. This leads to catastrophic failure and de-wirement.

| OVERHEAD LINE CAMPAIGN CHANGES – DATA SHEET | |
|---|---|
| <b>ACTION REQUIRED</b> | Fit arcing horns at the earth end of both ceramic bead insulators. |
