| Ref: | NR/L2/ELP/27009/MOD C53 |

| OVERHEAD LINE CAMPAIGN CHANGES – DATA SHEET | |
| <b>53</b> | <b>REVISED RETURN CONDUCTOR SUPPORT DESIGN AT BOOSTER TRANSFORMER CONNECTION LOCATIONS</b> |

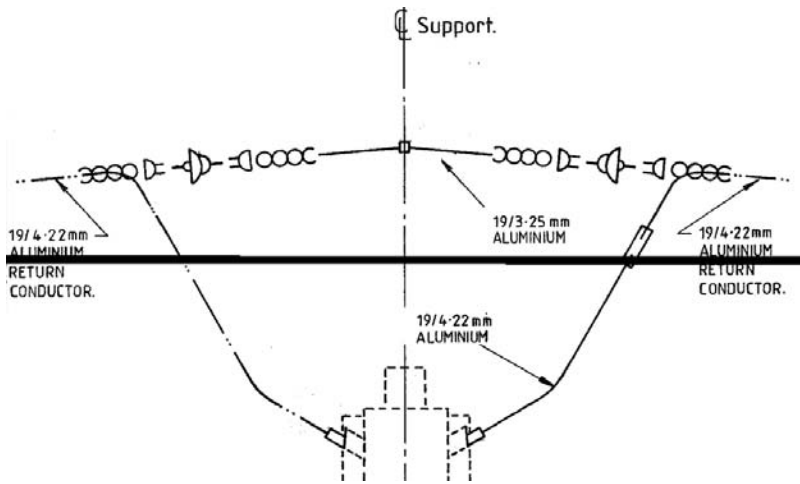
| OVERHEAD LINE CAMPAIGN CHANGES – DATA SHEET | |
|---|---|
| <b>PROBLEM</b> | <p>The existing design over stresses the 19/3.25 aluminium earthed section, leading to a risk of it parting and pulling out the secondary bushes of the booster transformer.</p> <p>Extract from 199/548 revision 6</p> |

| OVERHEAD LINE CAMPAIGN CHANGES – DATA SHEET | |
|---|---|
| <b>ACTION REQUIRED</b> | Replace the existing 19/3.25 aluminium earthed section with 19/4.22 aluminium conductor. The correct arrangement is shown as style 199/548/001 on the attached OLEMI drawing. |
