| Ref: | NR/L2/ELP/27009/MOD C61 |

| OVERHEAD LINE CAMPAIGN CHANGES – DATA SHEET | |
| <b>61</b> | <b>MODIFICATION OF ARTHUR FLURY SECTION INSULATORS PRONE TO PREMATURE SKID FAILURE</b> |

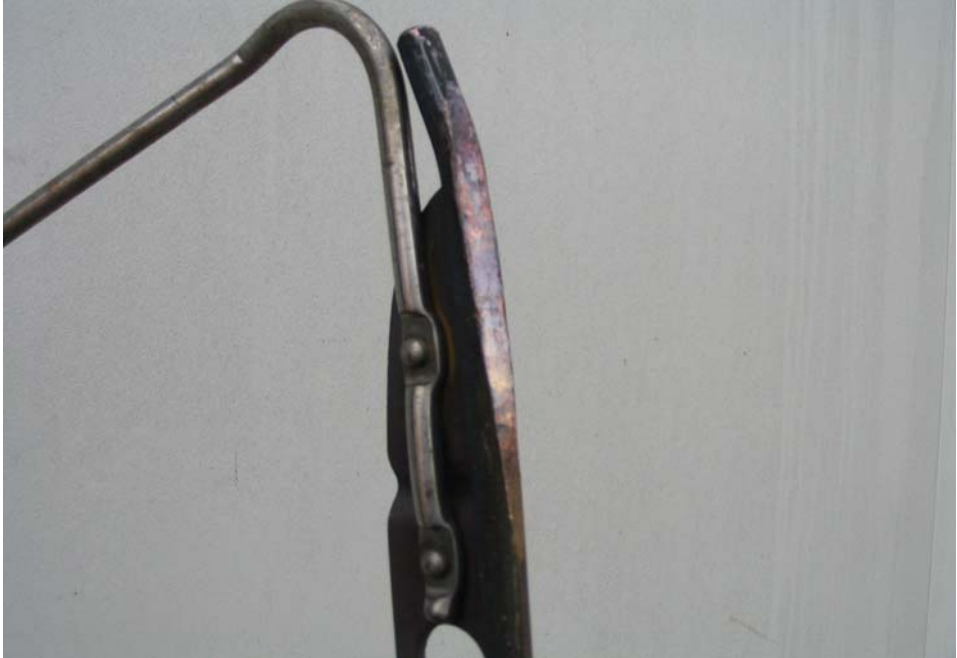
| OVERHEAD LINE CAMPAIGN CHANGES – DATA SHEET | |
|---|---|
| <b>COMPONENT</b> | Arthur Flury section insulators, standard type, particularly with original design of skids. |
| <b>PROBLEM</b> | High numbers of pantograph passages at speeds above 60 mph causes rapid wear of the section insulator skids. This leads to the skid breaking and fouling pantographs. |

| OVERHEAD LINE CAMPAIGN CHANGES – DATA SHEET | |
|---|---|
| <b>ACTION REQUIRED</b> | Convert affected section insulators to the Arthur Flury 'overlapping skid' design. |
