| Ref: | NR/L2/ELP/27009/MOD C62 |

| OVERHEAD LINE CAMPAIGN CHANGES – DATA SHEET | |
| <b>62</b> | <b>MODIFICATION OF ARTHUR FLURY ‘SKIDDED’ NEUTRAL SECTION INSULATORS</b> |

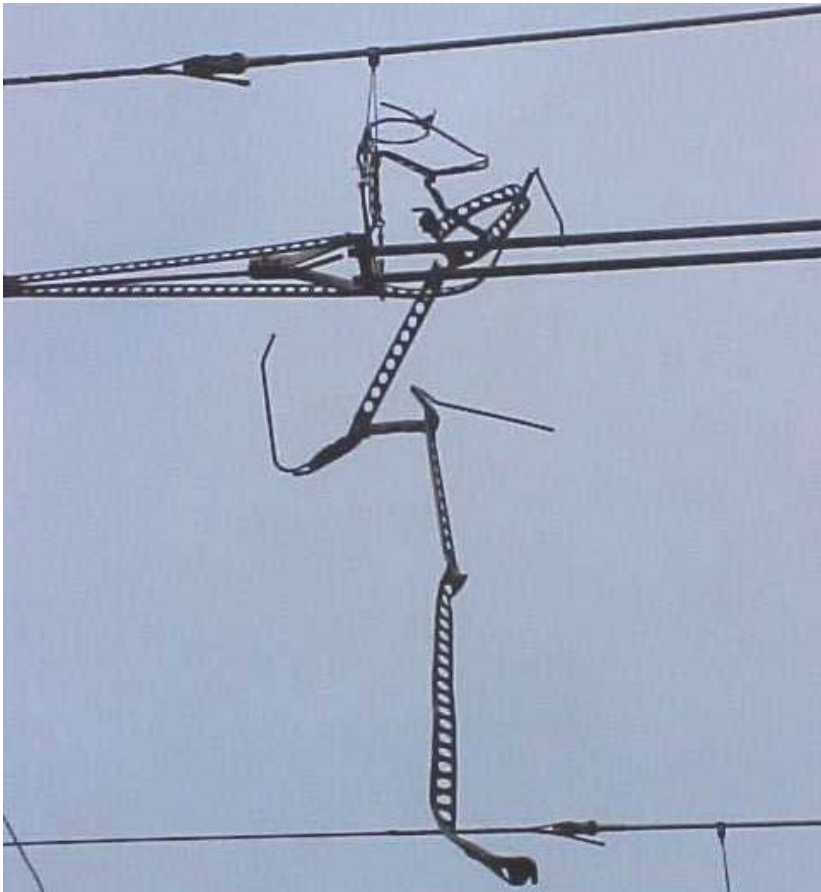
| OVERHEAD LINE CAMPAIGN CHANGES – DATA SHEET | |
|---|---|
| <b>COMPONENT</b> | Twin rod / ‘skidded’ Arthur Flury neutral sections, where installed in areas with line speeds above 90 mph. |
| <b>PROBLEM</b> | Where twin rod (‘skidded’) Arthur Flury neutral section insulators are fitted in areas with line speeds above 90 mph, the skids will suffer from rapid wear. This will lead to the skid breaking and fouling pantographs. |

Convert any affected neutral sections to Arthur Flury skidless / single rod designs, with lever arms on the entrance to the neutral section.
