| Ref: | NR/L2/ELP/27009/MOD C66 |

| OVERHEAD LINE CAMPAIGN CHANGES – DATA SHEET | |
| <b>66</b> | <b>RENEW ARC DAMAGED REGISTRATION ARMS IN HEADSPAN ASSEMBLIES.</b> |

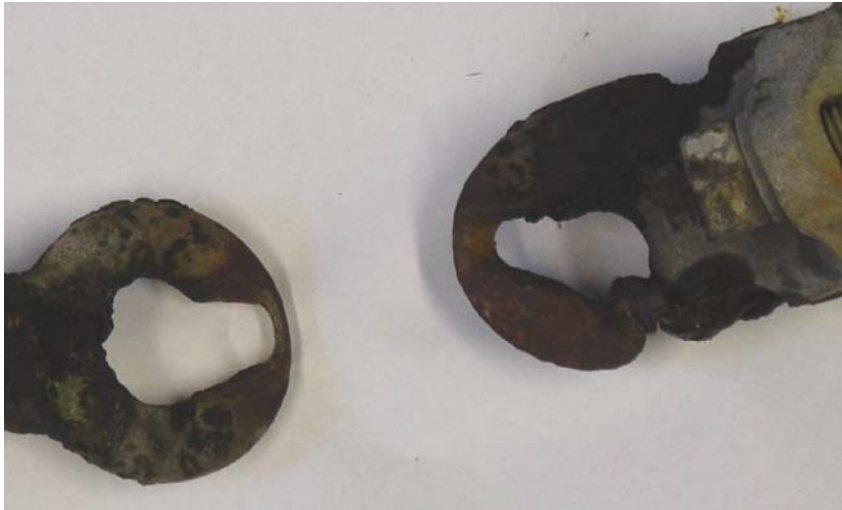
| OVERHEAD LINE CAMPAIGN CHANGES – DATA SHEET | |
|---|---|
| <b>PROBLEM</b> | <p>On headspan assemblies over loop lines where the loop is electrically common to the adjacent main line, traction current can flow through the span wire and registration arm hook fittings. This causes rapid electrical erosion and a risk of the arm falling foul of pantographs.</p> |

| OVERHEAD LINE CAMPAIGN CHANGES – DATA SHEET | |
|---|---|
| <b>ACTION REQUIRED</b> | <p>Replace affected registration arms and install additional jumpers to prevent current flow through the hook fittings.</p> <p>Fit jumpers between catenaries using LDV and lower span wire to support the jumper wire.</p> <p>Prioritise affected locations as follows:</p> <ol style="list-style-type: none"> <li>1. Sites with previous failures;</li> <li>2. Sites with known burning but no previous failures;</li> <li>3. Sites potentially at risk but with no burning found.</li> </ol> |
