| Ref: | NR/L2/ELP/27009/MOD C76 |

| OVERHEAD LINE CAMPAIGN CHANGES – DATA SHEET | |
| <b>76</b> | <b>LEVER ARM MODIFICATION TO ARTHUR FLURY NEUTRAL SECTIONS</b> |

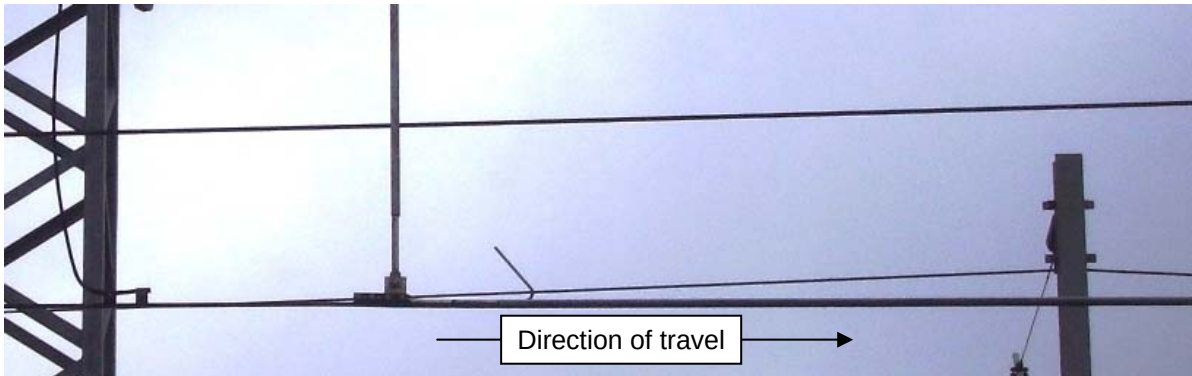
| OVERHEAD LINE CAMPAIGN CHANGES – DATA SHEET | |
|---|---|
| <b>PROBLEM</b> | <p>The original design of this neutral section tended to flex at the entry end, at the splice between the contact wire and the insulator ferrule. This caused poor wear at the interface, leading to pantograph damage. This was particularly a problem in high speed lines.</p> <p>This campaign change relates to special inspection notice NR/SIN/111. That notice should be read as well as this campaign change.</p> |
| <p>Arthur Flury skidless neutral section without lever arm.</p> | |

Fit the lever arm and arcing horn modification kit as follows. This lever improves the profile and stiffness of the neutral section at the joint between the contact wire and the neutral section ferrule.

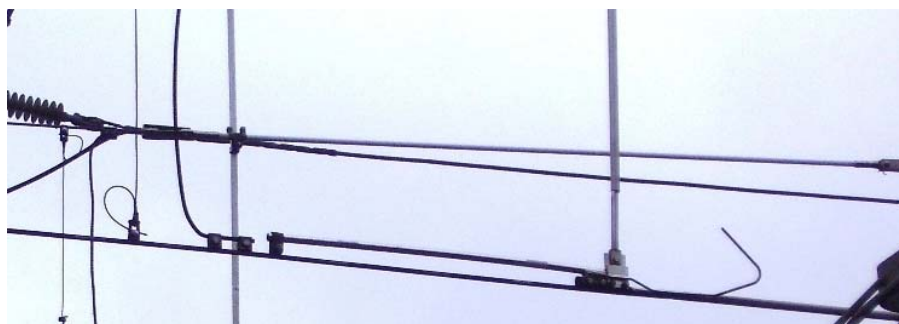
Modified neutral section (with old arcing horn shown)
