| Ref: | NR/L3/SIG/19272 |
| Issue: | 5 |

# Signalling Equipment Workshop Engineering Notice (SIGWEN021) Signalling Relays

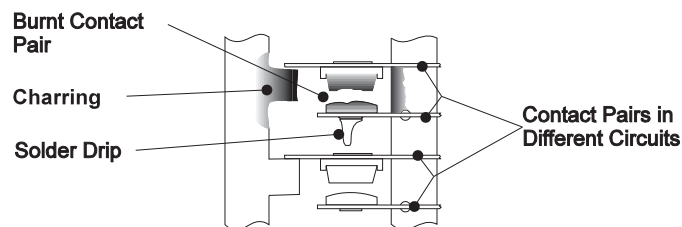
Figure 1

When current passes through a contact, heat is generated. Where the current is high enough, the heat can melt the solder that secures the contact to the spring. Very occasionally, this has run down and formed a bridge to the next contact. See Figure 1.

Any such damage found should be repaired by replacement of components.

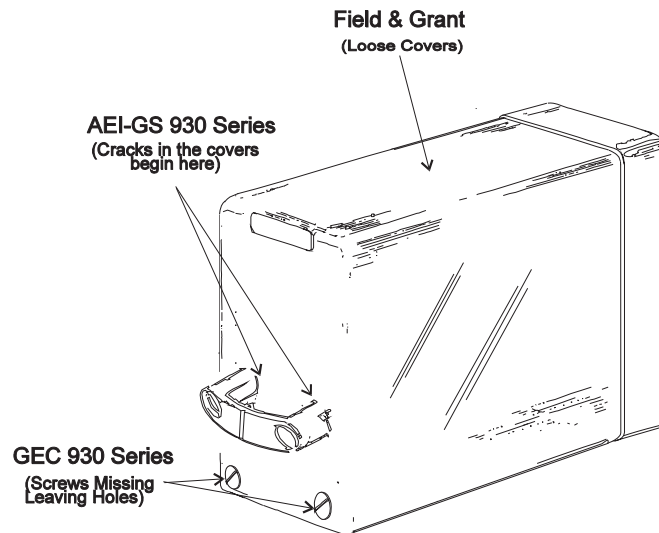
Figure 3

Some relays made by Tyers, Zone Controls (later known as STS Signals Ltd) and AEI-GS, were manufactured without adequate internal support for the handle. Consequently, sustained or prolonged pressure on the handle by the retaining clip has caused their covers to crack.

The cracks start near the base of the handle and usually spread across the top and down the sides of the cover. One cover was found almost split in half.

The cracking occurs owing to the sudden shock caused when a tight fitting relay retaining clip is 'snapped' into position in the handle's clip recess. The continuing pressure from the clip then causes the cracks to spread. See Figure 3.
