| Ref: | <b>NR/SIN/143</b> |

# Special Inspection Notice

## Special Inspection of Architectural Features attached to Station Building Assets

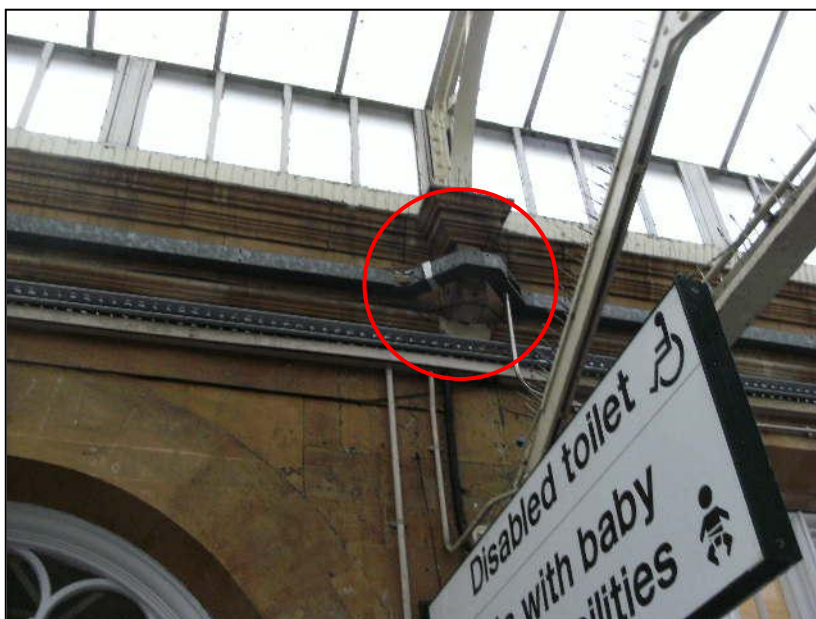
On the 13<sup>th</sup> January, 2012 a piece of masonry fell from the building wall at the rear of platform 1 on Bath Spa Station. No passengers or member of staff were reported as harmed when the piece fell, though the area was open to public and staff. The area was cordoned off from public access.

Following this incident the maintenance contractor for the location, (Birse Rail), attended site and noted the piece of stone which had fallen formed part of a decorative course along the length of the platform building. It was approximately 12" x 8" in size. The remaining stonework in the immediate vicinity was carefully checked with no further defects noted.

**Photograph 1:** The original location of the failed section is visible as a pale section in the centre of the picture along with various conduits and cable runs installed over time

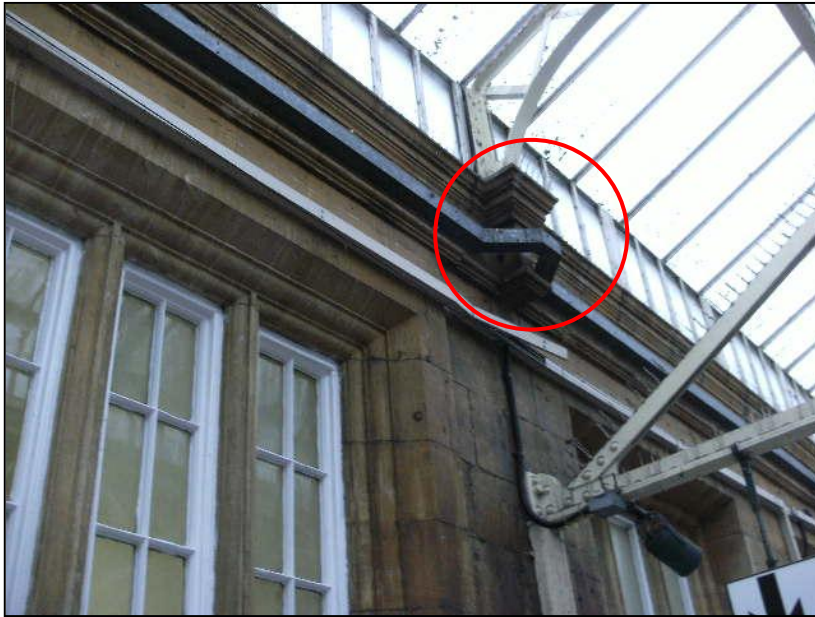
**Photograph 2:** Showing a typical (intact) section of stone moulding to the same wall

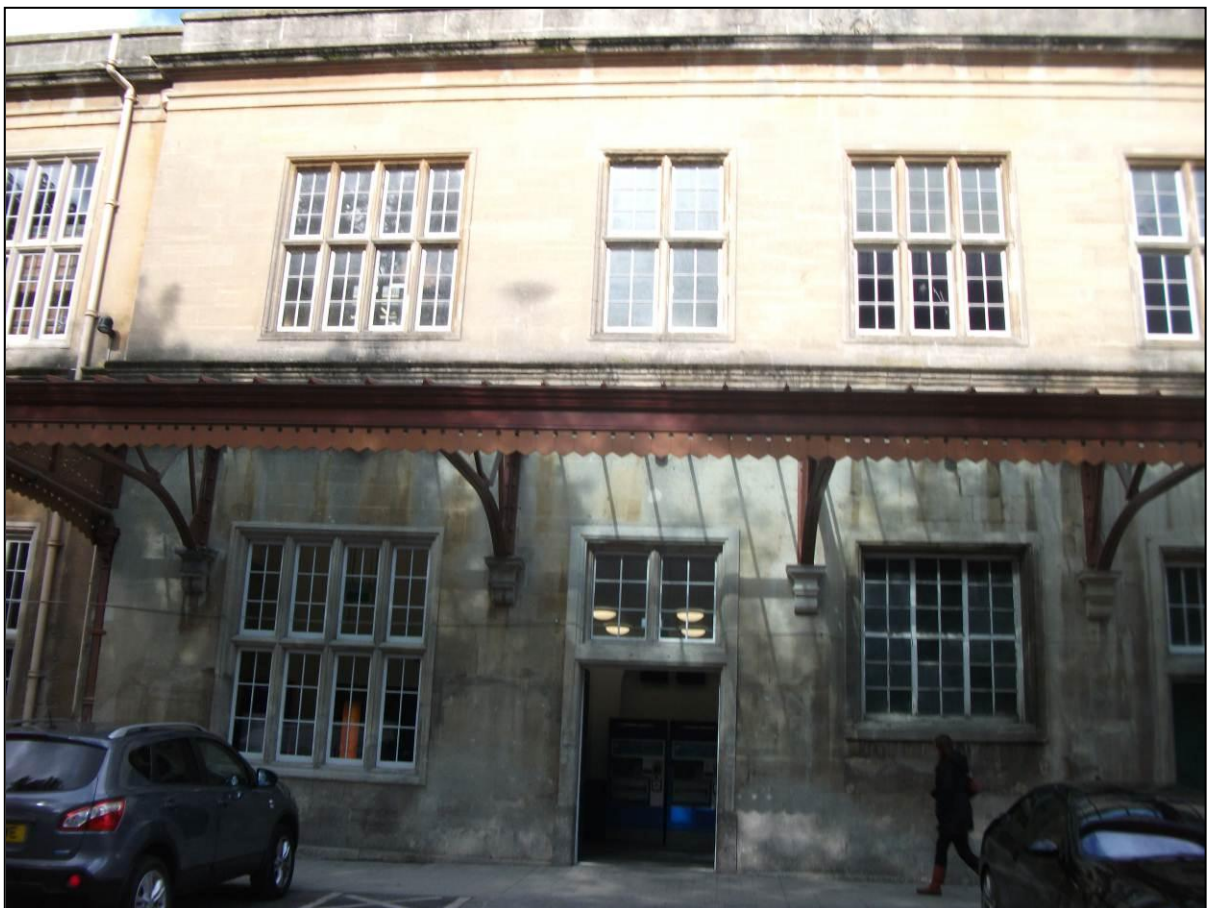
**Photograph 3:** Bath Spa External Corbel and Parapet Ledge
