# TECHNICAL INSTRUCTION

TI 098  
Issue 1  
June 2008  
Page 1 of 2

NETWORK RAIL - SIGNAL ENGINEERING

## BR 843 Barrier Side Arm Retaining Bolt

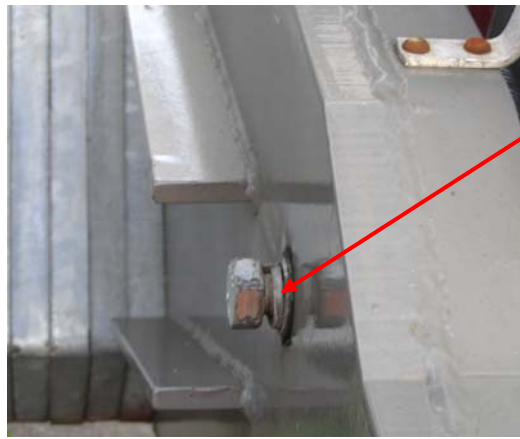
Picture 1

A defect was recently discovered whereby the side arm retaining bolt of a BR 843 pedestal had worked itself loose (see picture 1 below)

Loose  
Side Arm  
Bolt

Particular attention should be given to carrying out the checks contained in LC21 Service A section 1, particularly clauses 1.2, and 1.4 correctly.

It is also intended that a torque value for this bolt will be included in the annual servicing of BR 843 barriers at the next issue. The manufacturers SPX, currently use a torque setting of 210Nm when the side arms are attached during the build process.

Please work to this torque value until further notice should it become necessary to tighten the bolt. If adjustment is required, the bolt should first be loosened and then torqued up to this setting.

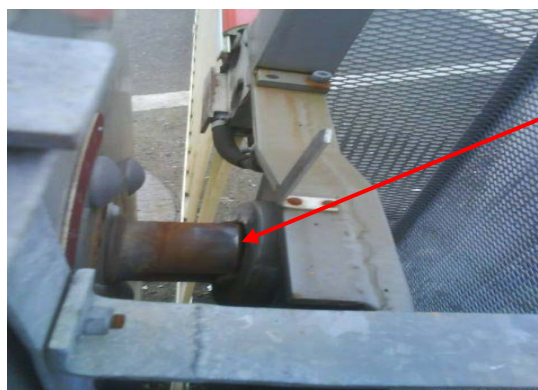
Picture 2

This resulted in the whole side arm assembly, including boom, becoming almost detached from the pivot shaft of BR 843 barrier pedestals, (see picture 2 below)

Side Arm  
almost  
Detached

Previous incidents similar to this have also been recorded at other crossings. These have so far all been discovered with the barriers in the lowered position but the potential exists for the side arms to become detached whilst in the raised position which could result in more serious consequences.
