# TECHNICAL INSTRUCTION

TI 107

NETWORK RAIL - SIGNAL ENGINEERING

## Thales AzLM Axle Counter System – Reliability Checks and Improvements

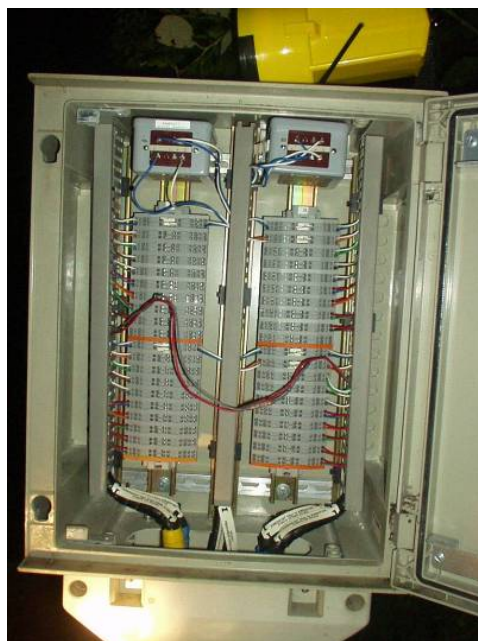
Figure 1

- b) On early AzLM Axle Counter projects a decision was taken to provide two sets of WAGO terminations in the line side locations (see Figure 1). This was to ease maintenance testing in the event of cable failure. However, the fact that there were now two termination points effectively doubled the potential failure points and led to a decline in reliability. Where this is the case the additional WAGO termination block may have to be removed to reduce the number of failure points. An inspection shall be carried out and all such installations identified and reported back to HQ Signal Engineering (email [david.mahoney@networkrail.co.uk](mailto:david.mahoney@networkrail.co.uk)). An assessment of the workload and costs involved to rectify this deficiency will then be carried out centrally.
