# TECHNICAL INSTRUCTION

TI 169

NETWORK RAIL - SIGNAL ENGINEERING

## Halogen Lamps in Bombardier Fibre Optic Signals & Indicators

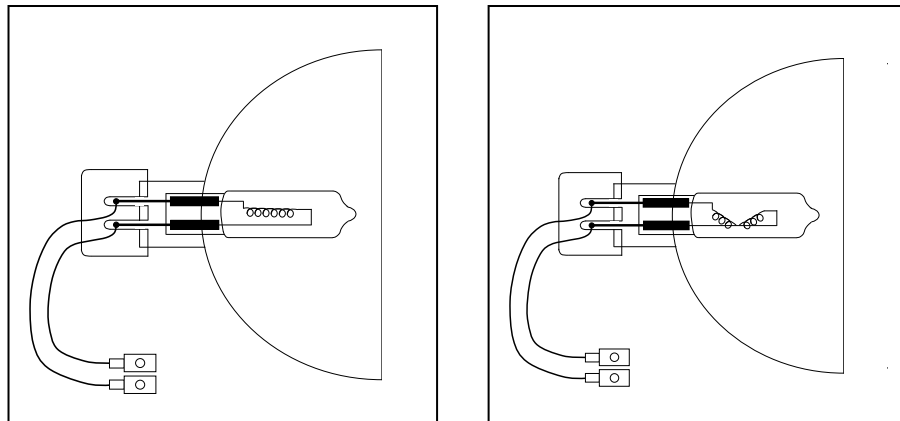
A Wrong Side Failure occurred where it was possible to clear a route with no indication displayed by the theatre indicator. Investigation found that lamp proving was maintained even though the halogen lamp had failed. The filament had failed in such a way as to create a short circuit that permitted sufficient current flow to satisfy lamp proving.

Figure 1 shows how the filament failed creating the short circuit.

Figure 1 – Intact & failed filament

This failure mode can be eliminated by paying careful attention to the orientation of the lamp when installing it. The lamps shall be installed so that the leads protrude from the bottom of the lamp assembly.
