# Modeling of Truck-Car Sideswipe Collisions Using Lug Patterns

Michael S. Varat, Stein E. Husher, John F. Kerkhoff  
Christopher D. Armstrong and John C. Steiner  
KEVA Engineering, LLC.

## ABSTRACT

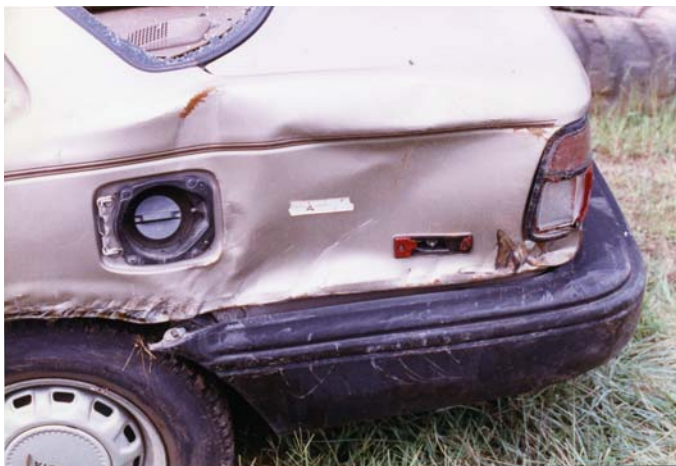
Figures 1 and 2 show typical markings seen in truck to car sideswipe collisions. While the truck involved in this collision was never identified, several conclusions can be drawn from the residual marks. The strikes on the left rear lower bumper return and quarter panel are at the correct height and orientation to be caused by truck front wheel lugs. The circular pattern on the left front door (Figure 2) was made by the protruding lugs of a heavy truck front wheel.

**Figure 1. Lug contacts on left rear of vehicle.**

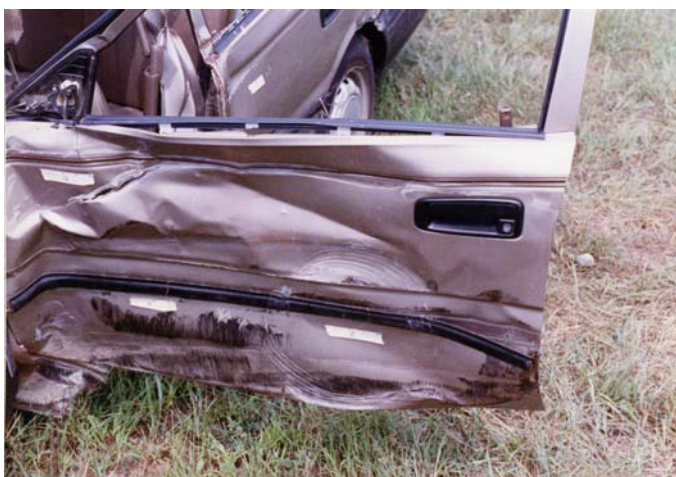
**Figure 2. Circular lug contacts on left front door.**

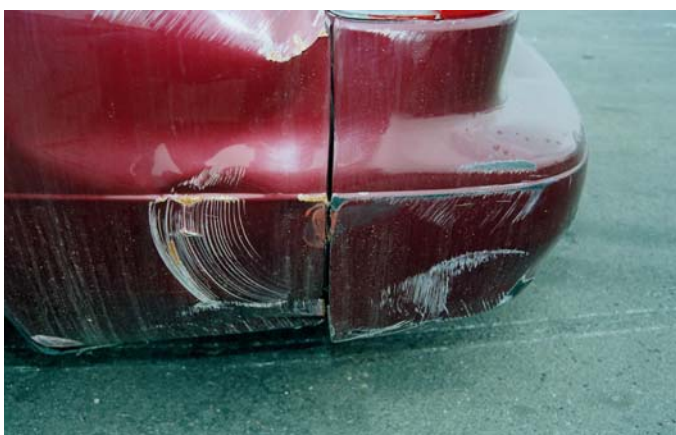
A second example of markings due to truck to car interaction is shown in Figures 3 and 4. Lug marks can be seen at the left rear corner of the rear bumper return along with a round orange paint transfer where the bumper return meets the fender. Figure 4 shows the truck wheel that interacted with the car in Figure 3. Note that the darker hub in Figure 4 is the same orange color as the paint transfer seen in Figure 3.

**Figure 3. Left side contact on right rear corner.**

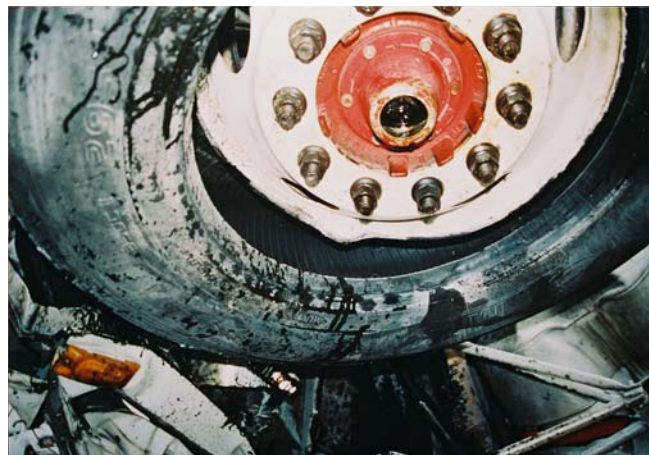
**Figure 4. Right front truck wheel that contacted the left side of the car in Figure 3.**

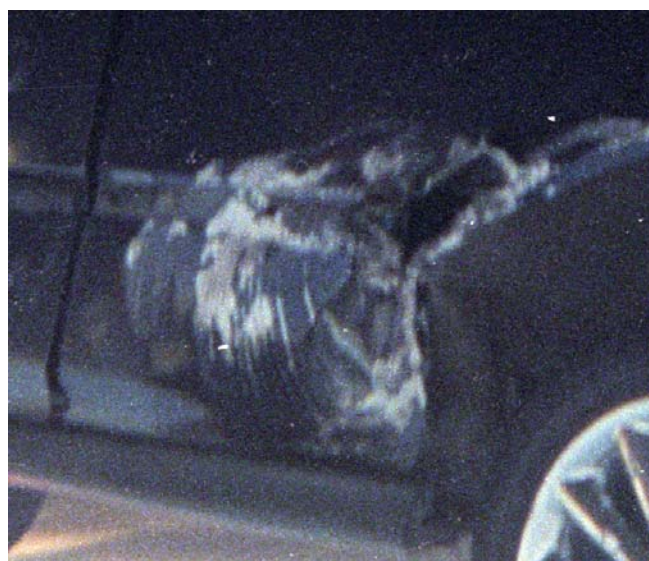
Figures 5 and 6 demonstrate another example of truck to car interaction. Lug contact marks are evident forward of the left rear wheel. Note also the forward deformation of the wheel cutout.

**Figure 5. Lug markings ahead of left rear wheel.**

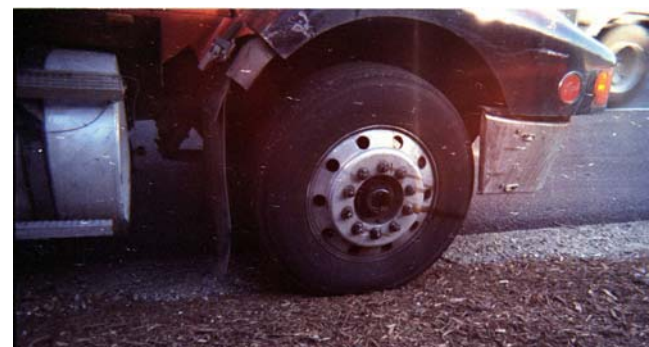
**Figure 6. Right front truck wheel that contacted the left side of the car in Figure 5.**

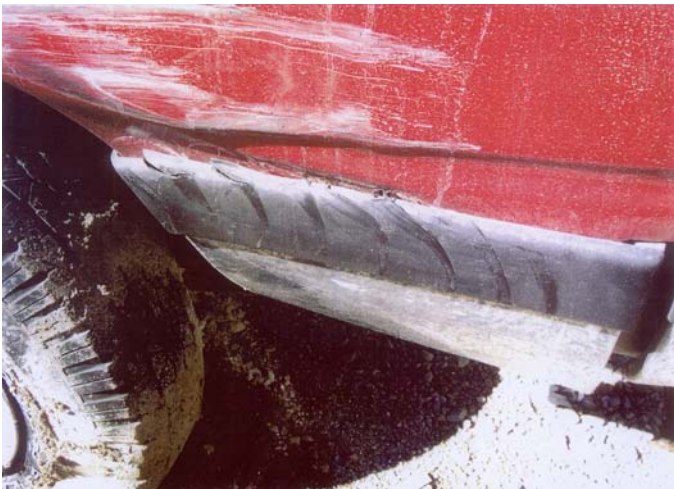
Figures 7 and 8 show a final example of truck to car interaction. Note the distinct forward arcing marks on the black plastic trim.

**Figure 7. Lug contact mark on lower left rear trim.**

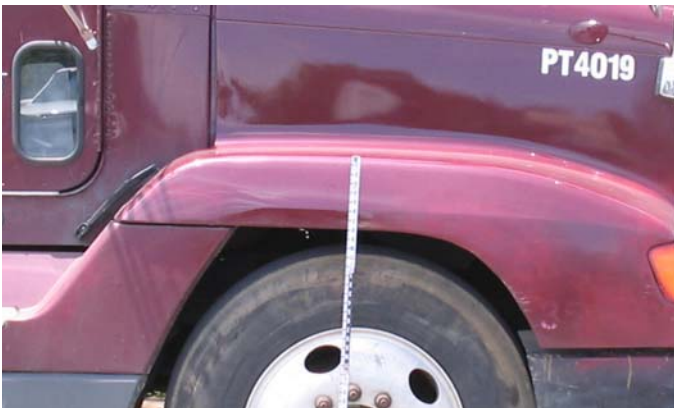
**Figure 8. Wheel of truck that contacted the car in Figure 7.**

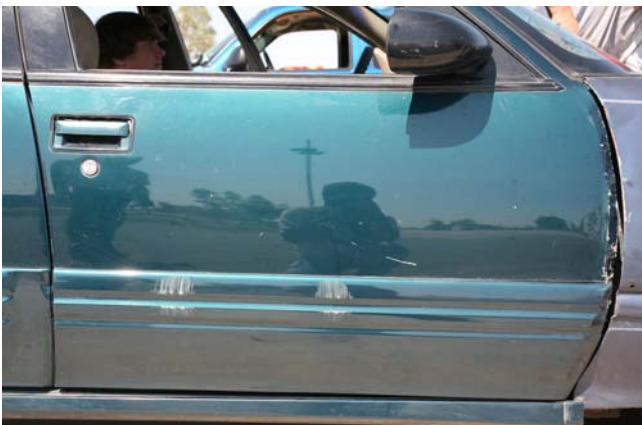
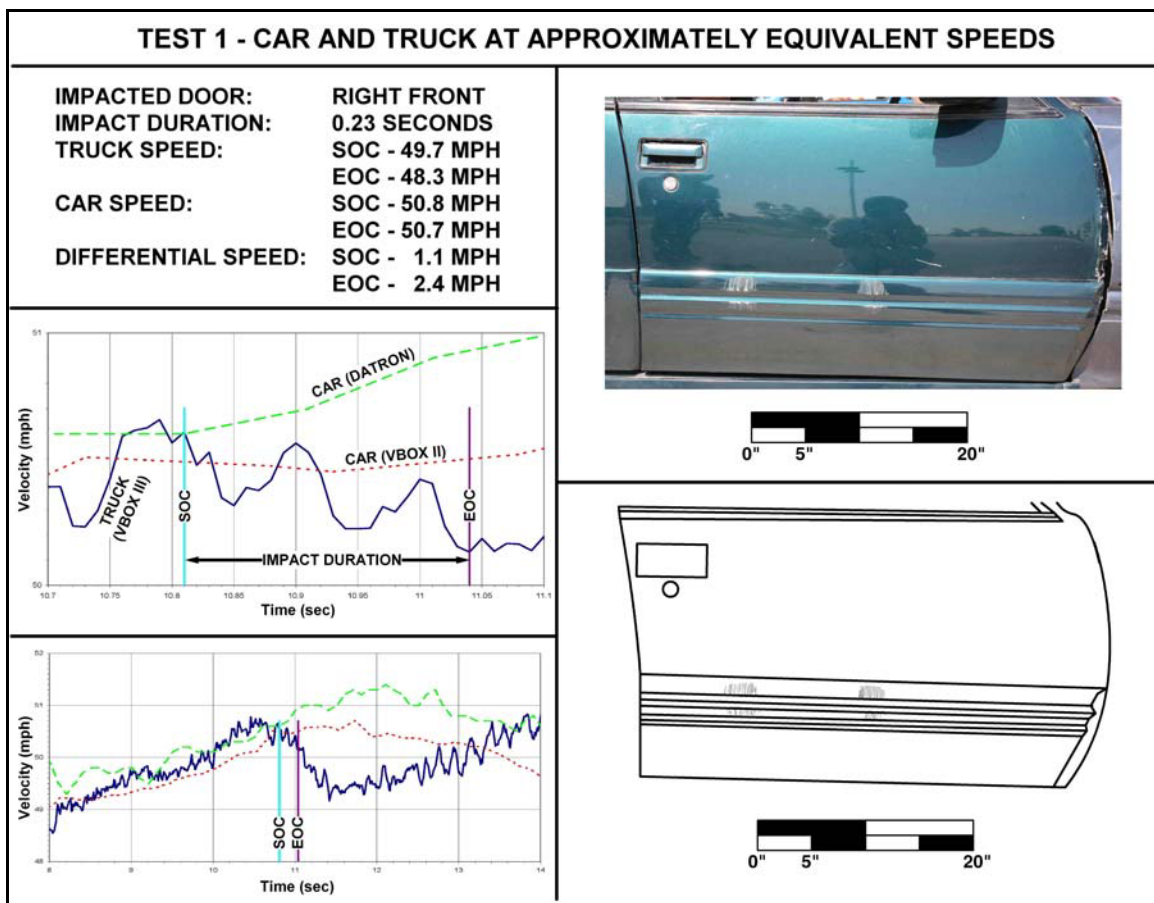
Figure 15. Test 1 – Right front door post test.

Test 1, Figures 15 and 17, involved a very light contact. In this test both vehicles were at approximately the same speed. As can be seen, the lugs lightly marked the beltline trim in two localized areas. The marks were from the front and rear of the rotating lugs.

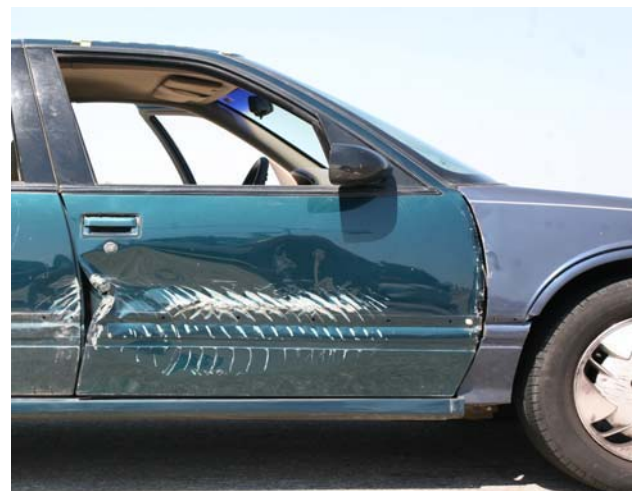
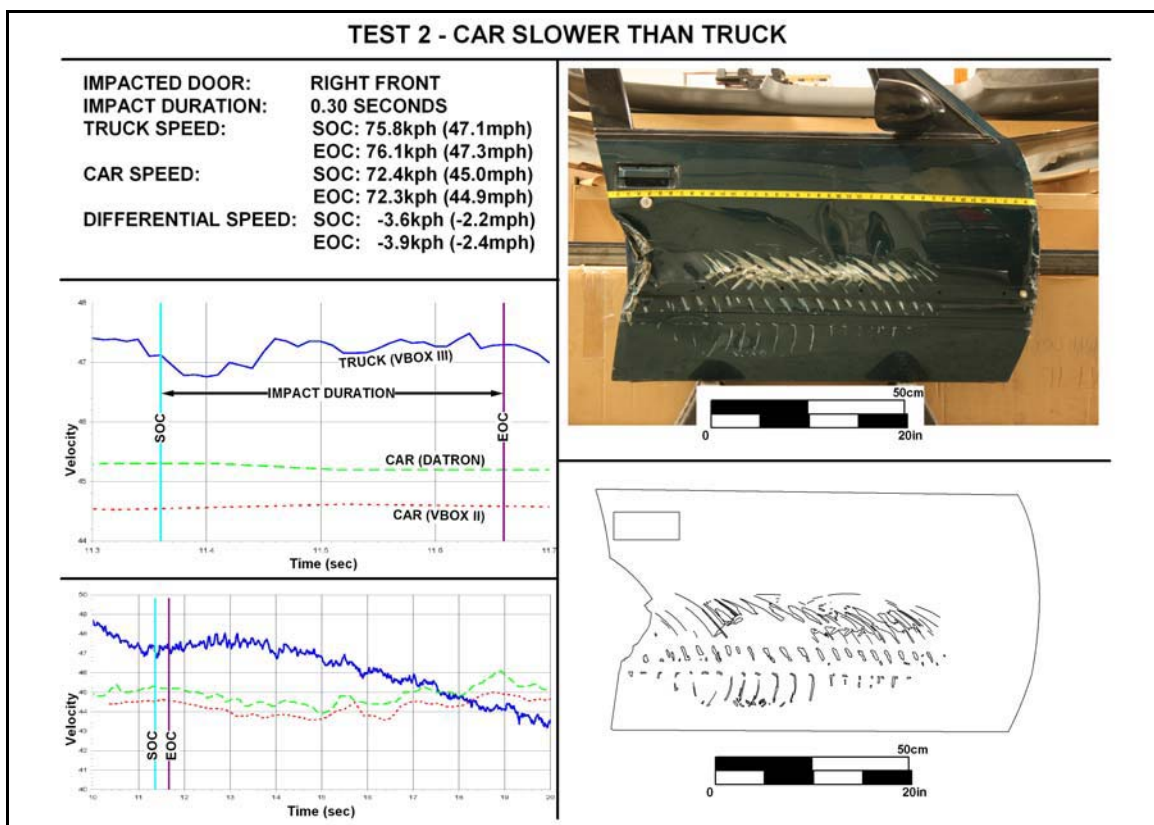
Figure 16. Test 2 – Right front door post test.

Test 2, Figures 16 and 18, involved a truck interacting with the right front door of a slower moving car. As can be seen, the aft edge of the door was crushed forward and the concavities of the lug marks are downward.
