# Occupant Kinematics and Injury Mechanisms During Rollover in a High Strength-to-Weight Ratio Vehicle

2010-01-0516

Michelle F. Heller, William N. Newberry, Janine E. Smedley, Senthil K. Eswaran, Jeffrey J. Croteau and Michael R. Carhart  
Exponent Failure Analysis Associates

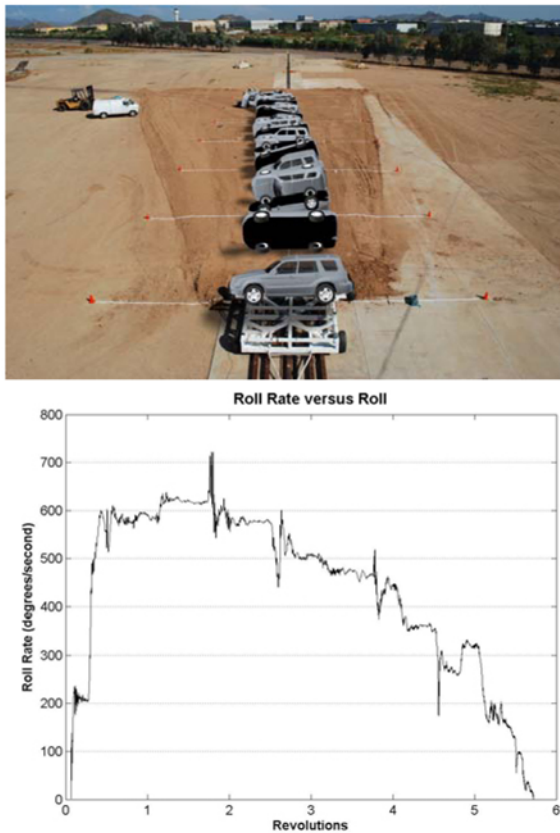
The speed of the test vehicle at roll initiation was approximately 69.8 kph (43.4 mph). During the rollover sequence, the test vehicle underwent a total of 5-3/4 rolls over a distance of 42.1 meters (138 feet). Average roll rate over the event was 389 degrees per second, while the peak exceeded 700 degrees per second (Figure 7). There were several roof-to-ground contacts resulting in elastic and plastic deformation of the roof structures. During the roll sequence, both the passenger and driver experienced several discrete neck loading events (Figure 8, Tables 1 and 2).

During the first roll, the vehicle traveled approximately 14 meters (47 feet) with an average roll rate of 365 degrees per second and a peak roll rate of 610 degrees per second. The first vehicle-to-ground contact occurred when the passenger-side beltline area contacted the ground, followed by ground contact between the passenger-side pillars and roof rail. During this contact, all of the passenger-side glass was fractured and deposited on the ground. The vehicle remained in contact with the ground as it rolled from the passenger-side roof rail, across the roof, to the driver-side, contacting the

**Figure 7. Vehicle rollover sequence re-created from video footage (top) and plot depicting vehicle roll velocity during the rollover event (bottom).**

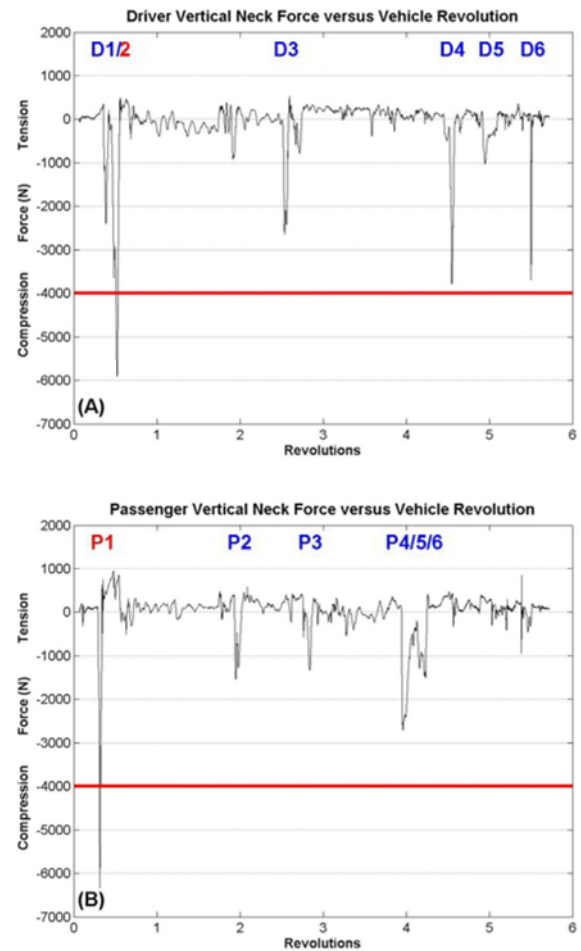
The peak compressive upper neck load measured for the passenger ATD (6,328 N or 1,423 lbs) occurred at approximately 0.49 seconds, during the first roof rail contact (passenger-side) with the ground. The highest passenger Head Injury Criteria ( $HIC_{15}$ ) observed in the rollover also occurred during this roof-to-ground contact and was measured to be 162.6. The ATD's torso was in contact with the interior of the vehicle at approximately the 1/4-roll position. As the vehicle continued to roll, the passenger ATD's head moved toward the roof rail at a location just forward of the B-pillar junction. The peak passenger compressive neck loading resulted from torso augmentation when the vehicle was oriented just past the 1/4-roll position (0.31 revolutions), and thus the orientation of the passenger ATD's head and torso was closer to horizontal relative to the ground plane than vertical during this loading event. The vertical roof displacement, measured at the right B-pillar, was 1.9 cm (0.8 inch) at the time of the passenger ATD peak compressive upper neck load (Figure 9).

During the first passenger-side roof rail contact, the driver-side roof rail moved outboard. The driver ATD also moved outboard until its head contacted and loaded against the roof structure, compressing the neck (approximately 2,406 N, or 541 lb) in the absence of driver-side roof-to ground contact (Figure 10) and in the presence of outward roof motion relative to the chassis. The driver ATD subsequently experienced a peak compressive upper neck load (5,912 N, or 1,329 lb) during the first driver-side roof contact. During roof-to-ground contact, the motion of the driver ATD head was arrested against the roof rail while the torso continued to move toward the ground, resulting in neck compression. This torso augmentation occurred at approximately the 1/2-roll position, and the lateral and vertical roof displacements (measured at the left B-pillar relative to the position prior to any deformation) at the time of peak driver ATD compressive upper neck loading were approximately 3.2 cm (1.3 inch)

**Figure 8. Driver (A) and Passenger (B) axial upper neck loads ( $F_z$ ) versus vehicle revolution.**
