# The Effects of Surface Texture on Fretting Fatigue between Fastener and Aluminum Structure

2010-01-1854

Published  
09/28/2010Hasim Mulazimoglu  
Alcoa Fastening Systems

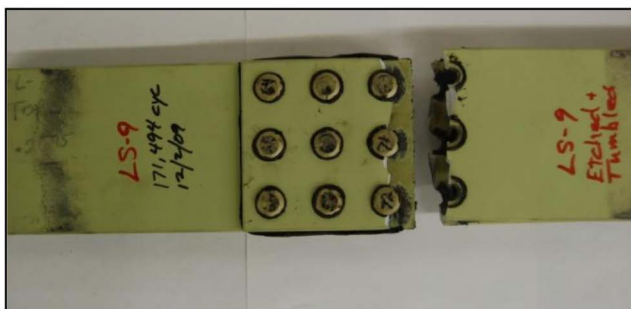
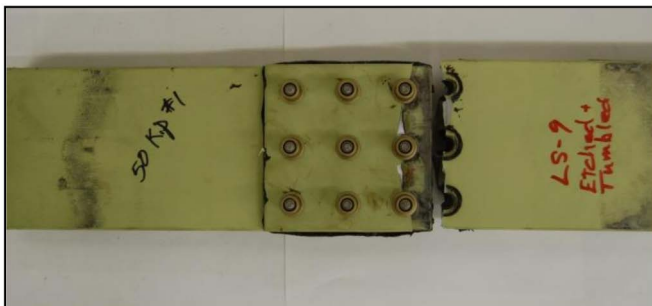
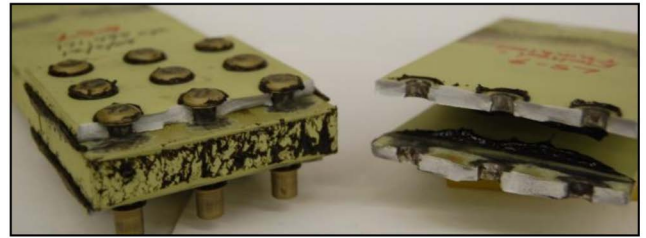
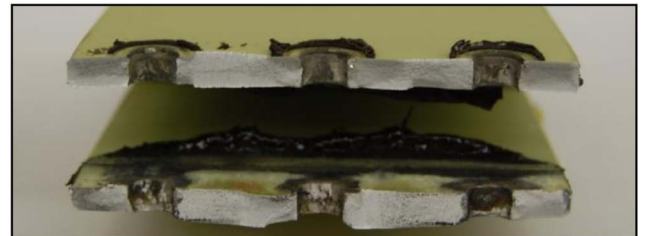
Figure 4 shows the typical failed test plate after lap shear fatigue testing. Table III summarizes the results of fatigue testing of the double lap shear specimens at load ratio of  $R=-0.1$ .

**Figure 4. Typical view of the failed test panels after lap shear fatigue testing**

Failure of each double lap shear sample, without exception, was due to the net section fracture of the aluminum splices and occurred along the first row of the fasteners consistent with the higher percentage of load transferred through this row. The first row carries increasing portion of the load as the end region of the plates exposes higher shear load transfer [15]. No dominant fracture location either on the head side or the collar side of the aluminum splices was present. It has been determined that the failure mode of the tested specimens is the fretting fatigue which occurred at hole/fastener interface. It was observed that the multiple fatigue cracks initiated primarily at or near the hole wall corners and grew in the region of the net section. Figure 5 provides low-magnification stereoscope images of representative specimens and possible fatigue crack initiation points of the fracture were also marked in these images.
