# Timber Utility Pole Fracture Mechanics Due to Non-Deformable and Deformable Moving Barrier Impacts

2011-01-0288

Jeffrey Croteau, Benjamin Frank, Daniel Peterson and Cleve Bare  
Exponent Inc.

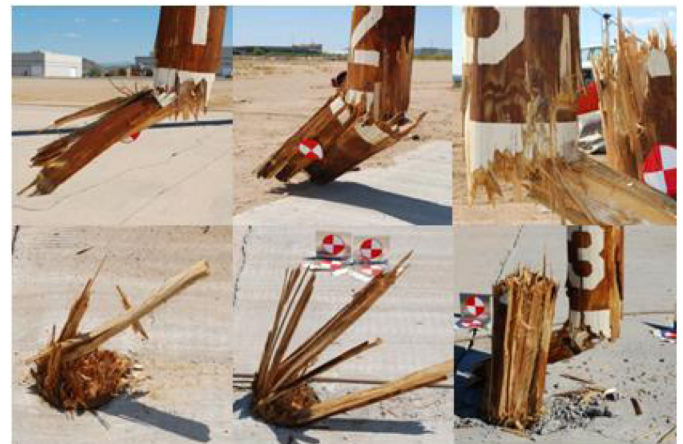
It is not surprising to find brash fractures in vehicle-pole collisions given the right impact speed and properties of timber under a dynamic impact. Physical properties of the wood, including its specific gravity (proportional to strength), the presence of knot clusters, and the variability of moisture content, can affect the nature of the timber fracture. The photographs in Figure 2 show the anchored end of the impacted utility poles in our first three tests and are representative of brash fractures.

**Figure 2. Brash fractures from 30 mph impact tests with a non-deformable moving barrier.**

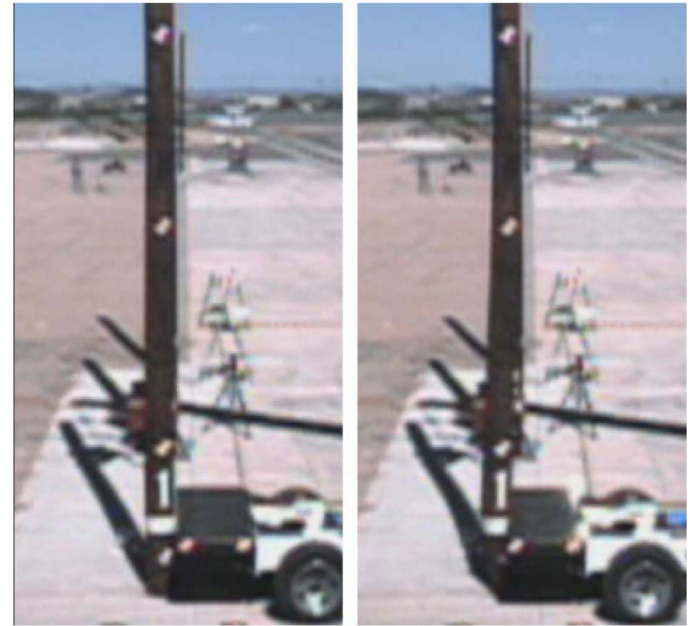
anchored end. Video footage of the overall interaction between the NDMB and the pole clearly shows local deformation to the pole in the contact zone (Figure 7). In this figure, the image on the left is at first contact (time zero) and the image on the right is at 10 ms. The pole center of mass has not moved during the first 10 ms of the impact, yet the pole has clearly fractured, as shown in the close-up frame captures from the high-speed video in Figure 8 and Figure 9. The apparent movement of the bottom portion of the pole is actually localized deformation caused by the barrier at the compression zone, and is associated with the strain energy required to cause the pole to fracture. The authors have defined this first region of the barrier deceleration as the “pole fracture” phase based on our analysis of the deceleration profile and confirmation from the high-speed video, which illustrates the local deformation to the pole and the clear fracture of the wood fibers on the non-struck side of the pole.

*Figure 7. Test photos from the 30.5 mph NDMB at time zero (left) and 10 ms (right) that shows local deformation of the pole in the contact zone and no movement of the pole center of mass.*

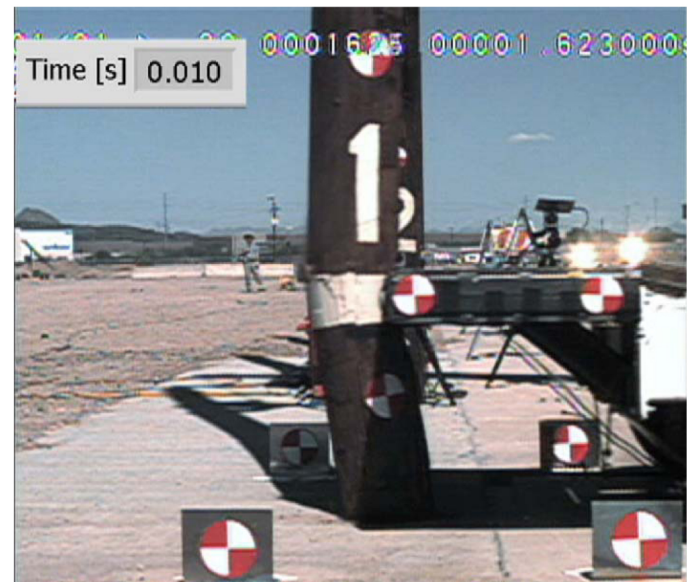
*Figure 8. Frame capture from the 30.5 mph NDMB test video, showing the left side of the pole at 10 ms from contact.*
