## Passenger Vehicle Response to Low-Speed Impacts Involving a Tractor-Semitrailer

2011-01-0291

Daniel Fittanto, Cleve Bare, James Smith and Chimba Mkandawire  
Exponent, Inc.

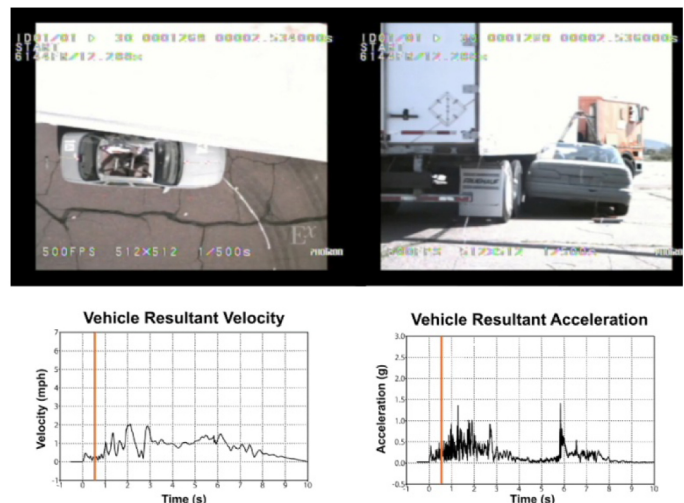
occurred between the trailer bottom rail and the left A-pillar on the sedan, rolling the vehicle chassis to the right ([Figure 8](#)). Peak acceleration of the sedan during the bottom rail contact with the A-pillar was approximately 0.5 g. As the trailer continued to move forward and shift laterally, the outside right tire on the forward trailer axle impacted the sedan's left quarter panel and left rear wheel, displacing the rear of the sedan laterally to the right, and inducing counterclockwise yaw rotation ([Figure 9](#)). Peak acceleration during this portion of the impact was 0.9 g. The combination of the sedan's lateral displacement and the continued yaw rotation of the trailer resulted in an increased impact angle for the subsequent impact of the trailer tire with the driver's door of the sedan ([Figure 10](#)). The maximum acceleration for the entire collision sequence of 1.4 g occurred during this portion of the impact. At this time, the sedan shifted laterally without additional rotation. The trailer tire continued forward, contacting the fender behind the left front wheel of the sedan ([Figure 11](#)). Peak acceleration during this portion of impact was 1.0 g. Finally, the trailer tire snagged the sedan's left front tire, orienting the vehicle nearly parallel with the trailer ([Figure 12](#)) and resulting in an acceleration peak of 0.9 g. The sedan was dragged a short distance until it eventually released from the trailer ([Figure 13](#)), at which time it experienced a second peak acceleration of 1.4 g. [Table 2](#) contains the impact description and corresponding sedan response data from Test 1A.

**Figure 8. Test 1A: Trailer bottom rail contacts sedan A-pillar.**

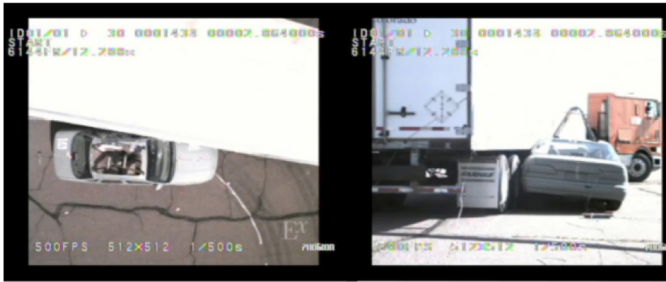
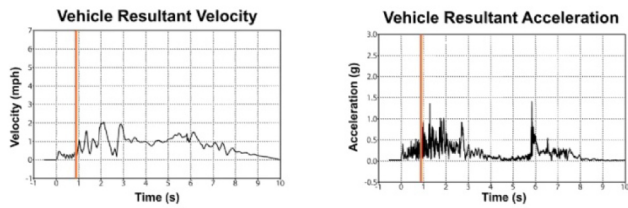
**Figure 9. Test 1A: Trailer tire contacts quarter panel.**

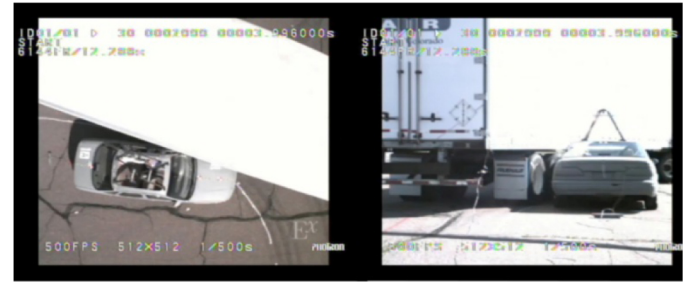
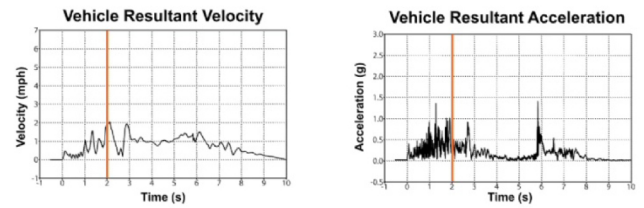
**Figure 11. Test 1A: Trailer tire contacts rear fender area.**

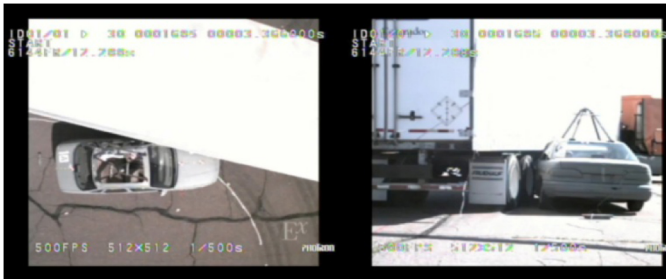
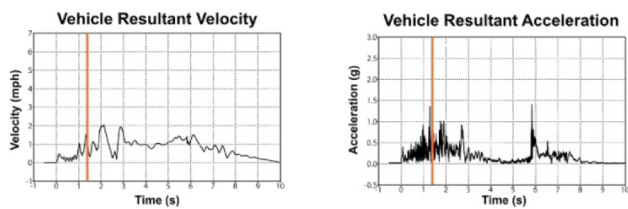
**Figure 10. Test 1A: Trailer tire contacts driver's door.**

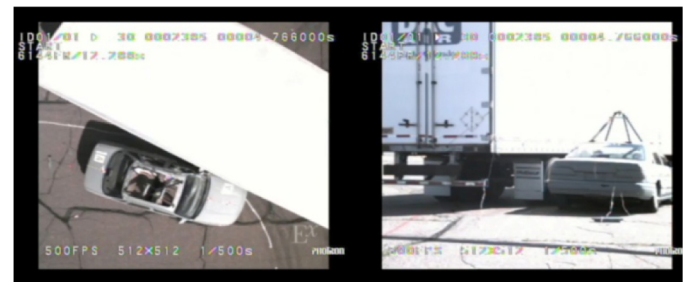
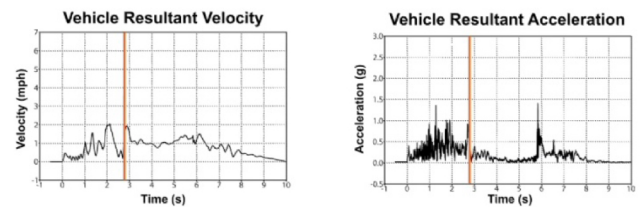
**Figure 12. Test 1A: Trailer tire snags left front wheel.**

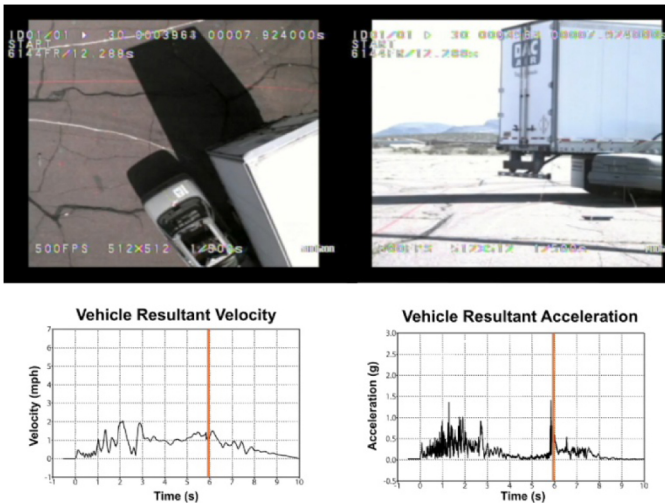
Figure 13. Test 1A: Sedan released from trailer tire.

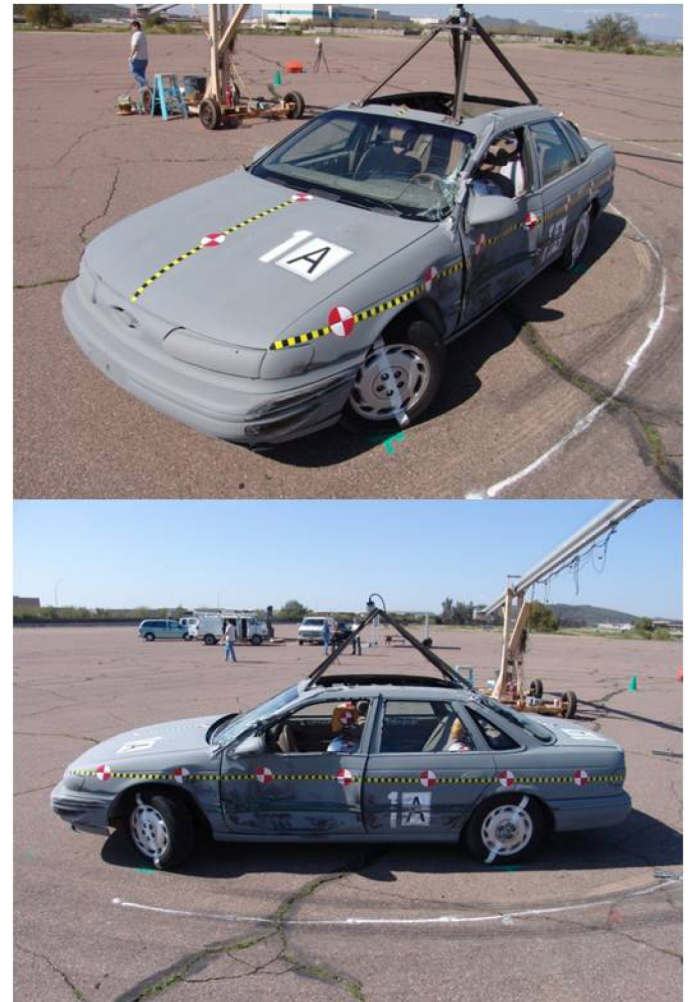
Figure 14. Test 1A post-test damage.

The sideswipe impact experienced during Test 1A resulted in significant visual damage to the sedan, as depicted in Figure 14. During the initial contact, the trailer bottom rail caused a distinctive horizontal crease in the sedan's A-pillar. The A-pillar deformation also resulted in the fracturing of the tempered glass in the window of the driver's door. The trailer tire contact created black transfer marks beginning on the quarter panel aft of the rear wheel, extending to the corner of the front bumper cover. Transfer was also produced on the wheel covers of the sedan. The sheet metal of the driver's side rear door, front door and fender was deformed inboard, with the greatest penetration at the driver's door. As the trailer tire moved forward on the vehicle, the left front wheel was snagged by the trailer tire and turned to the right. Post-impact, the steering system was not observed to be damaged.

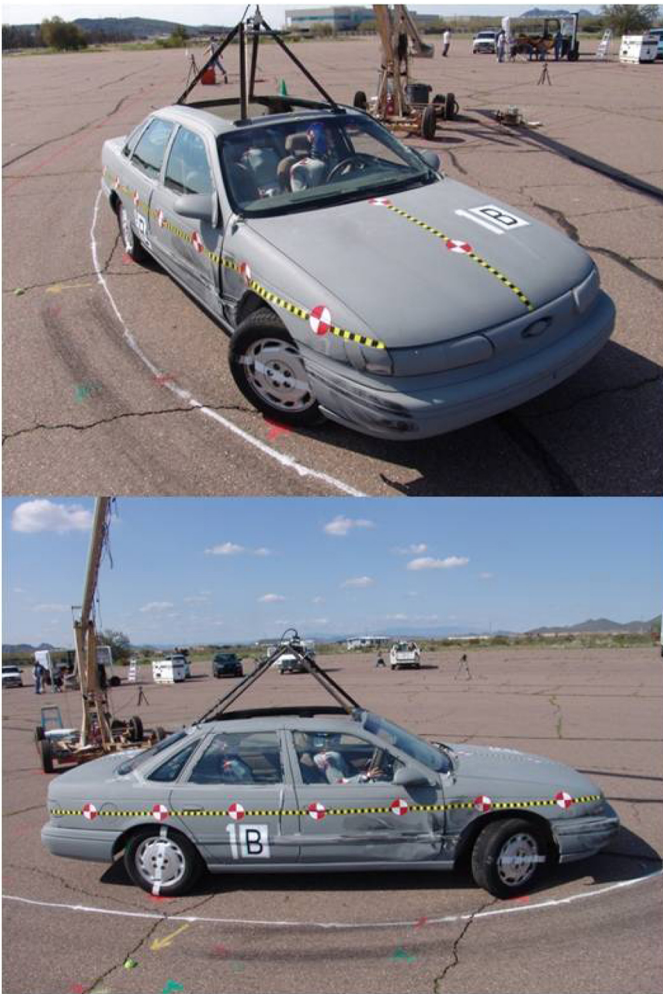
**Figure 15. Test 1B post-test sedan damage**

In this test, the steering wheel of the sedan was initially turned 360 degrees to the left to facilitate the trailer tire snagging the right front tire on the sedan. Initial contact from the trailer tire occurred approximately three-quarters of the way back on the front passenger's side door as depicted the bottom image of [Figure 15](#). Black tire transfer was evident at the initial contact point on the door and extended forward to

the right corner of the front bumper cover. The front suspension system was not damaged during the collision.
