## An Examination of Snapshot Data in Caterpillar Electronic Control Modules

2011-01-0807

Published  
04/12/2011Timothy P. Austin  
Wisconsin State PatrolMichael J. Farrell  
Fox Valley Technical College

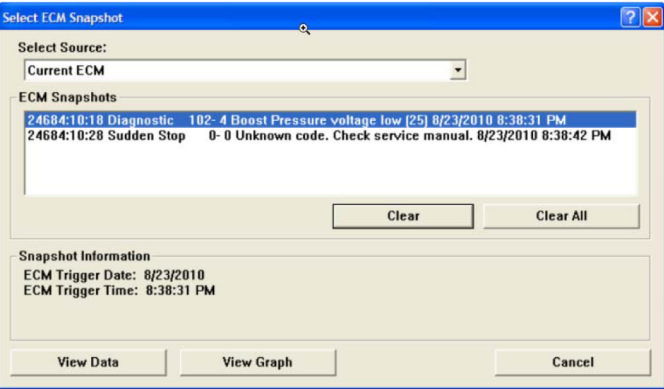
For all of the Quick Stop files created during this testing, Snapshot time differed from the Critical Event Log by 14 to 15 seconds. Testing indicated that the actual time was consistent with that recorded in the Critical Event Log. [Figure 6](#) shows the available snapshot for a Quick Stop file, while [Figure 7](#) shows the Critical Event Log timed 15 seconds prior.

Figure 6. Sudden Stop (Quick Stop Occurrence) Shown at 8:38:42 PM.

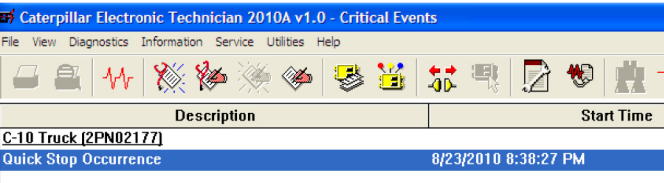
Figure 7. Critical Event Log Showing Quick Stop Occurrence at 8:38:27 PM.

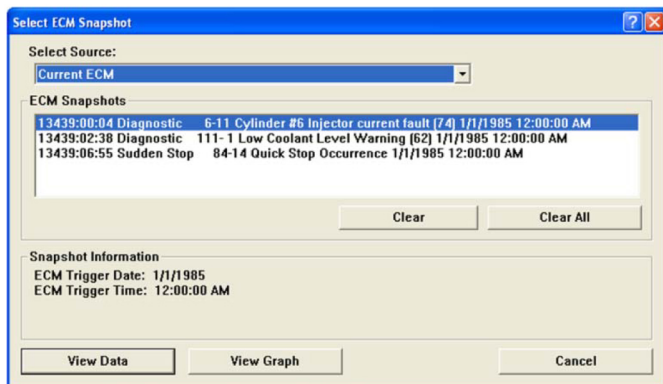
As part of this testing, two 5EK 3406E “CA” ECMs which were incapable of recording time and date information were examined. For snapshots written by the authors, a date and time was shown in conjunction with the saved records. However, for each occurrence, the snapshot was shown as having occurred on January 1, 1985 at 12:00:00 a.m. This is shown in [Figure 9](#). It should be noted that while the dates and times are shown as being the same for three snapshots, diagnostic clock intervals confirm that they occurred at different times.

**Figure 9. Date and Time Stamp for 5EK 3406E “CA” ECM without Clock Ability**

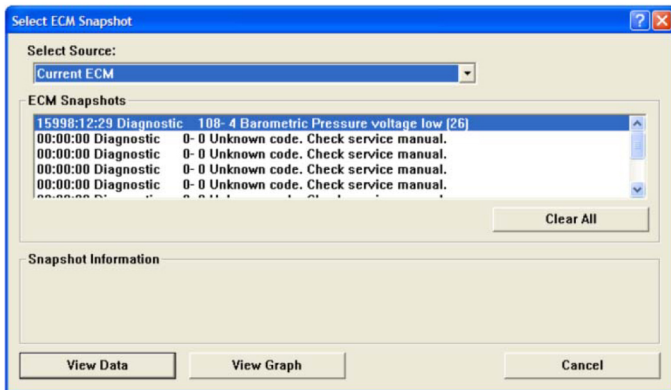
In some tests, when power was reapplied to the ECMs, an initial control snapshot triggered by the authors was shown along with several other new snapshots labeled as being “0-0 Unknown Code.” These additional Snapshots were shown as having occurred at diagnostic time “00:00:00.” Furthermore, the diagnostic time for the snapshot was shown to have occurred at diagnostic time “15998:12:29.” However, the fault was actually set at “13438.12.29.” An example of this observation is shown in [Figure 11](#).

**Figure 11. Available Snapshots Following Loss of Power to 5EK 3406E “CA” ECM.**

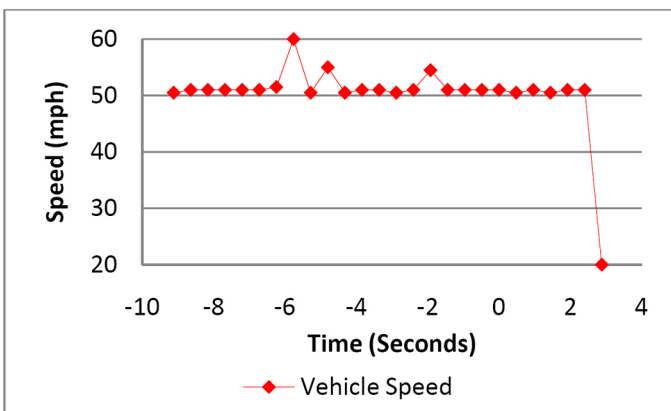
When viewing the files imaged after the power loss in comparison with the control (pre-power loss) snapshots, data were found to be anomalous. For example, what should have been displayed as relatively constant entries were instead records with sharp spikes and/or changes in the data. [Figure 12](#) shows the snapshot data prior to initiating the power loss, while [Figure 13](#) shows the file after it was displayed with an improper diagnostic time and in combination with “0-0 Unknown Code” entries.

**Figure 13. 108-4 Barometric Pressure Voltage Low Control Snapshot As Imaged After Power Loss.**

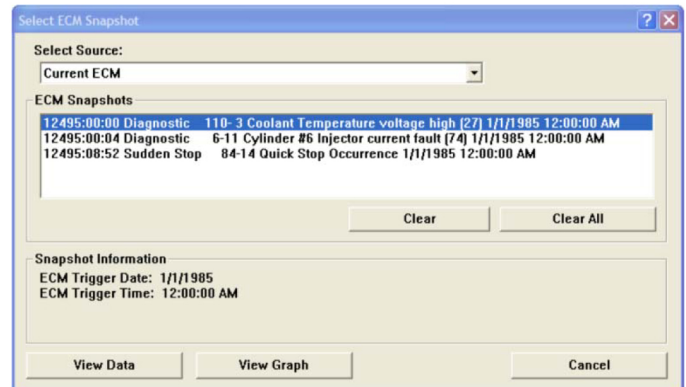
As was stated previously, although a Quick Stop file was created, the authors were not able to retrieve the data from either “CA” ECM that was tested. In spite of the Quick Stop event having been logged and a snapshot being shown as available, an error message was received when attempting to

**Figure 14. 5EK 3406E “CA” ECM Showing an Available Quick Stop Snapshot.**
