# Analysis of Ticking Noise from Cam Bearing of a Diesel Engine

Jouji Kimura, Ayumi Kasai, Shuji Saitoh and Atsushi Yamamoto  
Isuzu Motors Ltd.

## ABSTRACT

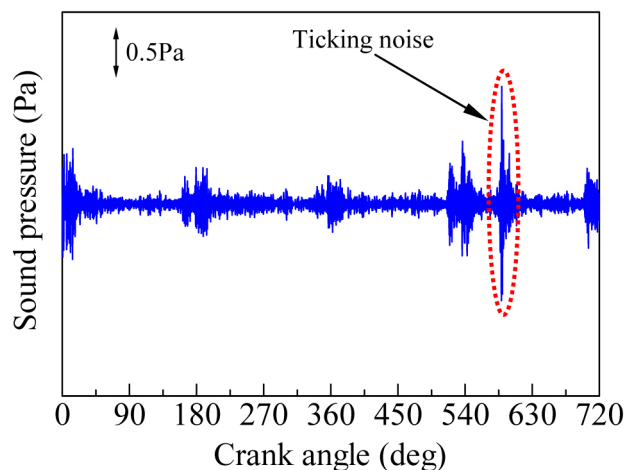
**Figure 3. Sound pressure in crank angle domain**

As ticking noise was heard from the intake camshaft, the following were measured; the vibrations on the bearing caps of the intake camshaft, the noise above the cylinder head cover and the crank angle with the engine speed, engine load and cylinder head oil temperature changed. Figure 3 shows the measured sound pressure which was processed with a high-pass filter with a cut-off frequency of 2.5 kHz, at an idling speed of 700 rpm and a cylinder head oil temperature of 120°C where the ticking noise was detected. Figure 4 shows the spectrogram of the ticking noise, and this indicates the frequency of the ticking noise is over 10 kHz.

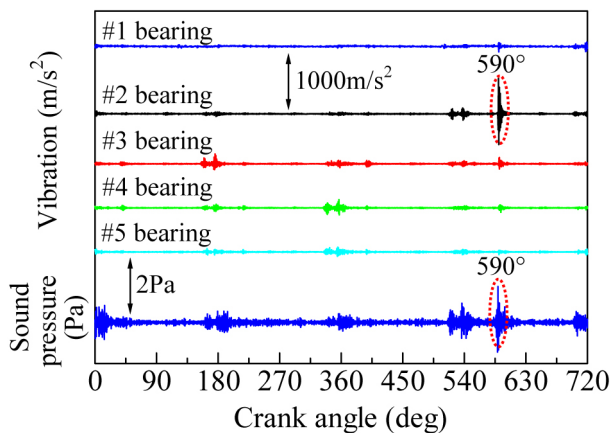
Figure 5. Ticking noise and cam bearing cap vibration

Figure 5 shows the vibration accelerations on the bearing caps of the intake camshaft and the sound pressure at an idling speed of 700 rpm and an oil temperature of 120°C when the ticking noise was detected. From Figure 5, it can be seen that the ticking noise comes from No.2 bearing because the extremely high acceleration appears only on No.2 bearing at the same timing as the ticking noise is detected, which is a crank angle of about 590° from the firing top dead center of No.1 cylinder. Ticking noise is closely related to the bearing vibration as shown in Figure 5. Therefore, the authors concluded that ticking noise could be recognized with the vibration instead of the sound pressure.

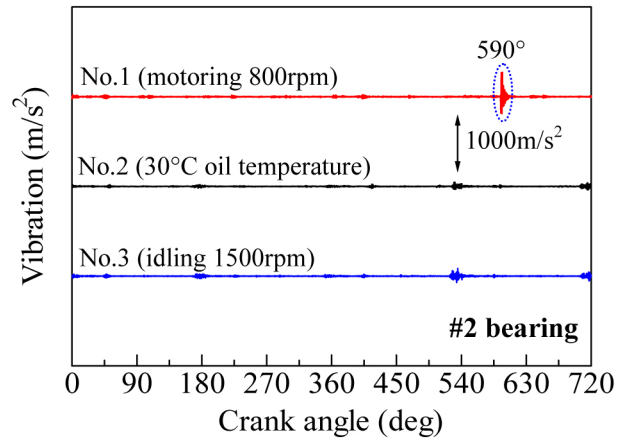
Figure 6. Vibrations under engine operating conditions shown in Table 2

Figure 6 shows No.2 bearing vibrations under the engine operating conditions shown in Table 2. This figure also shows the effects of the following parameters on ticking noise; firing/not firing (motoring), engine speed and oil temperature.

Ticking noise also appears under the motoring conditions. No.1 in Figure 6 shows No.2 bearing vibration at a motoring speed of 800 rpm and an oil temperature of 110°C. From No. 1 in Figure 6, it can be seen that ticking noise appears. Ticking noise disappears when the oil temperature is 100°C or lower, or when the engine speed is raised to 1500 rpm or higher. No.2 in Figure 6 shows No.2 bearing vibration at an oil temperature of 30°C and an idling speed of 700 rpm. No.3 in Figure 6 shows No.2 bearing vibration at an idling speed of 1500 rpm and an oil temperature of 120°C. From No.2 and No.3 in Figure 6, it can be seen that ticking noise disappears.

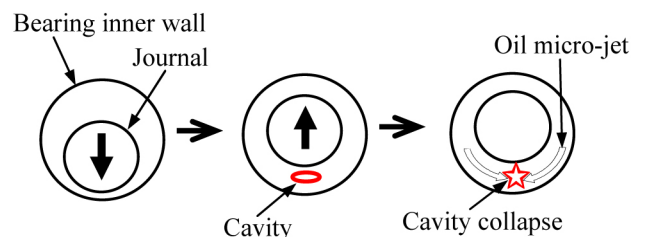
Figure 7. Mechanism of ticking noise occurrence

The authors assumed the generating mechanism of ticking noise from the cam bearing, based on their experiences of ticking noise from the main bearing of the crankshaft in a diesel engine, as shown in Figure 7 [2]. As the cam journal is getting close to the inner wall of the bearing under a cam force, the oil film pressure between the journal and bearing increases and reaches the maximum, and then the oil film thickness decreases and reaches the minimum. Cavity is formed when the journal leaves from the inner wall of the bearing and the oil film pressure suddenly drops to near zero because of the release of cam force. The cavity implodes forming an oil micro-jet [4] when the velocity of the journal center reaches the maximum. The impact force of the imploding cavity excites the bearing and this causes ticking noise. The possibility of cavitation occurrence in the oil film becomes higher (a) as the fluctuation of oil film pressure becomes larger, (b) as the oil film thickness becomes smaller, and (c) as the velocity of the journal leaving from the inner wall of the bearing becomes higher [2].
