# Full-Scale Burn Test of a 2001 Full-Size Pickup Truck

Jeff D. Colwell  
Exponent Inc.

**CITATION:** Colwell, J., "Full-Scale Burn Test of a 2001 Full-Size Pickup Truck," *SAE Int. J. Trans. Safety* 1(2):2013, doi: 10.4271/2013-01-0214.

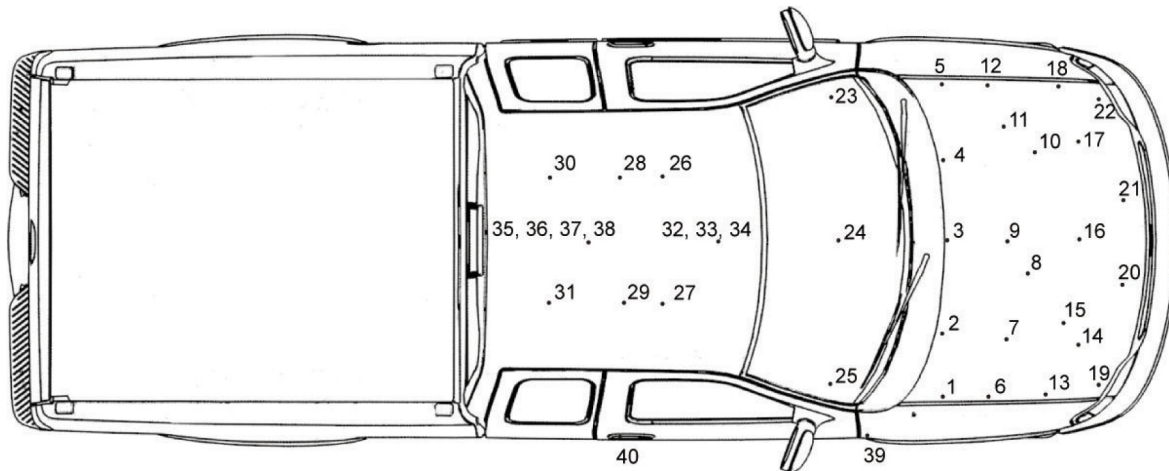
**Figure 1. Top view of instrumentation locations.**

The vehicle was instrumented with 40 24-gauge, K-type thermocouples with fiberglass insulation. The measurement junction of each thermocouple was created with a thermocouple welder that produced a nominal bead diameter of 1 mm. As shown in [Figure 1](#), 22 of these thermocouples were located in the engine compartment, 16 were in the passenger compartment and 2 were located on exterior body panels. [Table 1](#) describes each thermocouple location. The engine and passenger compartment thermocouples were held in place with steel wires in a grid-like manner, with the bead not in contact with any objects. Some thermocouples were located along the perimeter of the engine compartment to facilitate temperature contour plots at selected times. With the exception of channel 15, which failed at the onset of the test, all the engine compartment thermocouples were within 4

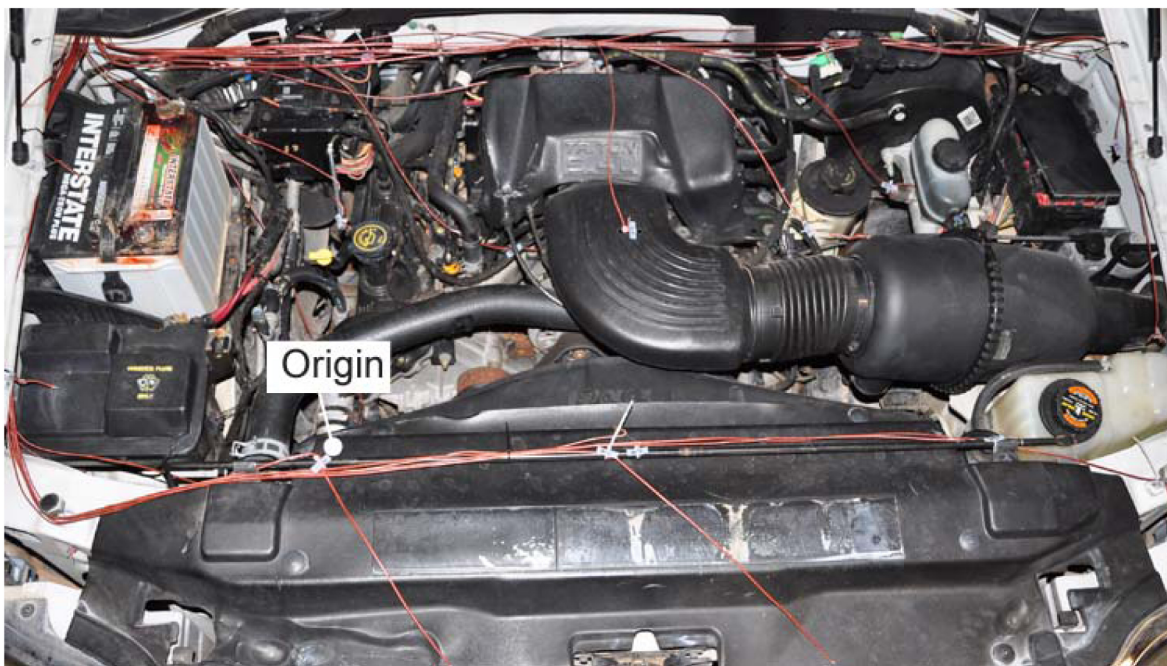
**Figure 3. Overview of the engine compartment components, fuel load and the point of origin of the fire.**

The fire was initiated using a small butane torch near the upper portion of the passenger side of the cooling fan shroud, as shown in [Figure 3](#). All data acquisition and video were synchronized to start at the time the torch was applied to this material. The torch was continuously applied to this location for 5 minutes and 7 seconds, and then the hood was closed.
