# Eliminating Engine Performance Degradation Over Time Through Compressor Redesign

Eric Krivitzky  
 Concepts NREC

Masashi Yamamoto  
 Mitsubishi FUSO Truck and Bus Corp.

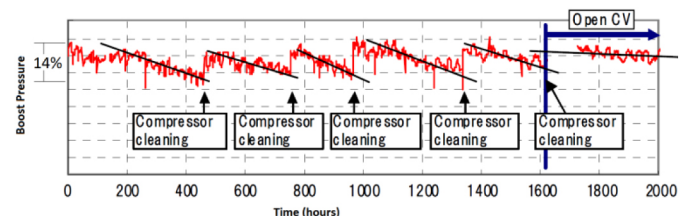
Diesel engines in the heavy-duty on-highway market are expected to perform consistently over extended maintenance and overhaul schedules. Minor deterioration in performance may be expected prior to engine overhaul, due to component wear and accumulated deposits, but significant degradation in power output or fuel economy over short periods of time is highly undesirable in a competitive market. Mitsubishi FUSO was experiencing such a scenario with one particular engine configuration. Engine durability testing revealed a reduction in turbocharger performance after relatively short runtimes. [Figure 1](#) indicates the boost pressure as a function of endurance test time. The test approach implemented engine controls to maintain a constant engine torque. As compressor pressure rise deteriorated, the system responded with an increase in exhaust gas temperature. In-field testing confirmed test-stand expectations of reduced engine power output. The deterioration of performance was linked directly

back to the ingestion of oil particles in the crankcase ventilation flow. If the crankcase vent was opened to atmosphere (OCV), rather than looped back to the engine inlet (CCV), the performance deterioration ceased.

**Figure 1. Boost pressure degradation over time on the engine endurance test stand. Cleaning of the compressor hardware returns performance back to initial levels.**

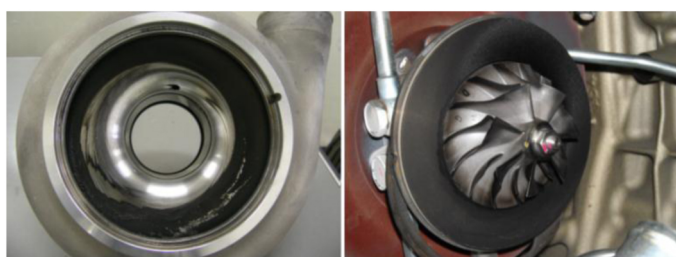
Disassembling the turbocharger after a few hundred hours of operation revealed a significant amount of oil accumulation on the compressor impeller, casing, diffuser, and volute walls, as indicated in [Figure 2](#). A thorough cleaning of the compressor components returns the performance to as-new condition for a small period of time (results shown in [Figure 1](#)).

**Figure 2. Oil buildup on the compressor's stationary and rotating walls.**

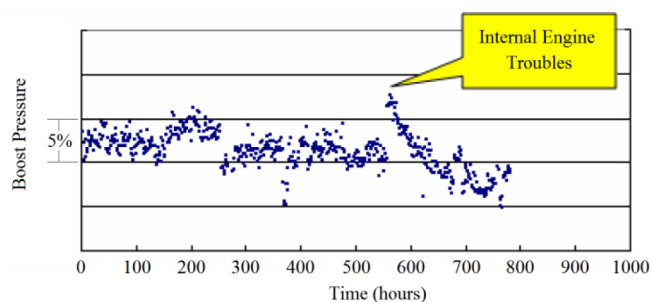
During the endurance test cycle, a second turbocharger model was fitted to the engine. This turbocharger, denoted 'B' herein, did not exhibit the same degradation in performance when subjected to the same environment as turbocharger 'A'. In fact, the performance with and without CCV was essentially identical, as shown in [Figure 3](#). Unfortunately, the reality of the situation was that turbocharger A provided higher performance levels and possessed additional traits, such that it was greatly preferred over turbocharger B. Oil accumulations were also observed in compressor B ([Figure 4](#)), however, the distribution of accumulation on the impeller was different than seen on compressor A.

**Figure 3. Compressor B performance does not degrade with time, even in the CCV configuration.**

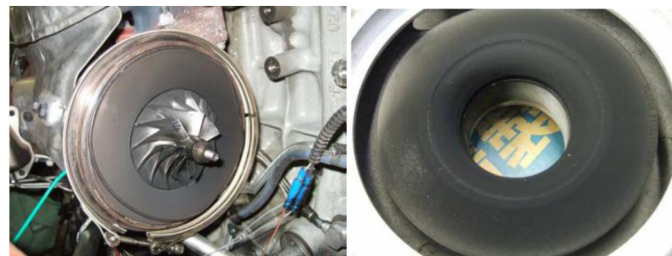
**Figure 4. Compressor B oil accumulation is similar to Compressor A on the stationary components.**

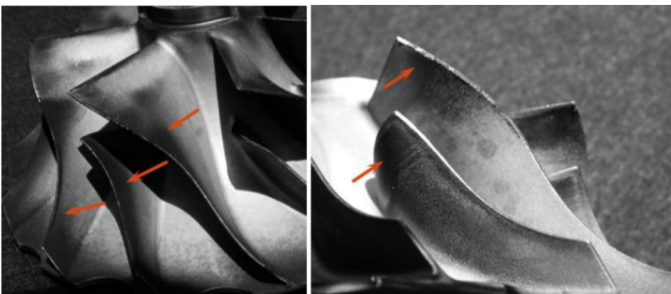
**Figure 6. Compressor A impeller oil deposit regions suggest high-incidence or near-surge operation.**

Careful examination of [Figure 6](#), showing the oil deposits on compressor A before installation of the blow-by filter, reveal deposition that is consistent with operation under high-incidence, or near-stall conditions. Two specific oily areas suggest this conclusion: there are significant deposits on the pressure side of the leading edge, while the suction side remains relatively clean. Further along the passage, a region of oil is observed that spans the passage and then appears to migrate towards the tip. The pressure side deposits are likely

inertial in nature, while the flow may be separating off the suction side of the leading edge, resulting in the relatively clean section of blading and the creation of a secondary flow region that migrates towards the shroud as it combines with the tip clearance flow (as depicted in [Figure 8](#)).

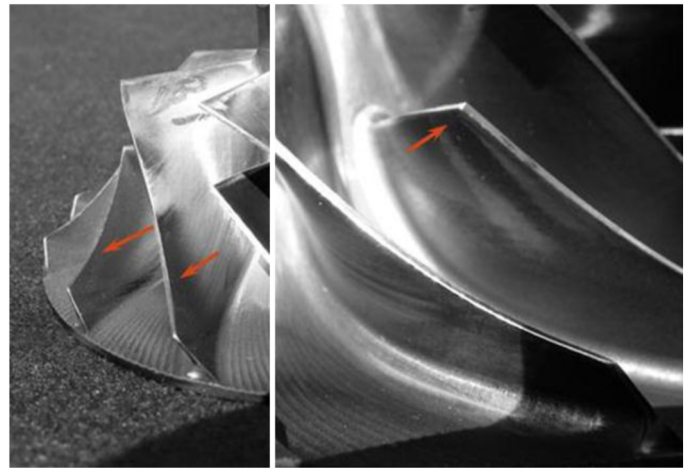
**Figure 7. Compressor B impeller oil deposit regions indicate a relatively benign compressor operating point.**

Close examination of [Figure 7](#), showing oil deposits on compressor B before installation of the blow-by filter, suggests minimal recirculation within the flow field and relatively benign incidence. The oil accumulation along the blade tip in the exducer region is consistent with traditional regions of low-momentum fluid found in this class of compressor, even at peak efficiency. Some accumulation is noted along the pressure side of the splitter blade, and this may be the result of negative incidence on the splitter itself or

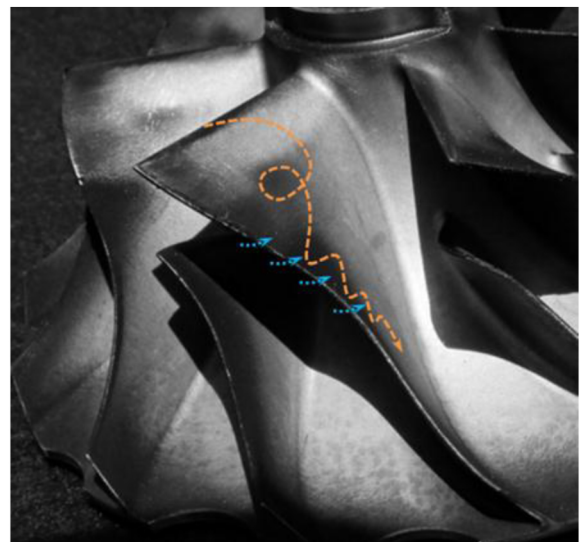
**Figure 8. A sketch showing the likely secondary flow field effects contributing to oil deposits within compressor A, operating at high incidence.**
