# AEROSPACE INFORMATION REPORT

**AIR5913™**
**REV. A**

## (R) Landing Gear Component Heat Damage

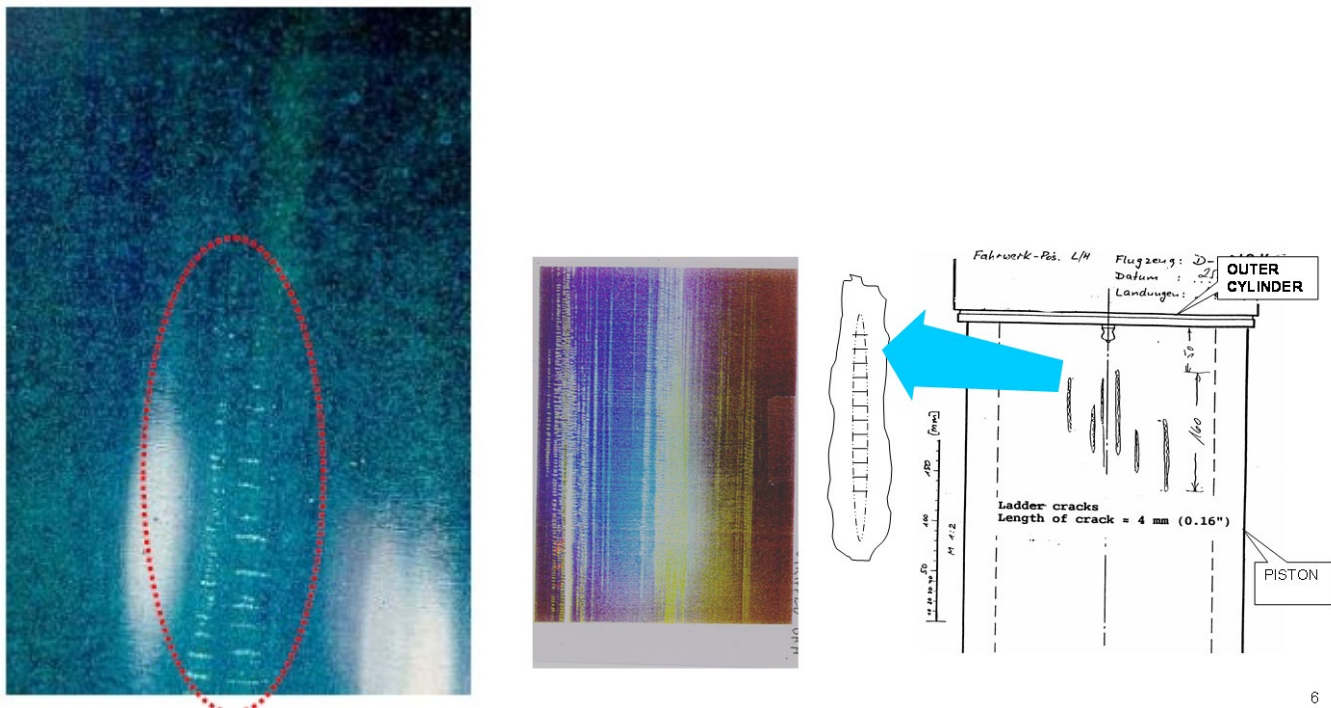
**Figure 3 - Ladder cracks**  
(magnetic particle indications evident in the photo to the left)

It is not possible to visually determine if base metal heat damage is present in landing gear shock struts, but when it does occur, it is typically accompanied by changes to the appearance of the chrome plating in the affected area. Visible evidence of possible damage can consist of bearing material transfer onto the chrome plate, darkened streaks, and/or smeared, chipped, or flaking plating. More severe cases of damage can be detectable by the naked eye as evidenced by plating breakdown in the form of multiple linear cracks that are oriented like rungs of a ladder, creating a condition commonly referred to as "Ladder Cracks" (see Figure 3). These cracks sometimes penetrate the substrate material and have led to a structural failure or rejection of the damaged part.
