## No. CF-87-13

### AIRWORTHINESS DIRECTIVE

### CF-87-13 SAUNDERS

Applies to all Saunders ST-27 aircraft.

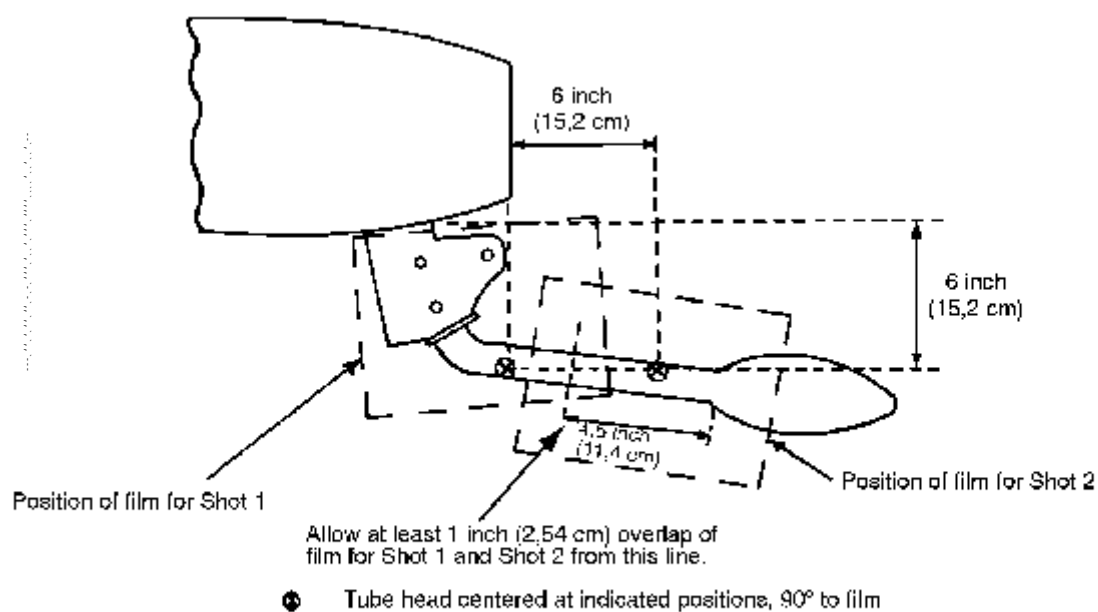
On June 21, 1987, British Aerospace issued Mandatory Technical News Sheet No. W19 concerning the aileron mass balance weight assemblies of Heron 114 aircraft, in response to a reported case of severe internal corrosion of a mass balance weight assembly. The aileron assemblies of the Heron were retained in the aircraft's conversion by Saunders to the ST-27.

2. Where no visible evidence of corrosion is apparent:
  - (a) within 28 days of the effective date of this Directive, perform a radiographic inspection of the mass balance weight assemblies, as shown in Figure 1 below, to detect internal corrosion in the double-tube-construction mass balance weight assembly arms, and

Table I of this Directive provides details required for the radiographic inspection. Figure 1 shows X-ray film and tube head positions for the inspection.

- (b) where evidence of internal corrosion is found by radiographic inspection, replace the affected mass balance weight assembly with a serviceable unit before further flight.

The radiographic inspection of 2(a) above must be performed by a radiographer qualified to CGSB Standard 48-GP-4M, Level II.
