## No. CF-88-07R2

### AIRWORTHINESS DIRECTIVE

### CF-88-07R2 MESSERSCHMITT-BOLKOW-BLOHM

Applies to all models of the BK 117 and BO 105 equipped with main rotor blade rotating control rod-ends, P/N 105-13141.01 and 105-13142.01.

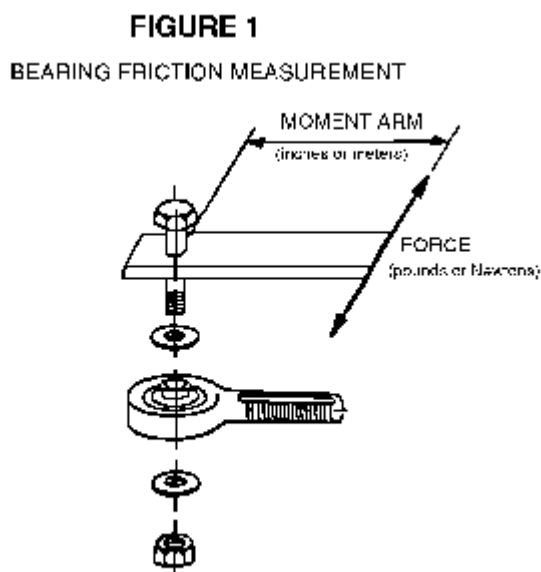
- 1) Remove the control rods from the helicopter.
- 2) Remove the rod-ends from the control rods.
- 3) Measure the force required to rotate the inner race of the rod-end bearings in the circumferential direction around a bolt centerline (ref. Figure 1).

- 4) If the bearing torque (FORCE X MOMENT ARM) required to rotate the bearing inner race is more than 1.5 N-m (13.3 in-lb), accomplish either of the following:

- (ii) Reduce the bearing friction by installing a bolt through the bearing inner race and tighten with a nut. Then, using a drill, spin the bearing at 60 to 100 RPM for 1- or 2-minute periods until friction torque is reduced to 1.5 N-m (13.3 in-lb) or below. Monitor temperature constantly to avoid overheating. (Bearing axial and radial play is not allowed.)
