## No. CF-91-38

### AIRWORTHINESS DIRECTIVE

### CF-91-38 DE HAVILLAND

Applies to all Boeing Canada, de Havilland Division Model DHC-1 Chipmunk aircraft.

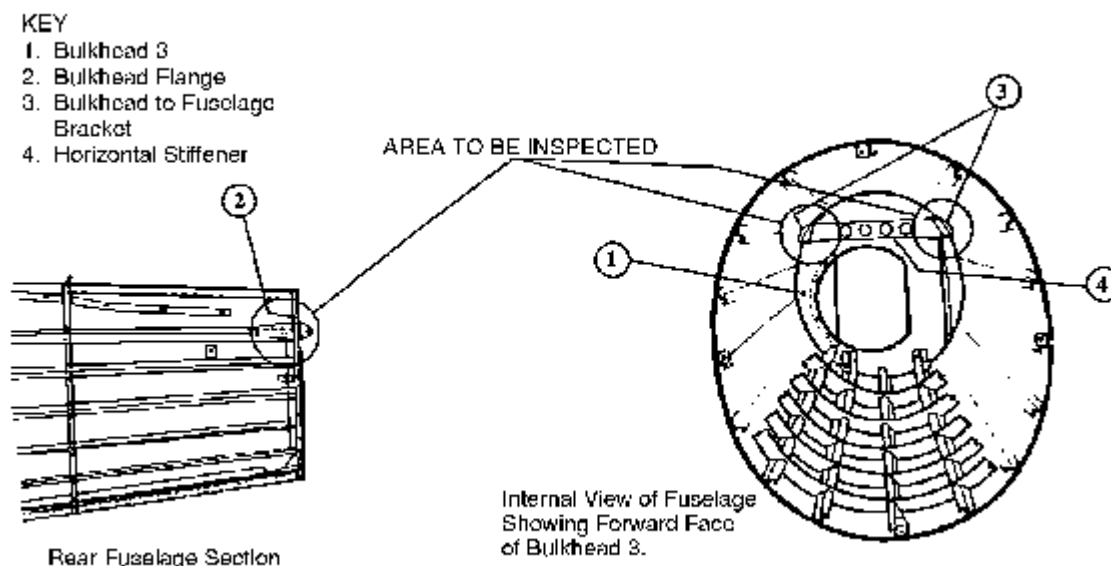
A significant number of fatigue cracks have been found on different structural components of the fuselage rear bulkhead in the area of the tailplane fitting. Cracks are initiated and propagated by reversed bending fatigue with multi-site origins. If not detected, cracks may grow to a critical stage, which could result in the failure of the fuselage rear bulkhead and the loss of the tailplane.

1. All aerobatic and glider towing flights are prohibited until an initial inspection per paragraph 2 of this directive has been completed.
2. Within ten (10) flight hours following the effective date of this directive, unless already accomplished within the previous 12 months, inspect the fuselage rear bulkhead for cracks as follows:
  - a) Remove the tailcone and gain access to the forward face of bulkhead No. 3 by removing the "D" cover plate covering the bulkhead lightening hole.
  - b) Locate the upper horizontal stiffener and brackets between the bulkhead and the fuselage (see accompanying illustration).

- c) Thoroughly clean the area around the stiffener brackets and the bulkhead flanges.
- d) Using a borescope with a flexible probe or a 10-power magnifying glass and a strong light, inspect the stiffener flange base, the bulkhead flange, the bulkhead-to-fuselage brackets on the forward face of the bulkhead and the area around the tailplane brackets in the aft face of the bulkhead for signs of cracks.
- e) If cracks are found, repair the cracked components before further flight.

- not exceeding 12 months or 200 flight hours, whichever occurs first, for original bulkheads; or
- not exceeding 36 months or 600 flight hours, whichever occurs first, for repaired or replacement bulkheads.
